Thomas Cole National Historic Site Historic Structure Report

Volume II: Appendices
October 2019

THOMAS COLE NATIONAL HISTORIC SITE
THOMAS COLE HOUSE
HISTORIC STRUCTURE REPORT
PMIS 216977

VOLUME II
APPENDICES

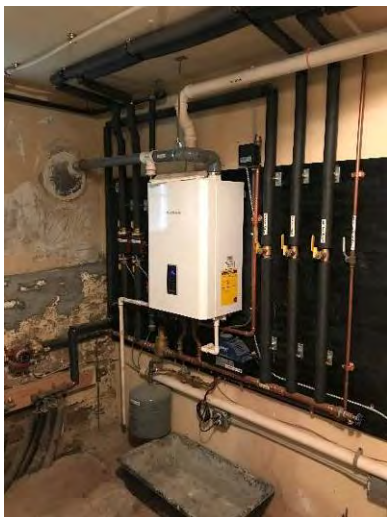
The Thomas Cole house heating hot water is provided by a natural gas fired condensing wall mounted boiler B-1, manufactured by Navien, model NCB-240 with a heating capacity of 112 MBH. The boiler is in the basement room B03 and was installed in 2016 along with additional HVAC upgrades and is in very good condition. The boiler provides hot water to three separate loops throughout the building in a reverse return piping configuration. Each loop has a Grundfos circulator to provide hot water out to the building. The first loop provides hot water to an air handling unit AHU-2 located in the attic serving the second floor. The second loop provides hot water to an air handling unit AHU-1 which serves the first floor. The third loop provides hot water to a radiant floor manifold with 4 PEX piping loops. The loops enter the floor in the boiler room and provide heating to the basement level. Additionally, the boiler has a 2" PVC combustion air intake routed to the exterior by the back porch off Room 102. The boiler 2" CPVC flue is routed directly out of the boiler into the base of the chimney. The flue piping is pitched back towards the boiler with a tee for condensate collection piped down to a separate condensate pump. The boiler and associated piping are installed neatly but the insulation is largely missing or incomplete.

*Wall Mounted Condensing
Boiler B-1 and Associated
Piping*

1. Remove all hot water piping insulation. Provide code compliant insulation throughout hot water system.
2. Remove flexible supply and return ductwork and replace with sheet metal ductwork. Remove nylon support straps and masonry support blocks and provide galvanized support straps.
3. Remove all refrigerant piping insulation. Replace with closed cell flexible elastomeric insulation. Fully insulate and seal suction and liquid lines from condensing unit connection to respective air handling unit.
4. Remove masonry blocks supporting AHU-2 and provide double neoprene isolation pads.

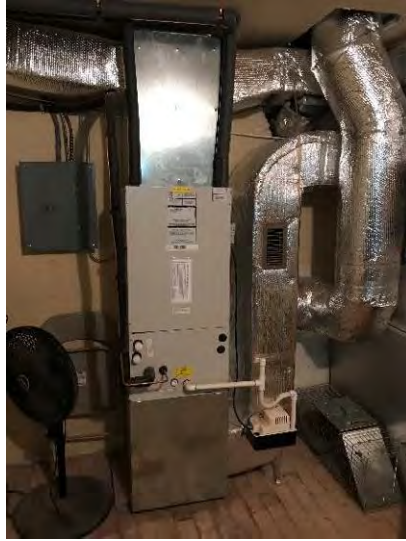
AHU-1 serves the first floor through floor registers located below the windows with a large return floor register located in the main corridor. Air distribution is provided by a combination of sheet metal and flexible ductwork throughout the basement level ceiling. AHU-1 and the associated ductwork were also installed as a part of the 2016 HVAC upgrades and are in good condition. Flexible ductwork is poorly supported with polyethylene straps and kinked, which can contribute to poor performance. AHU-1 has an integral drain pan with a pitched 3/4" PVC pipe to a remote condensate pump. This condensate is discharged to the exterior through rubber tubing.

AHU-1 Serving the First Floor

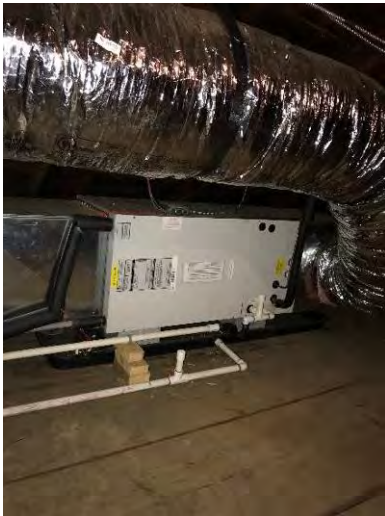
AHU-2 serves the second floor through ceiling supply grilles located above the windows at the exterior walls. The return air is drawn into the corridor and back to the unit through a sidewall grille located in the stairwell. Ductwork is a combination of sheet metal and flexible duct. Rigid ductwork is supported by masonry blocks which rest on the attic floor. Flexible supply ductwork is not supported, but rests on the attic floor. Much of the insulation is damaged or missing entirely. Return ductwork is flexible and supported from the attic rafters by nylon straps. AHU-2 is also supported by masonry blocks which will transfer vibration and noise to the space below.

*Horizontal Air Handling Unit
AHU-2 Serving Second Floor*

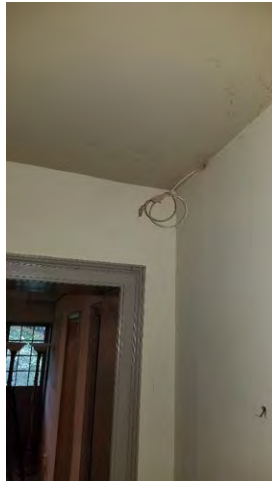
Exposed conductors

7. Repair or remove all exposed conductors in room B01.
8. Provide a new emergency lighting inverter system to energize new emergency LED lighting fixtures throughout the building.

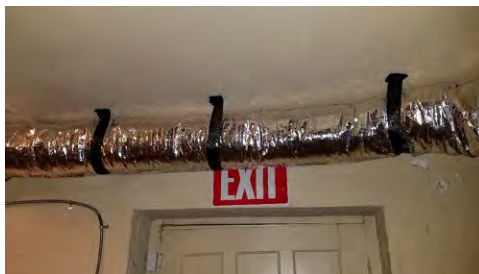
Exit Sign in room B03

2. The existing ductwork in room B03 on basement floor is blocking the exit sign for means of egress in violation of the International Building Code (IBC).

2. Relocate existing mechanical ductwork blocking exit sign in room B03.
3. Replace existing receptacles in B07 with GFCI receptacles.
4. Provide new weather proof enclosure for existing GFCI receptacle under the south deck.

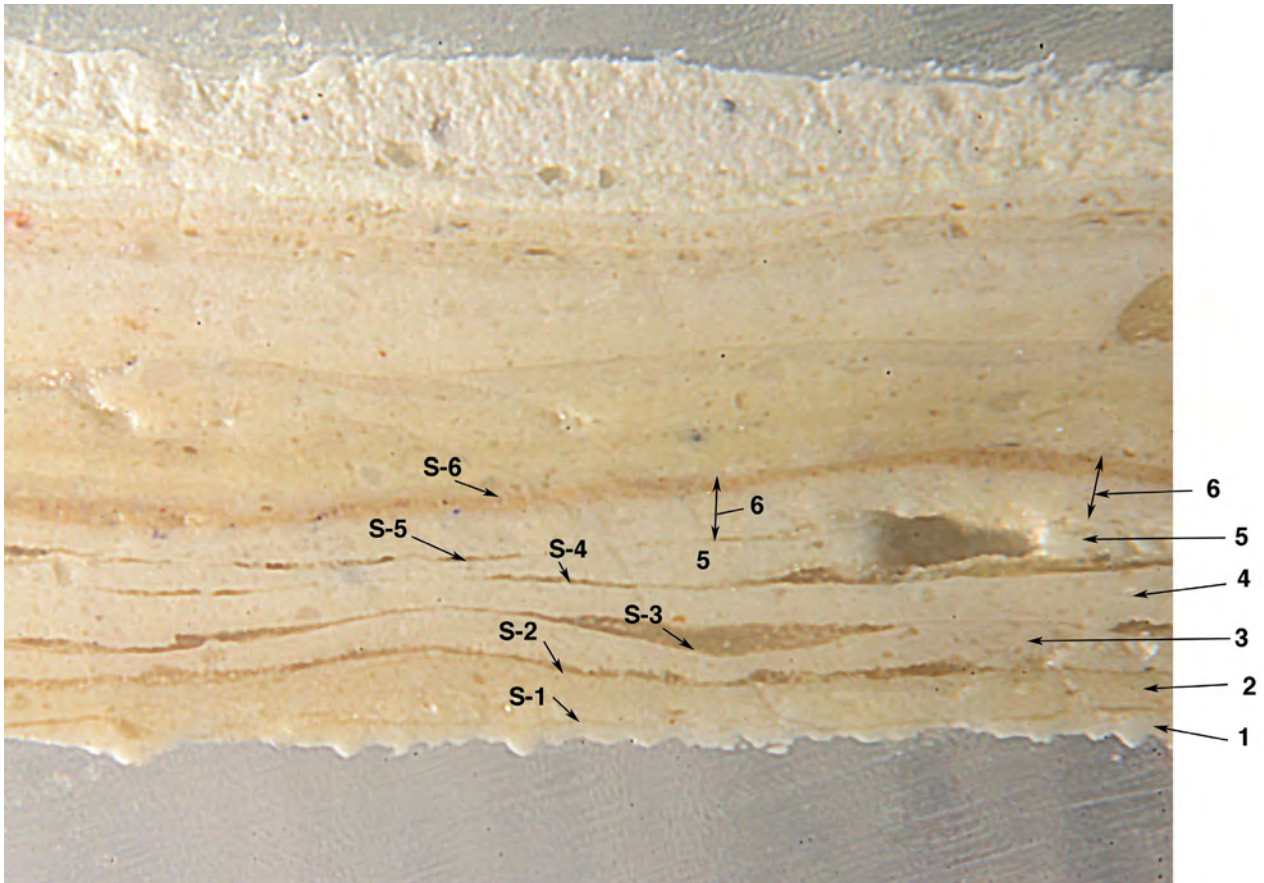
Note: the sample has been mounted in polymer resin, cut and polished to 8000 micron grit polishing cloth for additional examination. The paint accumulation has delaminated from the wood, however, the ridges of the first layer indicates the impression of the wood substrate. The critical layers for this study are the early finishes. Note that the light brown finish [6] is an excellent benchmark. These noted finishes are all prepared with lead white. The first finish [1] and the second finish [2] may both date to the pre-1836 Thompson period. It is estimated that finish 3 may be from the Cole period. Note also the distinct surface delamination planes at S-2, S-3 that indicate a longer exposure period. Finishes 4 and 5 may or may not be from the Cole period: this space appears to have been repainted more frequently than some of the other rooms. The surfaces of finishes 4 and 5 are also readily distinguished by the slight delamination of the succeeding finish in each case [S-4, S-5]. The sixth finish is prepared with a lead white ground and a light brown finish [6]. The later finishes are also seen in this cross section.

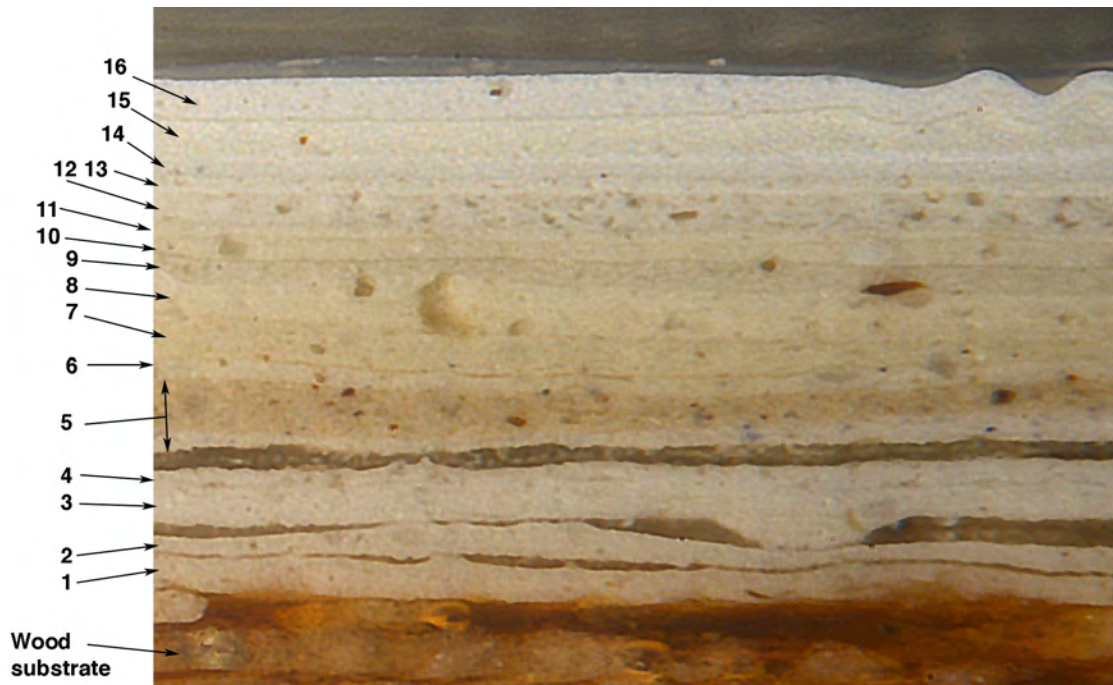
Note: the sample has been mounted in polymer resin, cut and polished to 8000 micron grit polishing cloth for additional examination. The wood substrate is seen at the base of the sample, as noted. The first finish on **Sample 101-1: Door Frame, Door to the East Parlor** is not present, rather it appears that the first finish on this element is the *second finish* on the Door frame. This suggests that the Pegboard may have been added between the first and the second painting campaign, during the pre- 1836 period. It appears that this pegboard would have been in place in 1836 when Thomas Cole married into the family. Note that the light brown benchmark layer is Finish 5 on the pegboard. There is a large build up of paint finishes, a total of sixteen finishes!

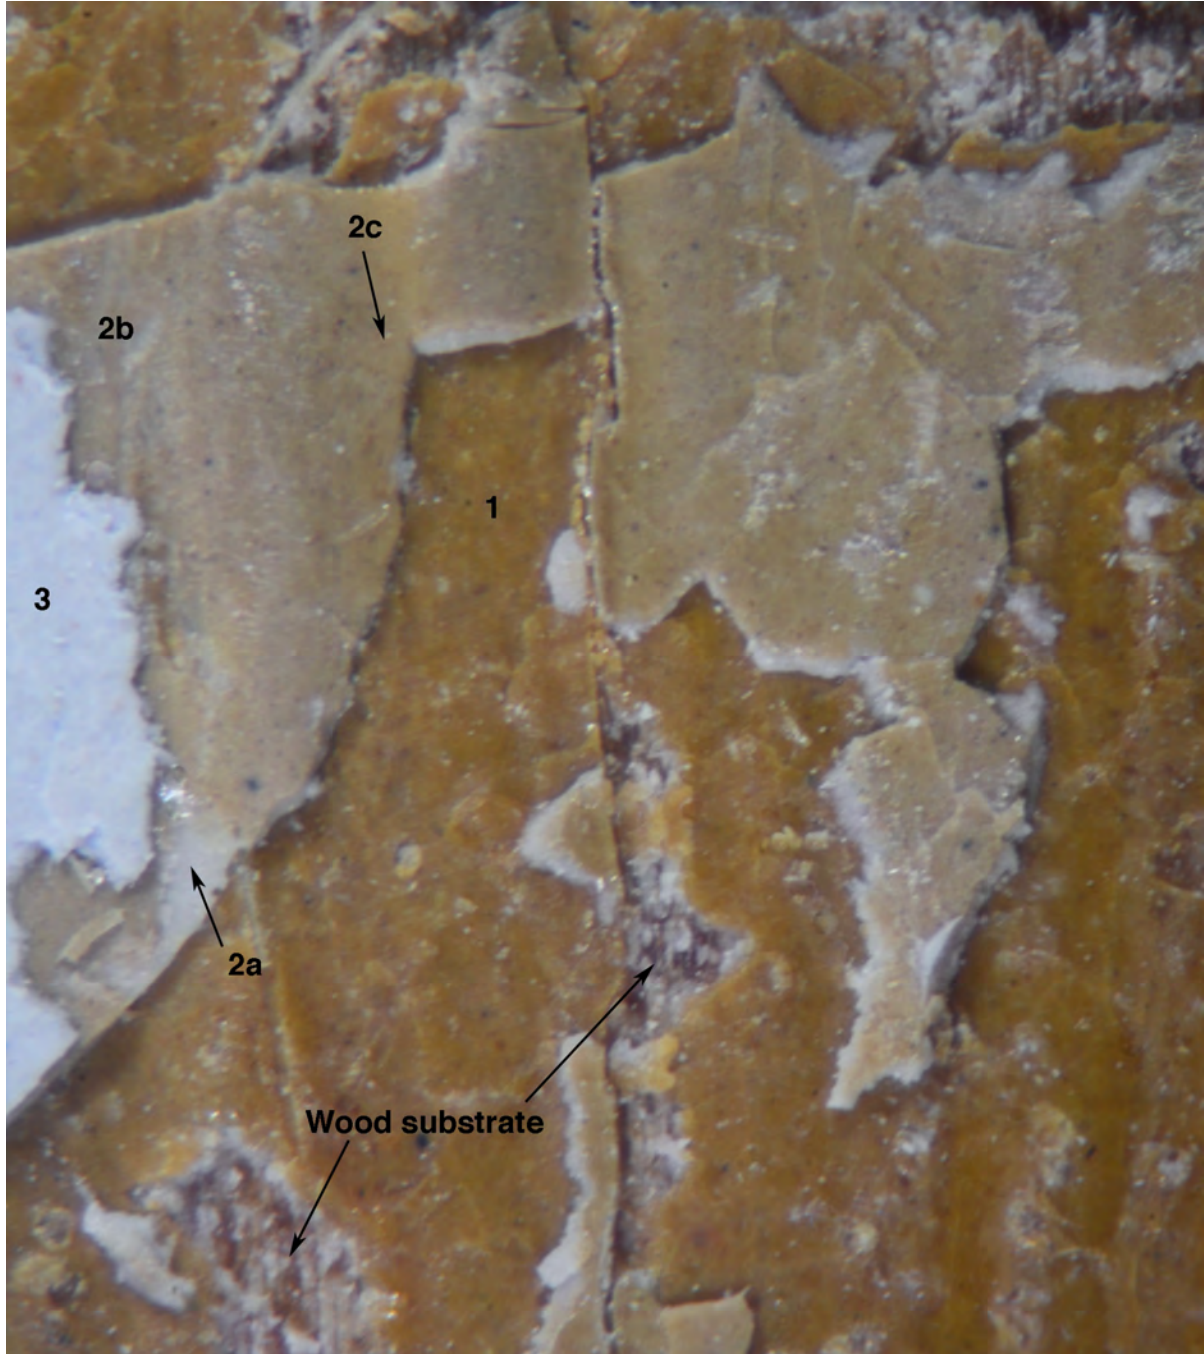
Note: The view of the sample is looking down onto the finish surface. The wood substrate is clearly seen where the paint finishes have delaminated. The yellow ochre first finish is clearly seen: this is a light wood grain effect. The second finish is visible: the white undercoat [2a], light brown [tan, 2b] finish is clearly seen: note the areas where the medium accumulation is particularly evident [2c] showing the yellowing of the surface. In this

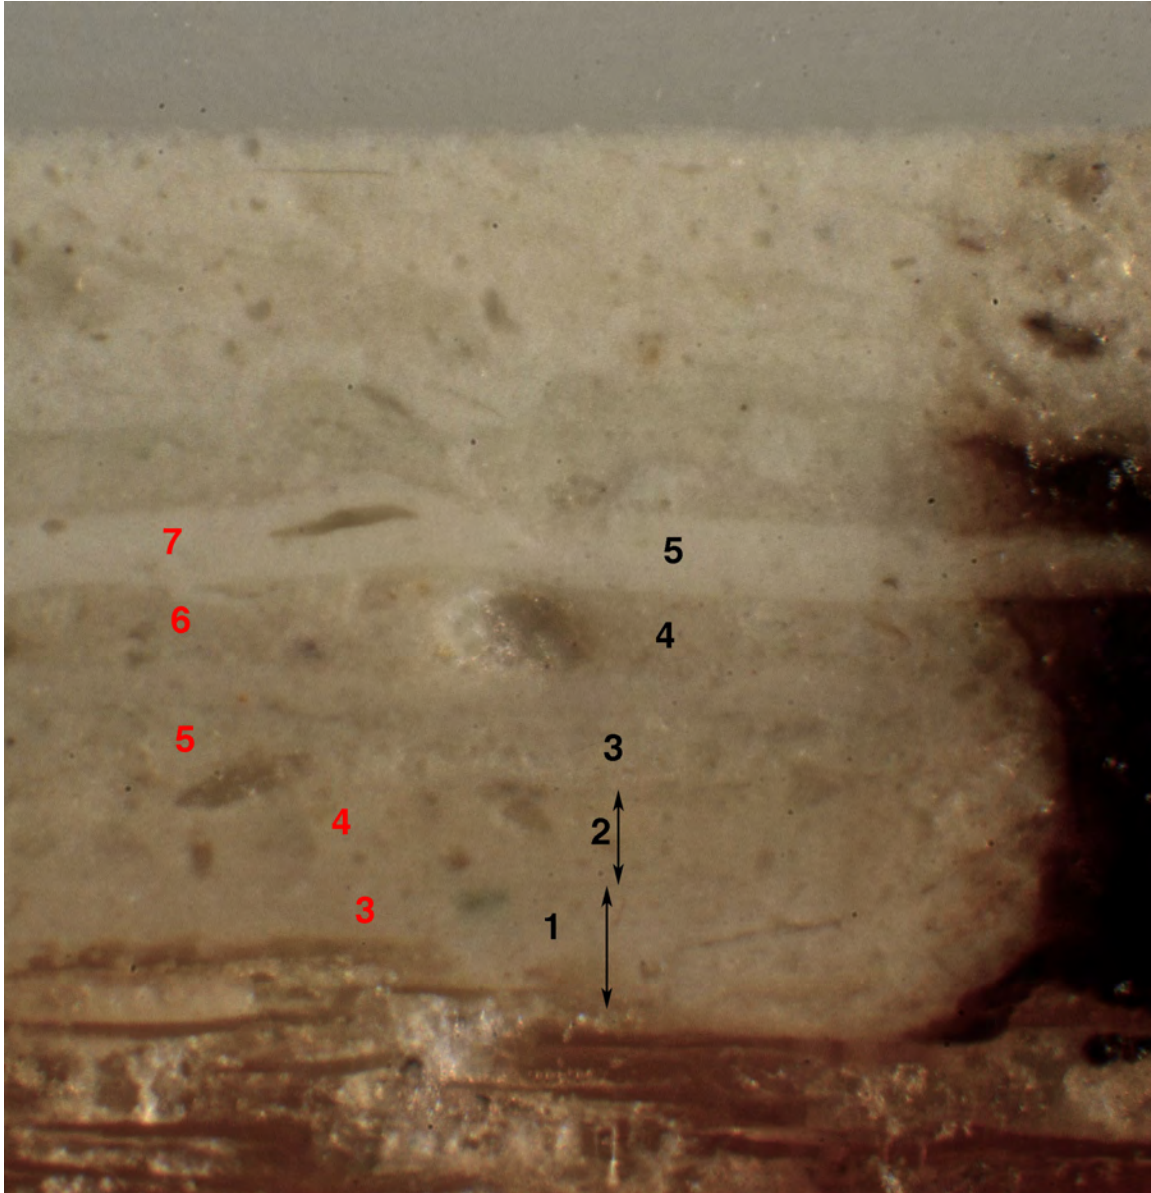
Note: The sample has been mounted in polymer resin, cut and polished to 10,000 micron grit polishing cloth for additional examination. The blackened area to the right has been exposed to a solution of sodium sulfide, which blackens the lead white component of the paint layers. The first layer [1] corresponds with the third finish on Sample 104-1: Door Frame of Door to Hall which is an original element [numbers shown in red]. This door and door frame are of a different design and have different molding profiles from the original woodwork.
