Thomas Cole National Historic Site Historic Structure Report

Volume I: Parts 1 & 2
October 2019

THOMAS COLE NATIONAL HISTORIC SITE
THOMAS COLE HOUSE
HISTORIC STRUCTURE REPORT
PMIS 216977

JOHN G. WAITE ASSOCIATES, ARCHITECTS

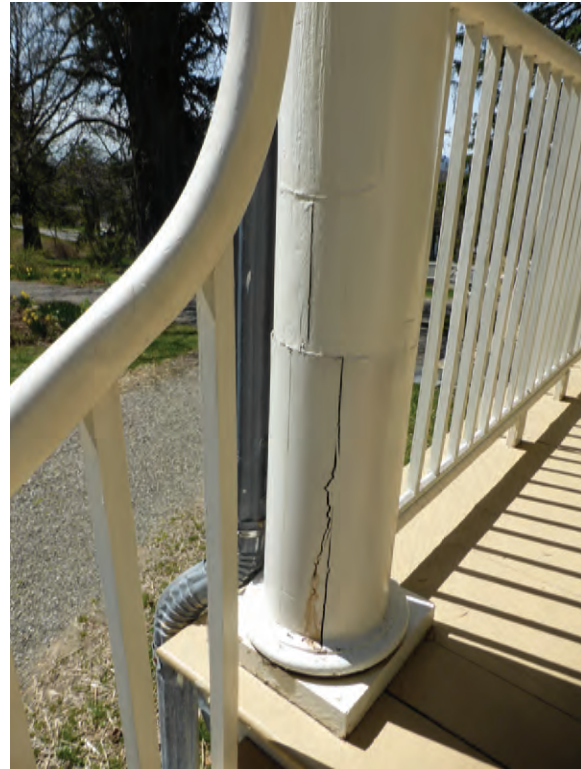
Figure 86. There are open seams in the repaired wood base of the southeast porch column. Water infiltration has caused rot and repair failure at several porch columns. JGWA, 2019.

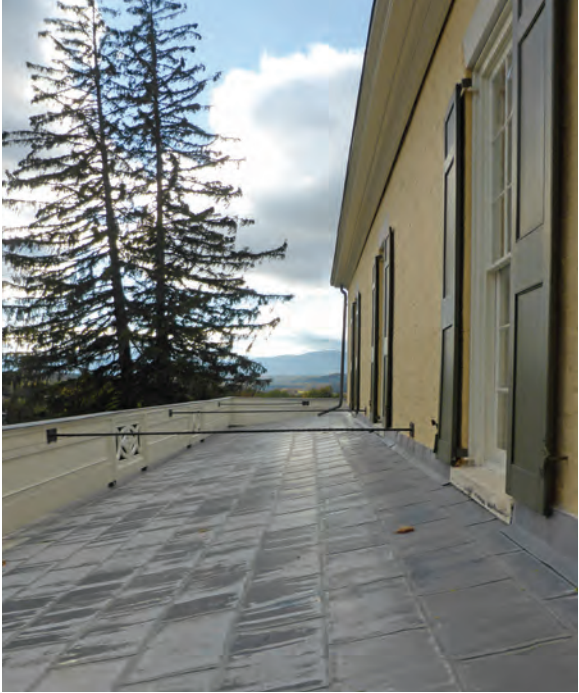
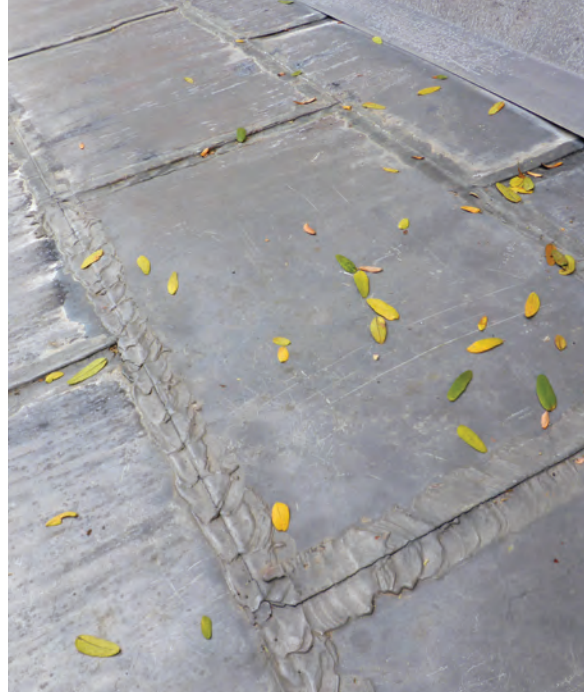
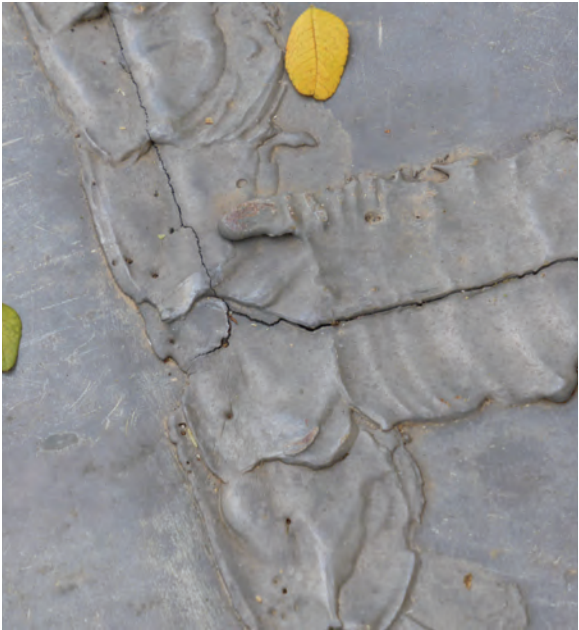
Figure 87. The excessive build-up of solder at the joints of the flat-lock seam metal roofing on the south porch has cracked. The soldered joints should be thoroughly sweated, so that solder flows freely into the seams. A cold joint, with solder build-up on the surface of the metal, does not provide serviceable performance. JGWA, 2019.

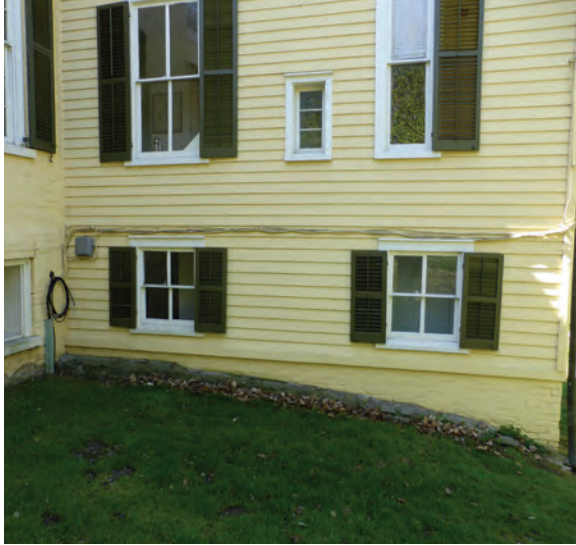
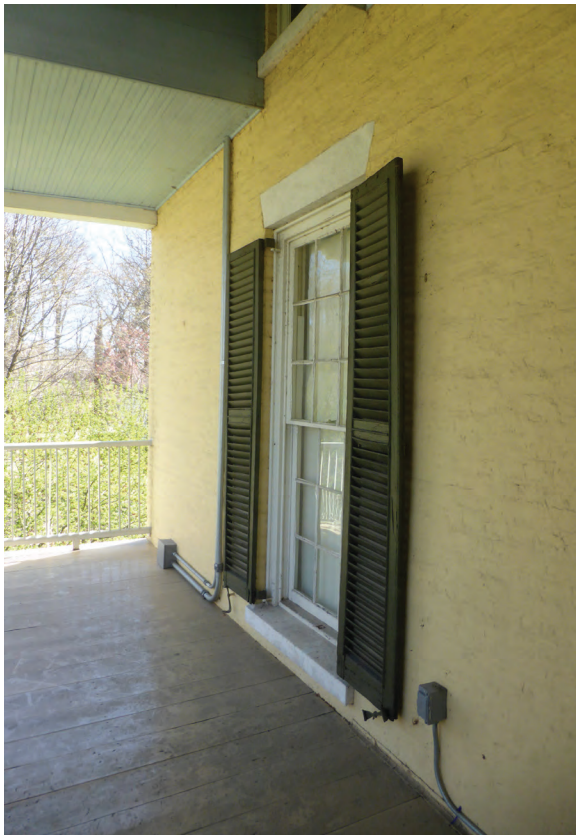
Figure 88. (Upper image) The low voltage wiring and cable routed along the façade of the north addition is visually obtrusive.

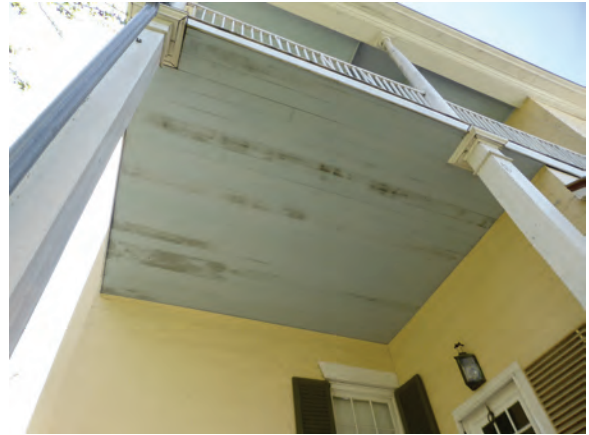
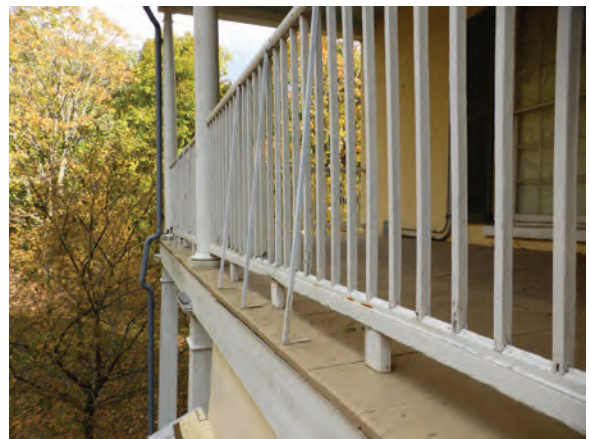
Figure 89. Northeast porch. Mildew is growing on the first-floor ceiling of the northeast porch (upper image). The wood railing is not well supported; it does not provide adequate resistance to lateral force, despite the addition of slender steel diagonal braces. The downspout at the northeast corner of the porch has broken loose of its attachment point on the post. JGWA, 2019.

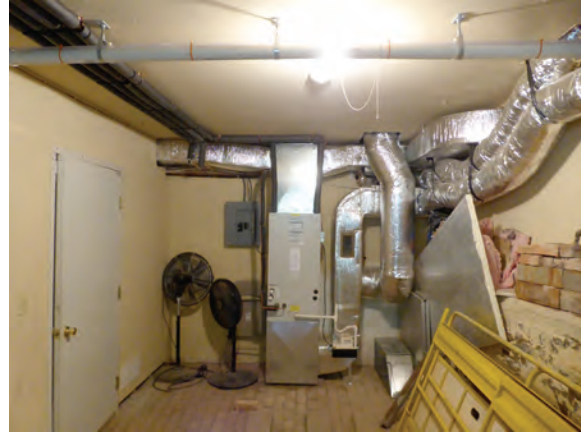
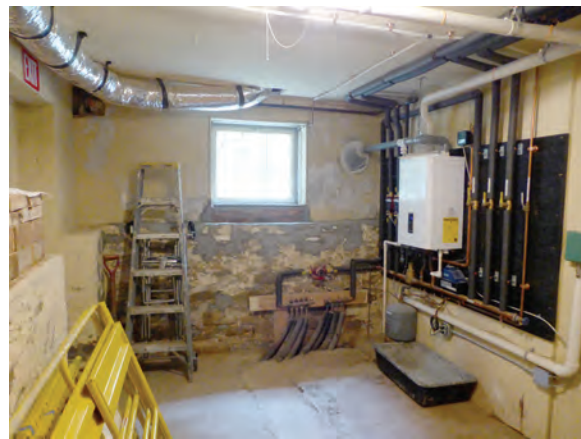
Figure 90. Heating pipes, manifolds and a gas-fired boiler have been surface-mounted to the walls at the southeast corner of Room B03. A fan-coil unit has been located at the west end of the room, and insulated ductwork has been routed throughout the space. The mechanical equipment thwarts historical interpretation of the space and increases the potential for fire. JGWA, 2019.

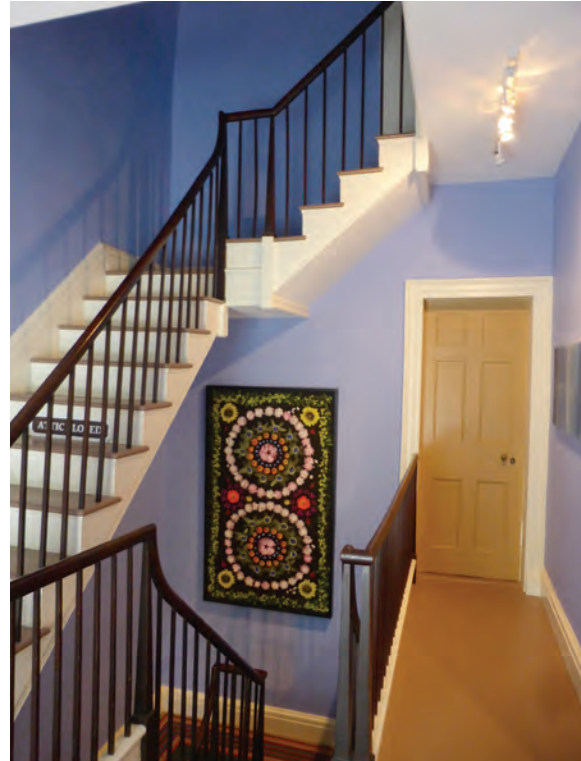
Figure 91. The interior stair railings are weak and will not resist lateral loads, particularly the horizontal railing at the second-floor landing and the raking handrail extending upward from the second floor. The later handrail is bowed outward to the east. JGWA, 2018.

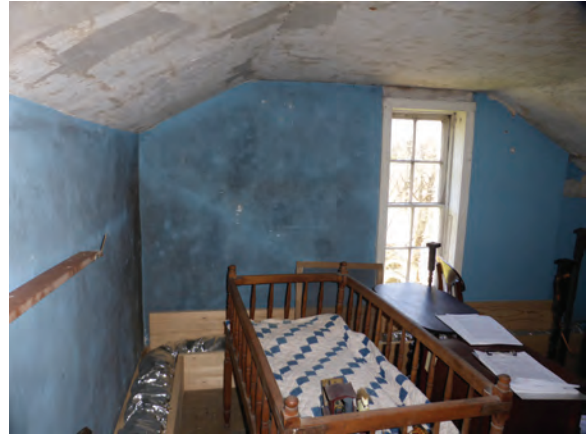
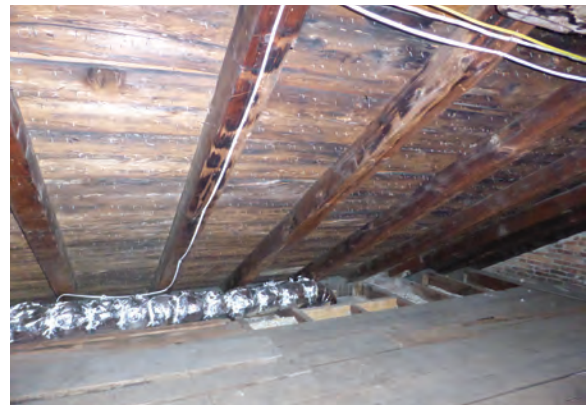
Figure 93. The paper and plaster ceiling and wall finishes in attic room 301 (upper image) are water-stained, dirty and cracked. Mildew appears to be growing on the walls in the northeast corner of the room. The roof rafters (lower image) are generally five inches wide and six inches deep, and spaced approximately thirty inches on-center. The roof structure may require reinforcement to adequately support snow loads. JGWA, 2019.
