Thomas Cole National Historic Site Historic Structure Report

Volume II: Appendices
October 2019

THOMAS COLE NATIONAL HISTORIC SITE
THOMAS COLE HOUSE
HISTORIC STRUCTURE REPORT
PMIS 216977

VOLUME II
APPENDICES

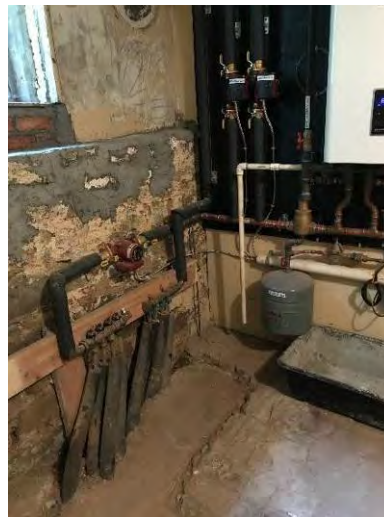
*Basement Radiant Floor Supply
and Return Manifolds*

1. Remove all hot water piping insulation. Provide code compliant insulation throughout hot water system.
2. Remove flexible supply and return ductwork and replace with sheet metal ductwork. Remove nylon support straps and masonry support blocks and provide galvanized support straps.
3. Remove all refrigerant piping insulation. Replace with closed cell flexible elastomeric insulation. Fully insulate and seal suction and liquid lines from condensing unit connection to respective air handling unit.
4. Remove masonry blocks supporting AHU-2 and provide double neoprene isolation pads.

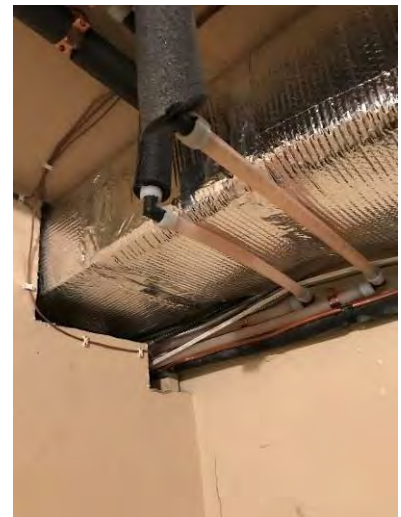
*Hot Water Supply and Return
PEX Piping*

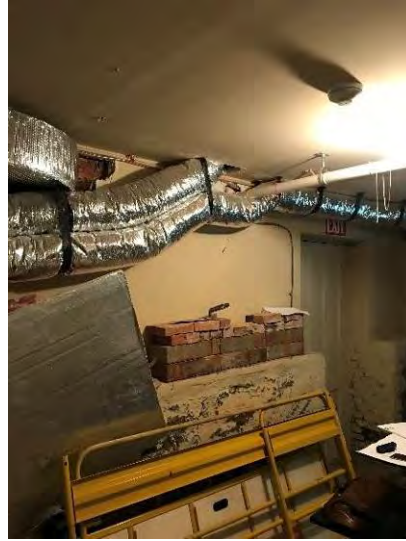
Flexible Ductwork and Polyethylene Support Straps

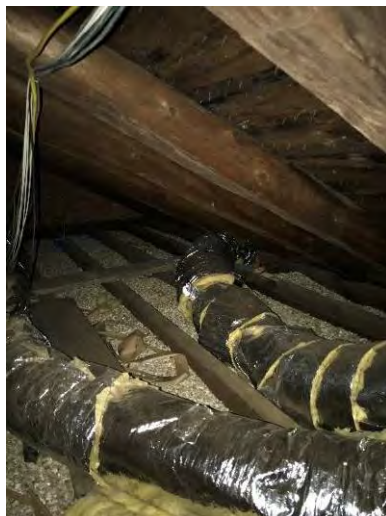
Flexible Ductwork in Attic Space

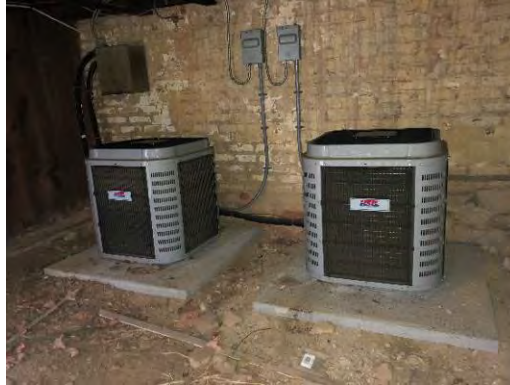
ACCU-1 and ACCU-2 are nominal 2-ton condensing units, manufactured by HEIL heating and cooling products, model number N4A324GKN200. They serve AHU-1 and AHU-2 and provide cooling to the first and second floors. Both units utilize R410A refrigerant and operate on 208V / 1PH circuits. The condensing units were installed in 2016 along with the other HVAC upgrades. The units are mounted underneath the front porch on cement equipment pads. The units are new in quality but should be serviced more often to prevent the heat exchanger fins from being clogged and reducing performance. Currently the fins require cleaning.

*Air Cooled Condensing Units Serving
AHU-1 and AHU-2*

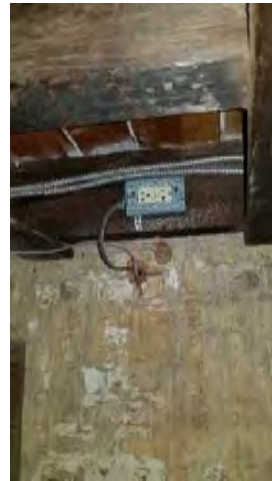
*Exterior GFCI
duplex receptacle*

2. Relocate existing mechanical ductwork blocking exit sign in room B03.
3. Replace existing receptacles in B07 with GFCI receptacles.
4. Provide new weather proof enclosure for existing GFCI receptacle under the south deck.

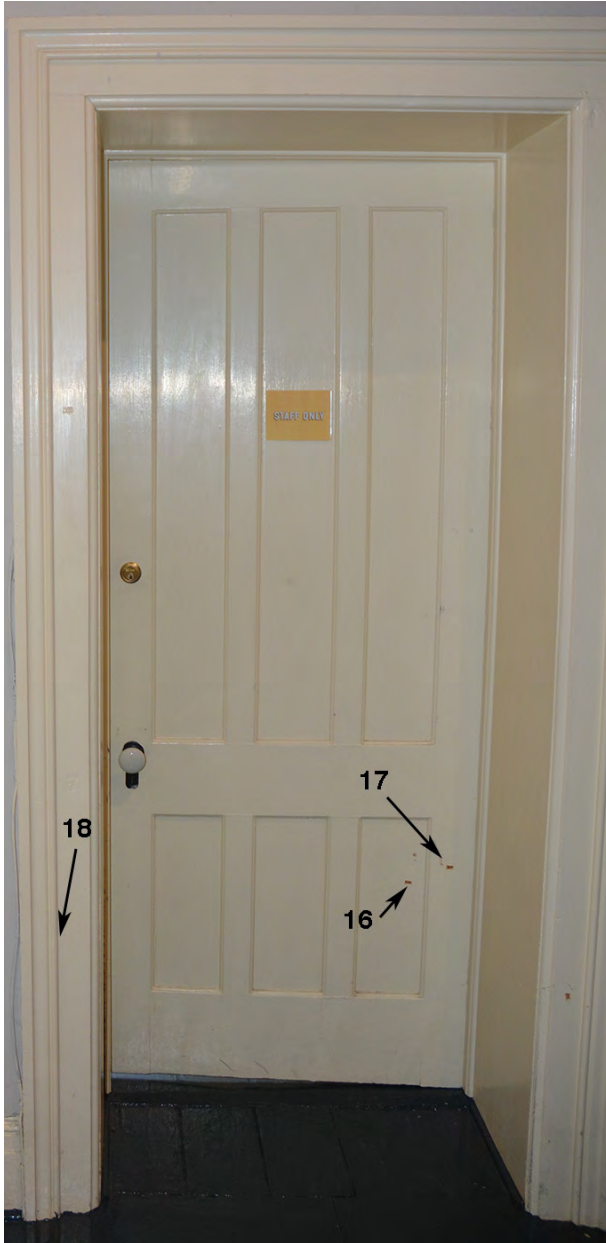
Room 104: North Wall, Door and Door Frame

Note: The door and door frame are not the same as the original doors and door frames seen on the south wall and the east wall. This door leads to the north ell, which is constructed of wood, as opposed to the masonry construction of the original house.

The cross section of the samples indicates that the first two paint finishes are missing from the door and door frame. The first two finishes are associated with the construction of the house, ca. 1815 and the Thomas Cole period 1836-1848. This indicates and supports the tradition that Maria Barstow Cole retained the decoration of the house as it was at the time of Thomas Cole's death in 1848 until her death in 1884. It appears that the north ell was added after that date, thus the addition of this door and door frame.

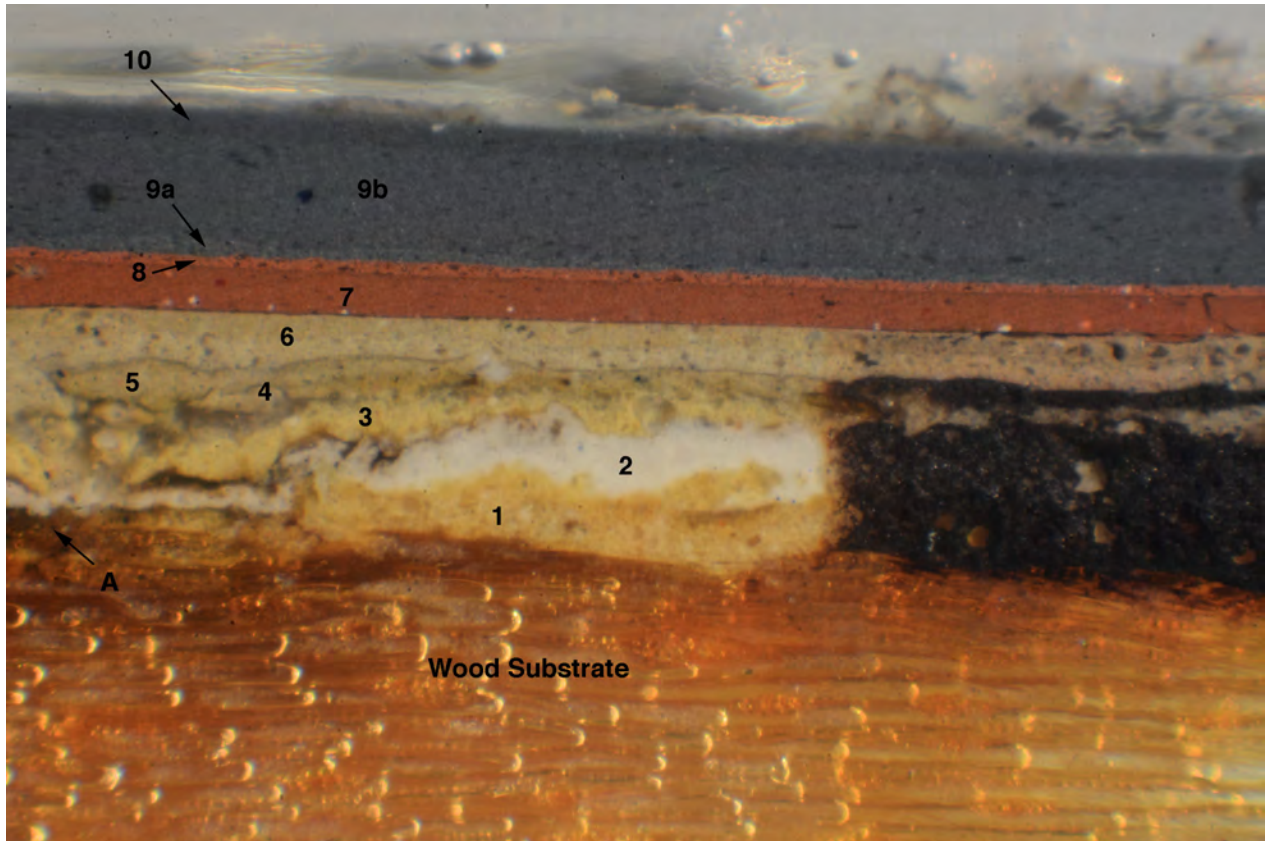
Sample 104-19: Floor boards, near north wall west of window frame

Note: The sample has been mounted in polymer resin, cut and polished to 10,000 micron grit polishing cloth for additional examination. The blackened area to the right has been exposed to a solution of sodium sulfide, which blackens the lead white component of the paint layers. There appears to be some surface particulate under the paint layers, however, the early layers were made with lead based pigments.

According to Historic Interiors Consultant Jean Dunbar, the floor of Room 104 was carpeted. Considering that the evidence that the floor enamels post date the installation of the cast iron radiators, all of the floor enamels probably date to the early to mid twentieth century.

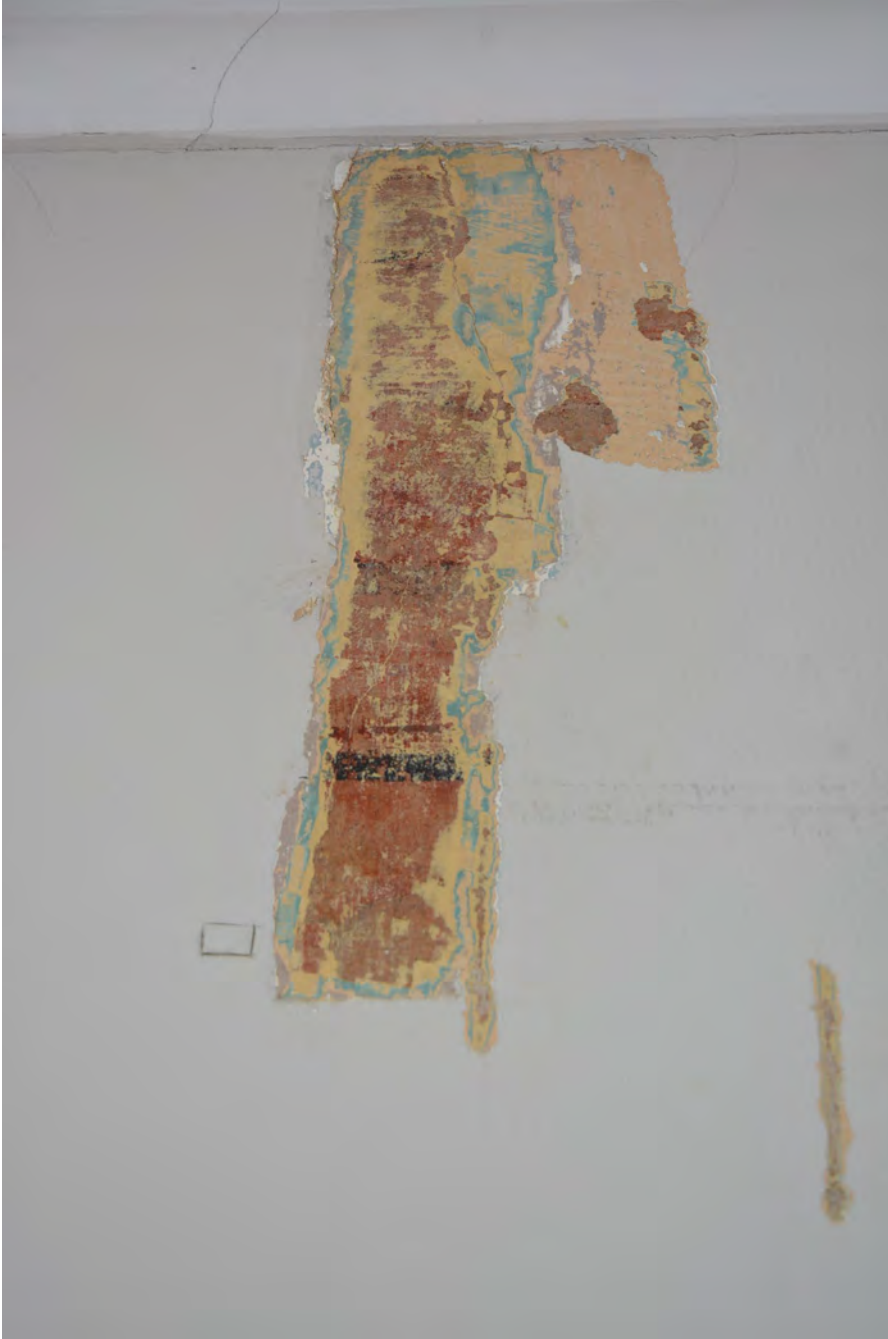
The Ceiling: The ceiling of Room 104 is new, dating from the period of the restoration. It is supported by a modern cove molding at the wall. This is seen in the photograph below, showing the exposure of the newly discovered frieze.

Note the new ceiling and cove molding are from the restoration ca. 2000. The frieze appears to continue behind the ca. 2000 period ceiling, as in the West Parlor

The exposure shows the banding that is part of a wide frieze in this room.

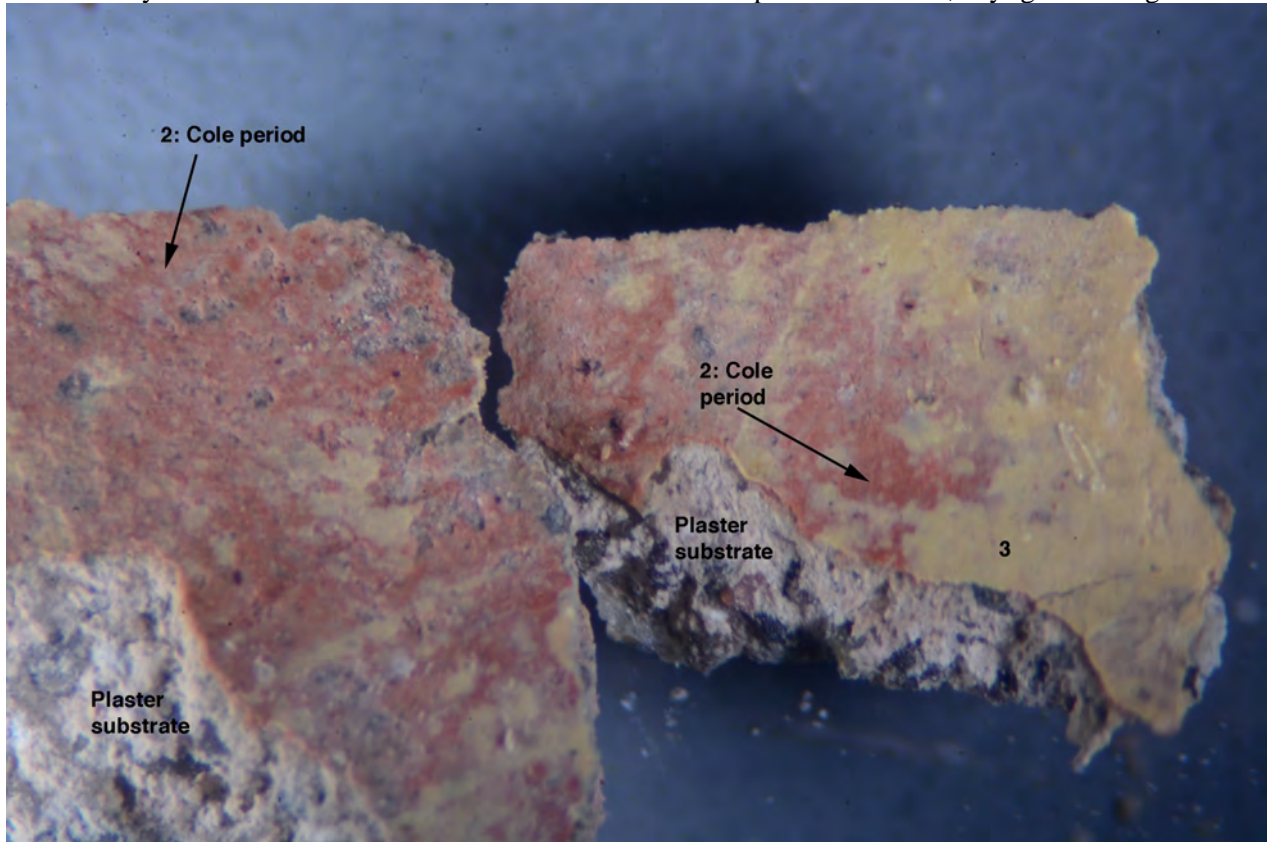
Sample 104- 20: Wall sample, 1'-0" below the modern cove molding

Note: The sample is viewed looking down onto the finish surface, from the side of the sample. The plaster substrate is clearly visible. Note the light red ground color, which is the Cole period color. It appears that this may not have been repainted after ca. 1884, but was repainted in the early twentieth century [3] with the light yellow finish.

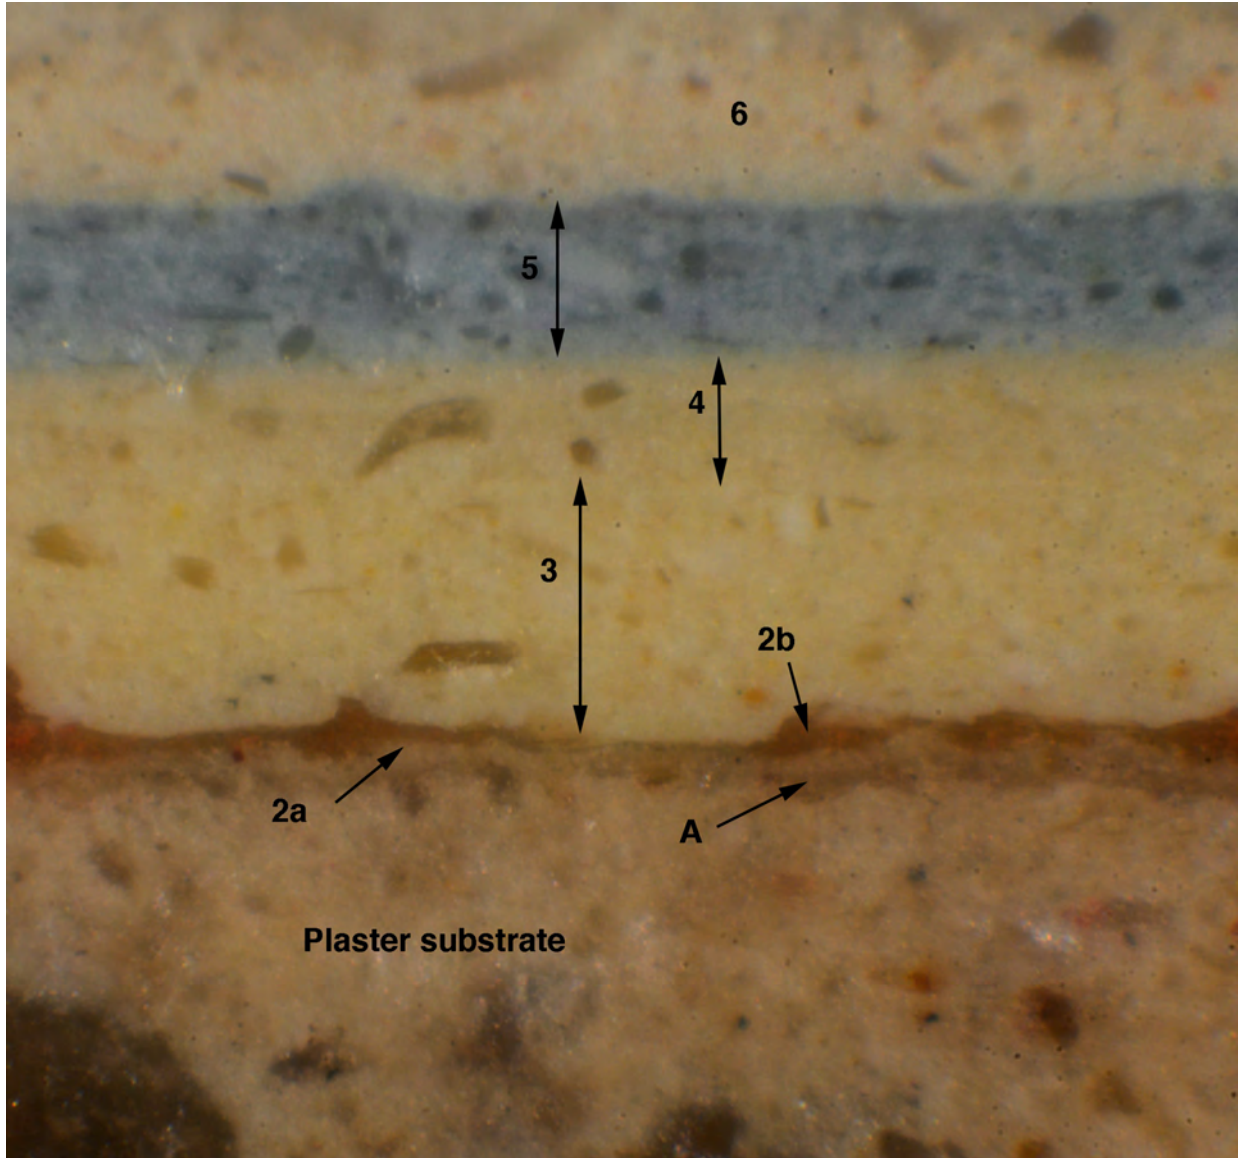
Sample 104- 21: Wall sample, North Wall, 10” above the baseboard

Note: The sample has been mounted in polymer resin, cut and polished to 10,000 micron grit polishing cloth for additional examination. The plaster substrate is clearly seen at the base of the sample. There is a thin line of water soluble glue substrate [A] that may indicate that the walls were papered in ca. 1815. There is a thin light brown undercoat [2a] that supports the thin red ochre finish [2b]. The thickness is varied, which may indicate damage from later scraping and preparation for repainting. The third and fourth finish appear to be from the first half of the twentieth century [3 and 4]. The blue finish [5] is associated with Edith Cole Silberstein: these are twentieth century finishes.

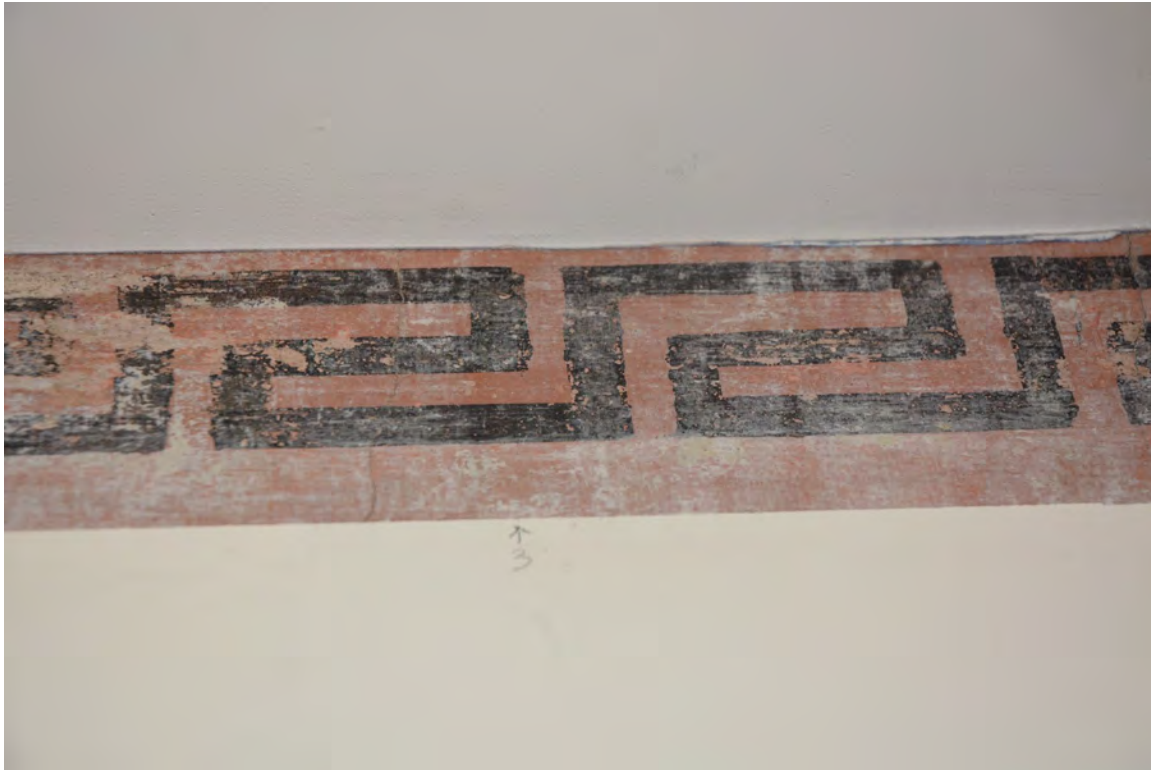
This small room, connected to the West Parlor retains the remarkable Greek Key frieze that was painted on the light red ground. This Greek Key, seen below, in this room and the other exposed friezes were conceived and painted by Thomas Cole. The ceiling is modern drywall, and may be covering some inches of wall surface that could be part of decoration of the upper wall [frieze].

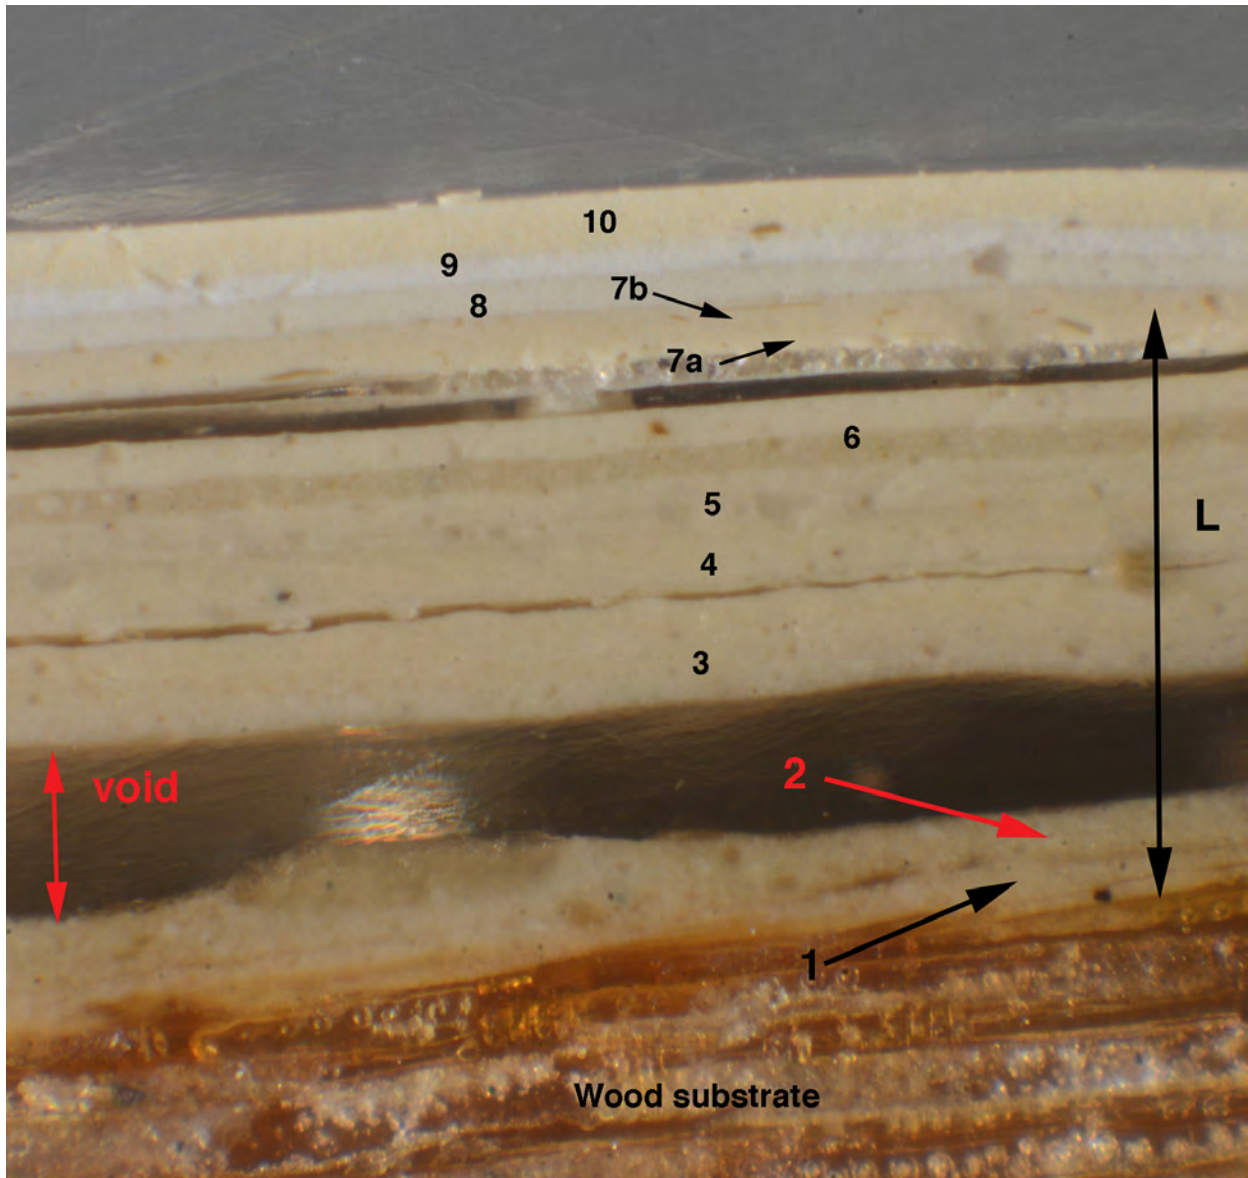
Sample 105-1: Window Frame

Note: The sample has been mounted in polymer resin, cut and polished to 10,000 micron grit polishing cloth for additional examination. The wood substrate is seen at the base of the sample, as indicated. The first finish [1] is clearly shown: this is a lead white finish. The second finish, which is very similar, is also a lead white finish [2]. Note the void: this is due to the long period of exposure of the Cole period finish. Layers 3, 4, 5, 6 and 7a are all lead white layers. The lead white based layers continue into the twentieth century. Finishes 8, 9 and 10 would date to post-1950.

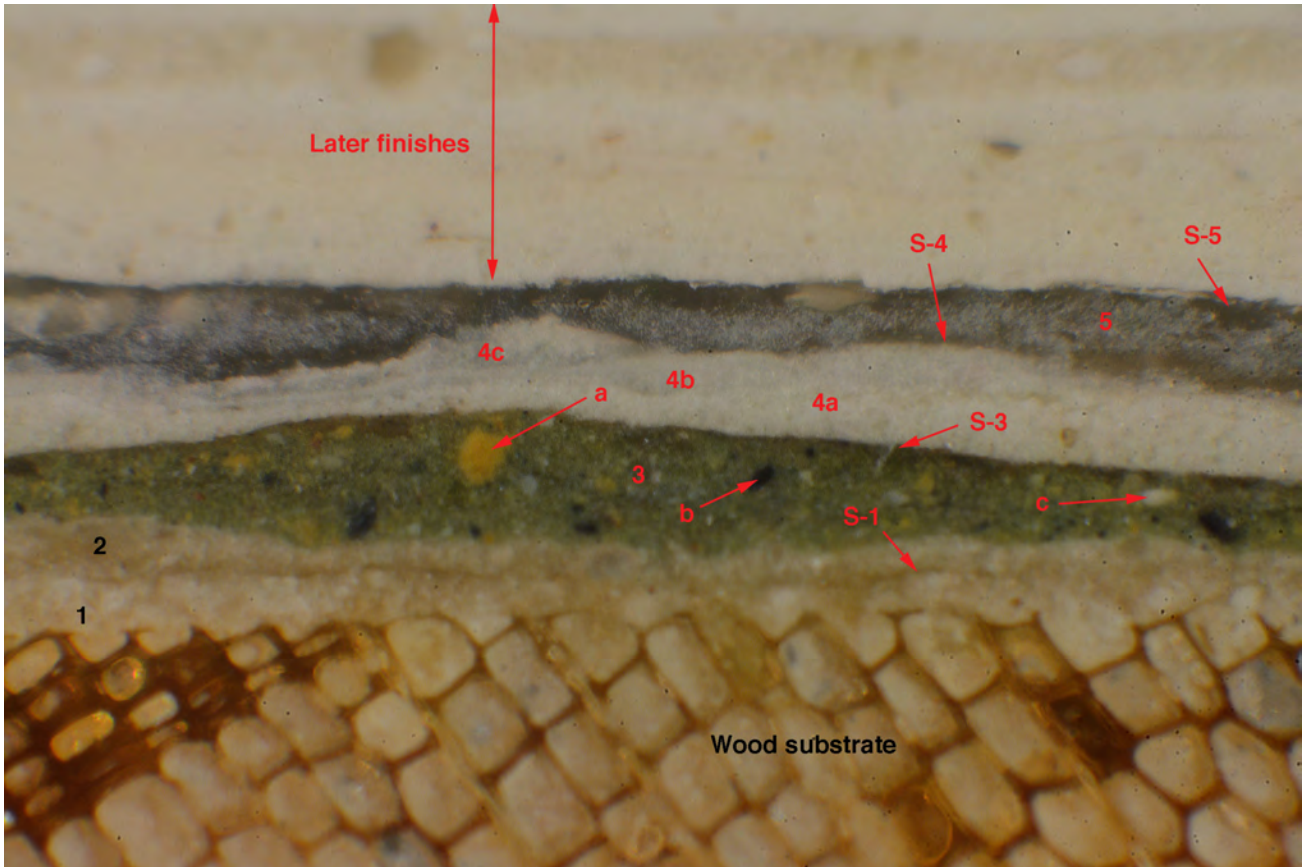
Sample 105-7: Baseboard fascia

Note: The sample has been mounted in polymer resin, cut and polished to 10,000 micron grit polishing cloth for additional examination. The wood substrate is seen at the base of the sample, as indicated. The first finish [1] is clearly shown: this is a lead white finish. The second layer [2] may have been exposed for a short period, but is more likely an undercoat for the distinctive chrome green finish: layer 3: note the brown oil/varnish at the surface of the chrome green finish [S-3] along with particulate. There are three thin lead white layers [4a, 4b, 4c] comprising the fourth finish. Based on the Hall Doors [101] and the Baseboard fascia of the West Parlor [Room 103] the chrome green finish dates to the Thomson period, pre-1836. The fourth finish may be the Cole period finish. This is followed by a dark gray finish, which is similar to a finish found during an earlier period on the Stair Risers. The dark gray may be considered for restoration as it may be within the Cole era: 1836-1848, however, the white finish, which is seen on most woodwork is the more likely finish.

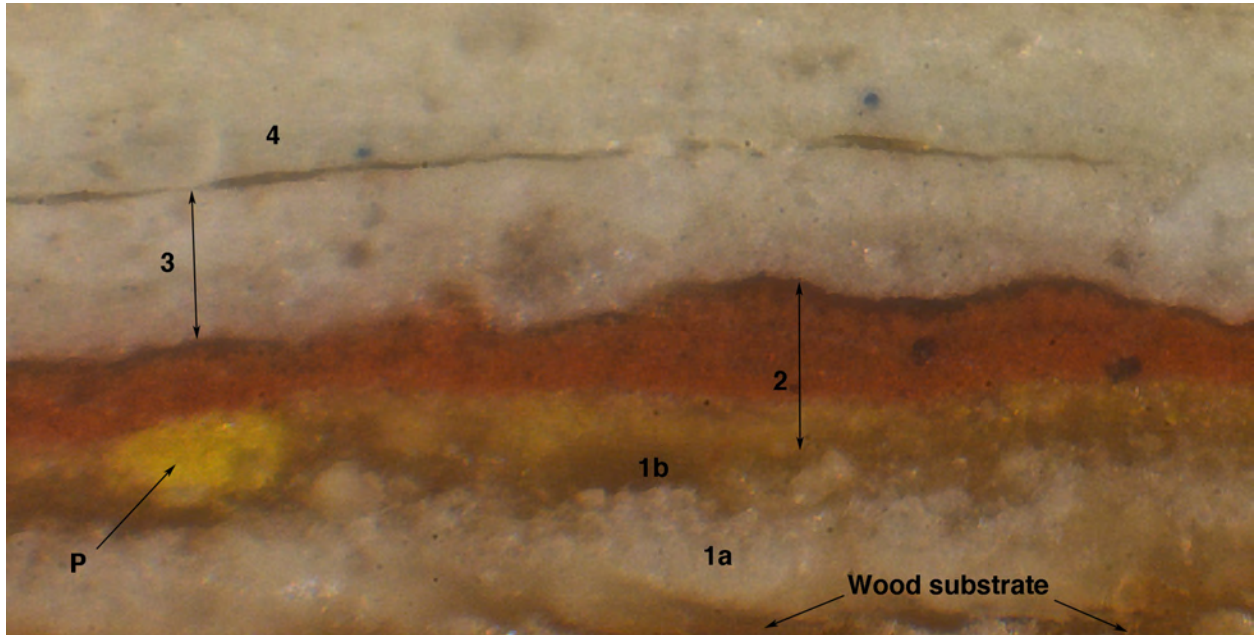
Sample 105-8: Door to West Parlor, panel

Note: The sample has been mounted in polymer resin, cut and polished for additional examination. The wood substrate seen [slightly] at the base of the sample. The first layer is a lead white primer/ground coat (1). This is followed by a yellowish glaze layer (1b): this is the first finish for the door. There may have been a change in plan at this point, because the more elaborate finish was achieved by the yellow ochre layer, red layer and the varnish coating [2]. This finish was exposed during the Cole period in this room.

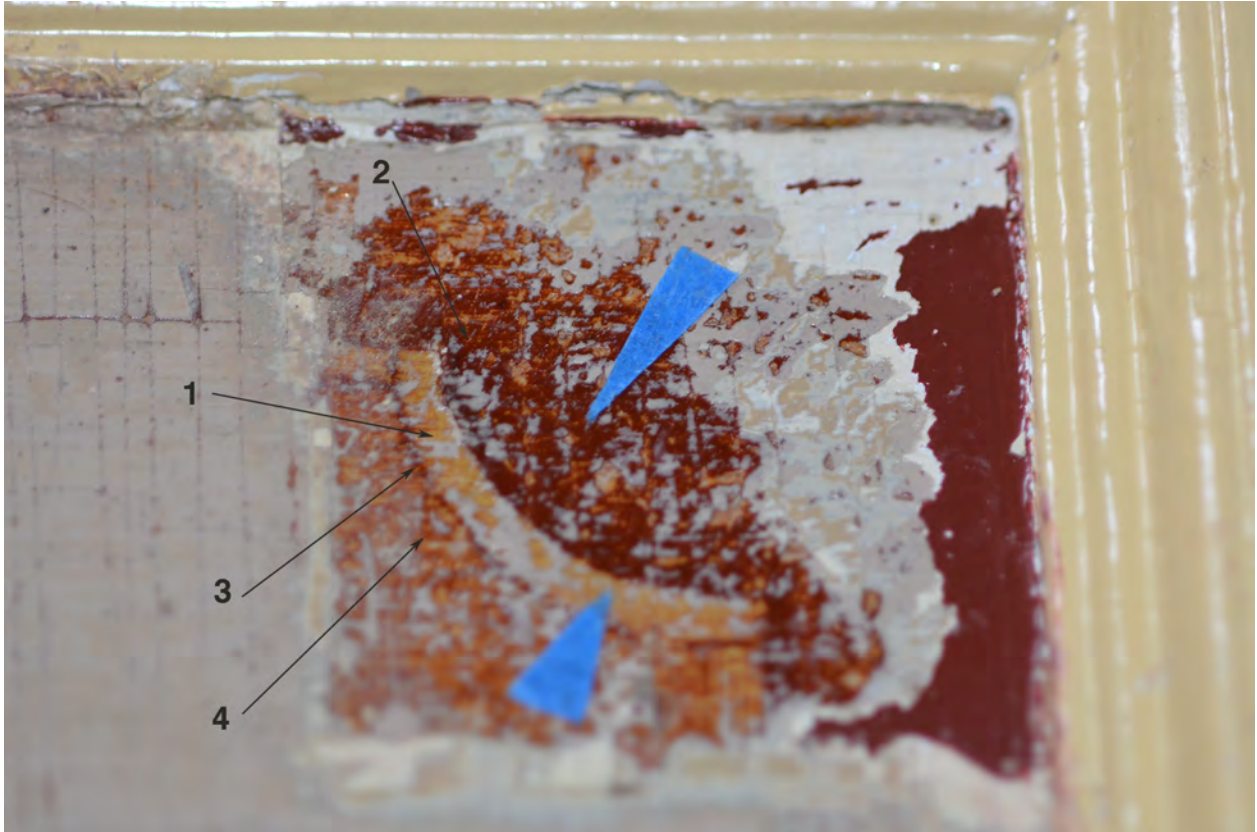
Door: On site photograph of corner of the panel

Note: The detail photograph above shows the grained inlay line detail (1), which has the white ground color. The wood effect is pale, like satinwood or maple. At a later date, a yellow ground was applied to the center section and under the corner and edge (2) that was ultimately painted with a red ochre finish. Note the red edge of the inlay line (3) and the center of the panel which also has the yellow ground and warm reddish brown grain. The center panel is entirely straight graining.

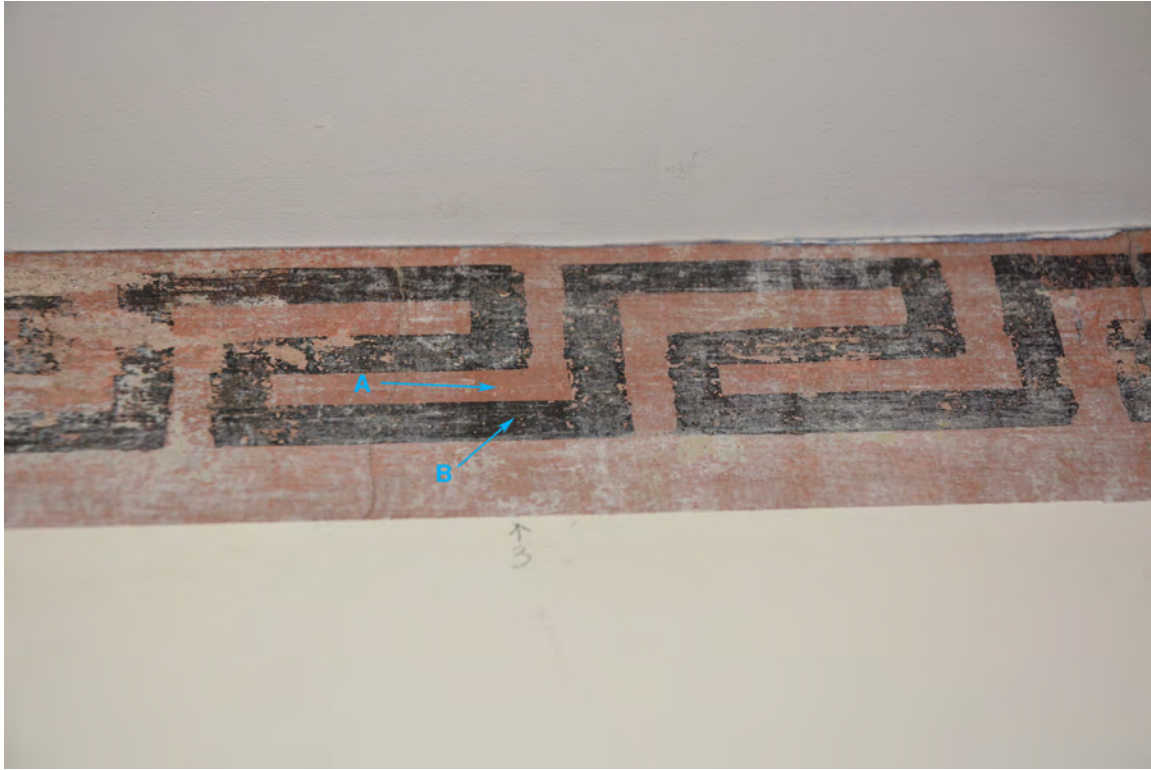
The Wall plaster: Cole period finish with stencil exposed

Note: The exposure of the Cole period finish with the Greek Key decoration afforded the opportunity to take a reading of the colors for documentation. The surfaces indicated [A, B] were carefully cleared of the film of the later [white] paint so that a clean surface could be read with the X-Rite SP-62 Sphere Spectrophotometer, Designated observer 2 degrees, Illuminant C. Illuminant C is a mathematical representation of filtered tungsten halogen (daylight). The color temperature is 6770K, simulating CIE average daylight.

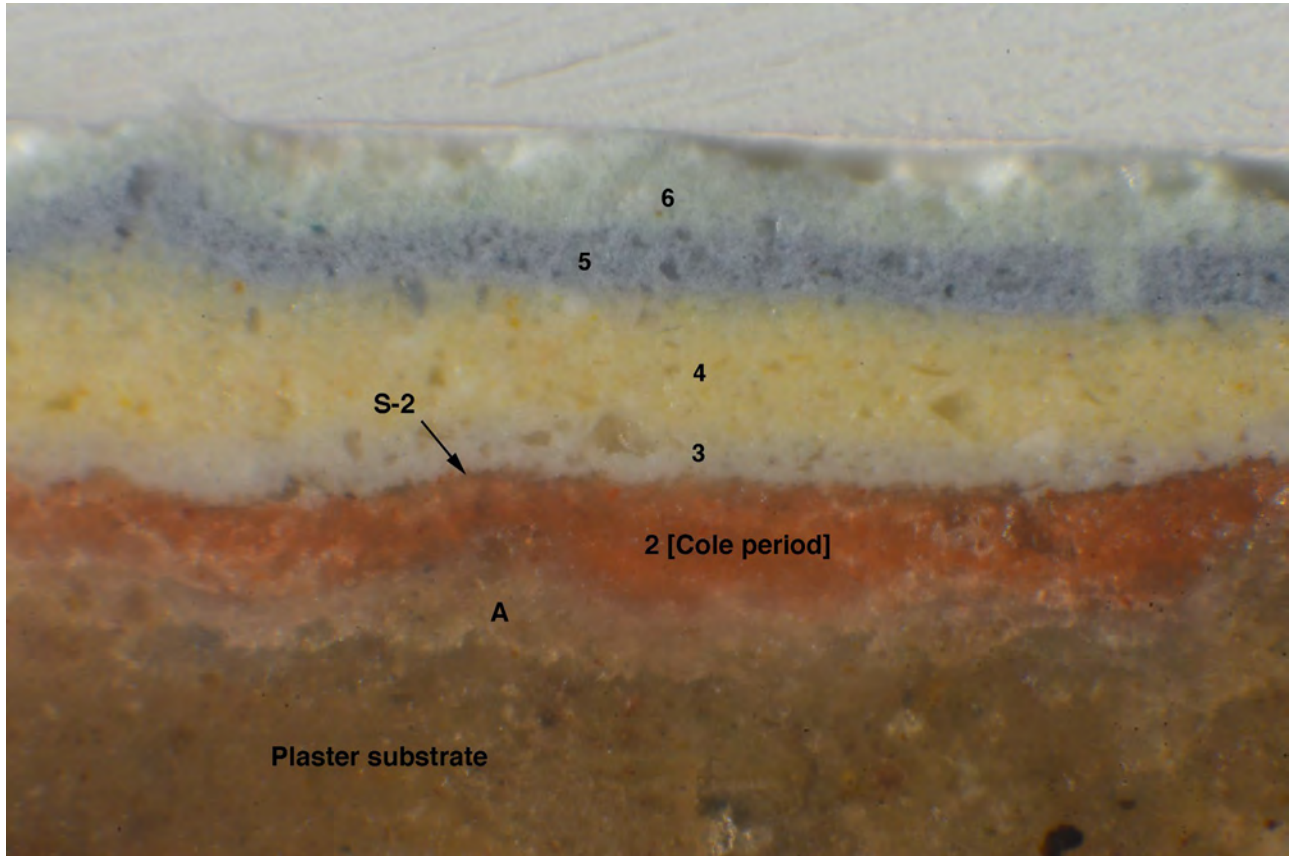
Sample 105-9: Plaster wall, from the East Wall

Note: The sample has been mounted in polymer resin cut and polished to 8000 micron grit polishing cloth for additional examination. The plaster substrate is seen at the base of the sample. The initial layer is the light brown [pinkish] that appears as an undercoat/primer. The finish [2] is the red ochre color that is still retained near the top of the wall. The surface of the paint shows some particulate accumulation [S-2]: this is the Cole era finish. The next painting campaign has a white lead finish [3] which is followed in this location by a light yellow finish [4] that dates to the twentieth century. The blue finish [5] is associated with Edith Cole Silberstein: these are twentieth century finishes. The last finish is a light green [6]

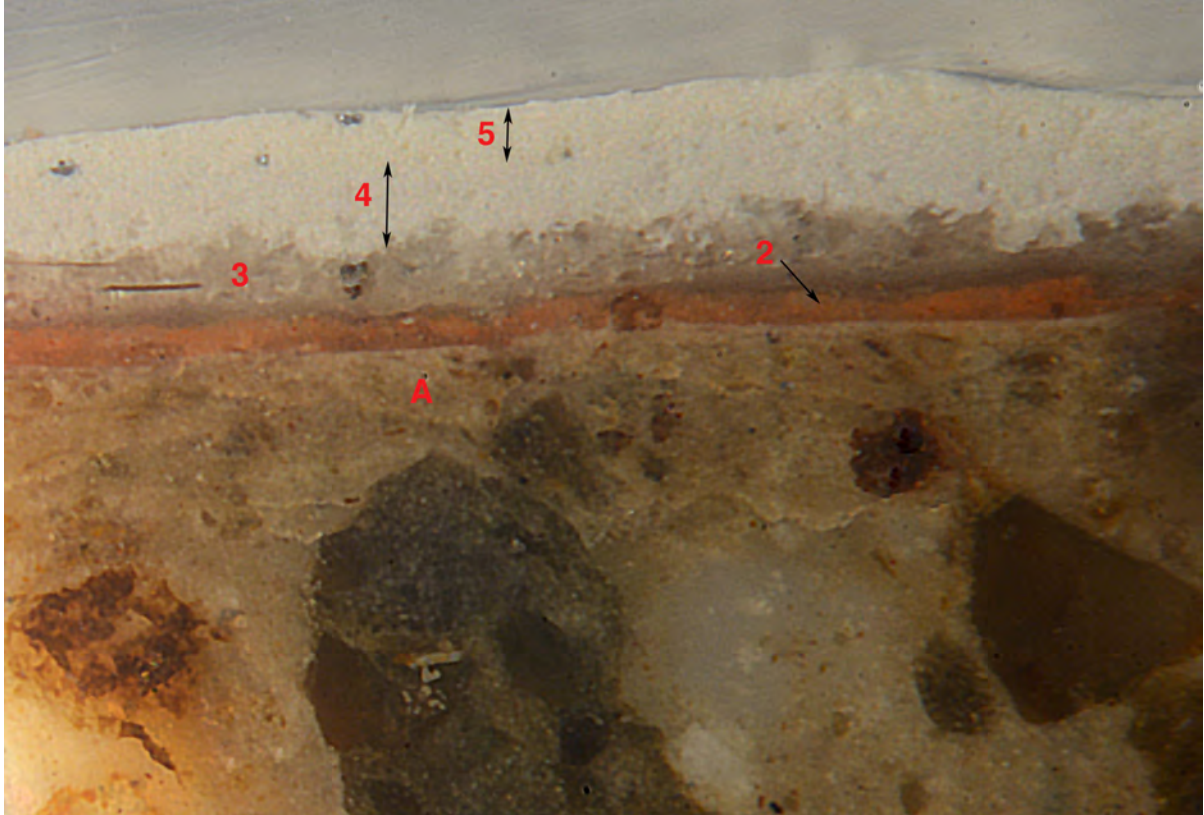
Sample 105-10: Plaster wall, from the South wall, above the Door

Note: The sample has been mounted in polymer resin cut and polished to 8,000 micron grit polishing cloth for additional examination. The plaster substrate is seen at the base of the sample. The initial layer is the light brown [pinkish] that appears as an undercoat/primer [A]. The finish [2] is the red ochre color that is still retained near the top of the wall. The surface of the paint shows some particulate accumulation [S-2]: this is the Cole era finish.

The remaining paint layers do not relate to the finishes on the east wall behind the Cabinet. The first is a white distemper finish [3]. There may have been a sequence of distemper finishes that have been removed, by washing down. Layers 4 and 5 are white latex acrylic finishes. This is an example of an area that must have been covered by something later removed.

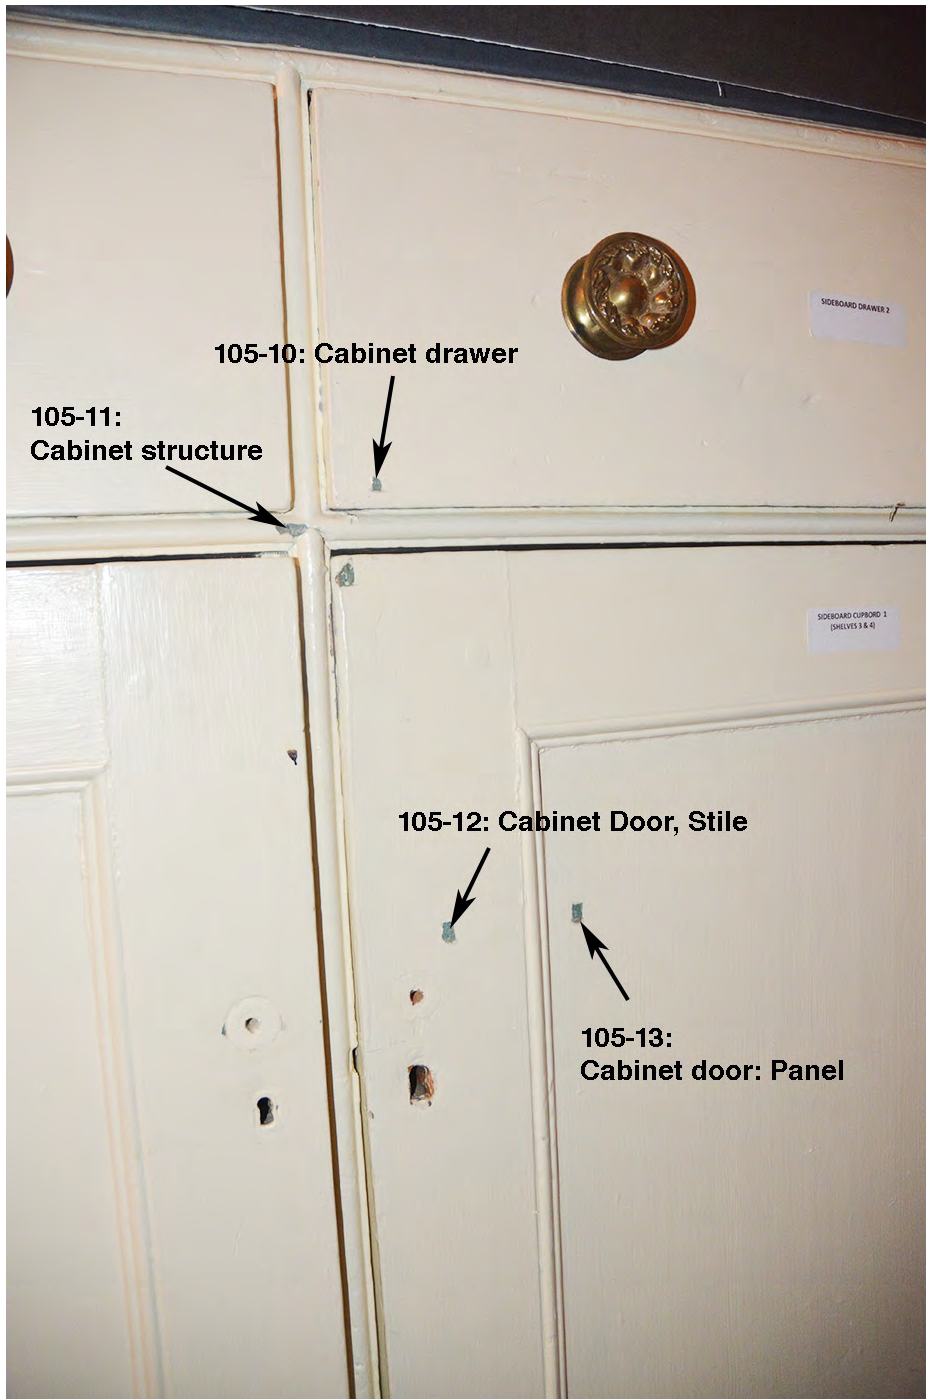
The Cabinet on the East Wall of Room 105

Samples were taken from a number of locations of this cabinet that runs along the east wall of the room. The construction is somewhat unusual in that the top is not a single board, but is interrupted by the vertical structure of the cabinet. The paint finishes indicate that the doors to the lower cupboards were added.

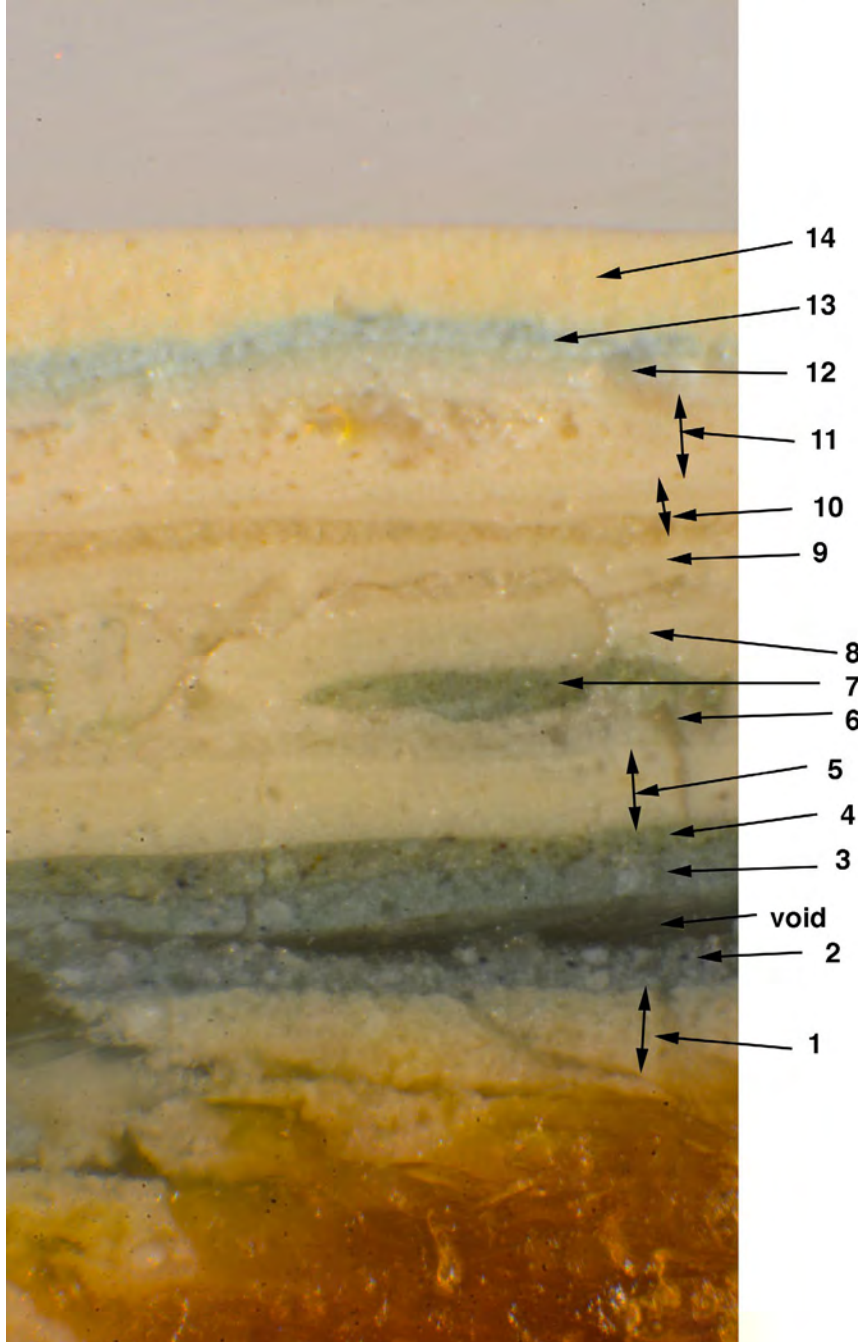
Sample 105-10: Cabinet drawer

Note: The wood substrate is seen at the base of the sample, supporting the initial lead white finish [1]. The lead white finish is followed by two moderate blue finishes [2,3] that were prepared with lead white and prussian blue pigments in oil; note the void between the two blue paint finishes. This is followed by a third layer of the prussian blue: this may be a “touch up layer” and has faded somewhat. **Finish 4 may be the last application of the Thomson period, pre-1836.** Finish 5, prepared with lead white may be the Cole era, when the walls were finished

with the red ochre finish and the black Greek Key was executed: this would be the finish period for restoration. Layers 6-8 may represent the same painting campaign, 7 appears to be a drop of green paint [!]. Layers 1 through 10 were prepared with lead white pigment. Finishes 11 to 14 are prepared with titanium dioxide white.

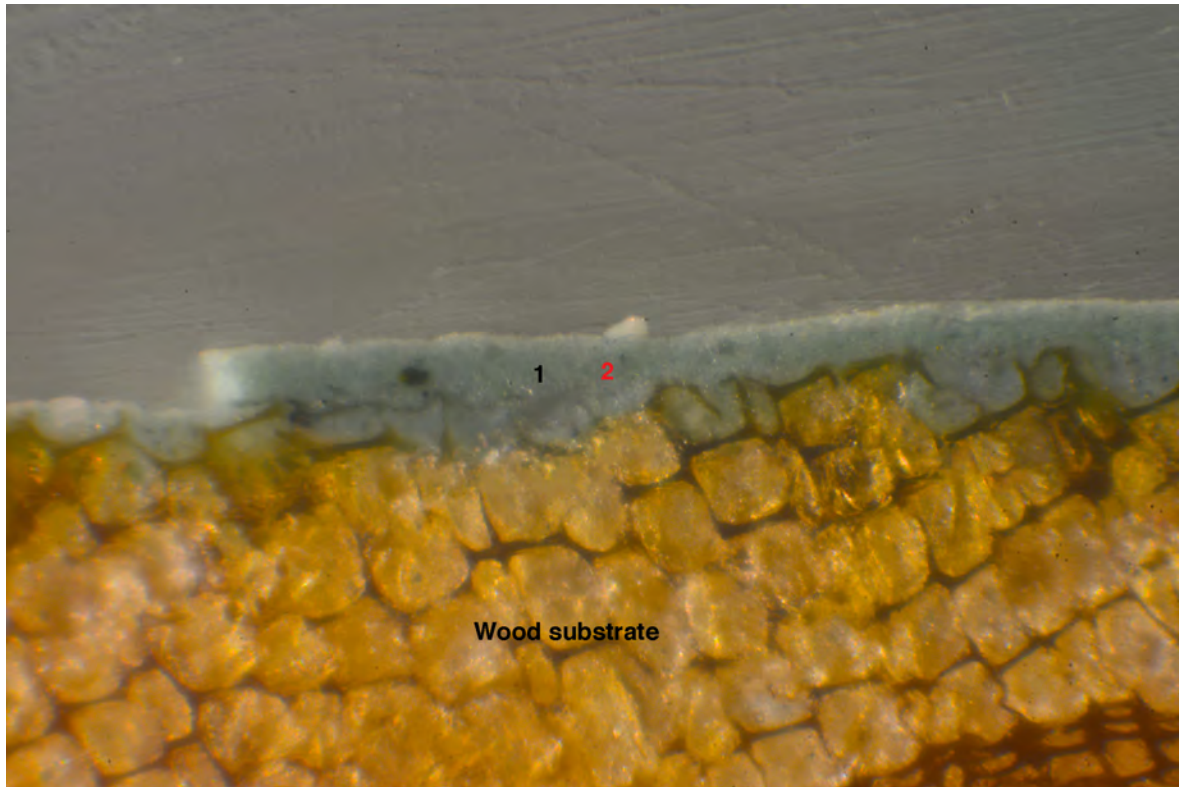
Sample 105-12: Cabinet Door

Note: The sample has been mounted in polymer resin, cut and polished to 10,000 micron grit polishing cloth for additional examination. The later finishes have been removed to permit this view. Note that the prussian blue color is the first finish [1, black] on this door, but is the second finish [2, red] on the drawer, Sample 105-10.
