Thomas Cole National Historic Site Historic Structure Report

Volume II: Appendices
October 2019

THOMAS COLE NATIONAL HISTORIC SITE
THOMAS COLE HOUSE
HISTORIC STRUCTURE REPORT
PMIS 216977

VOLUME II
APPENDICES

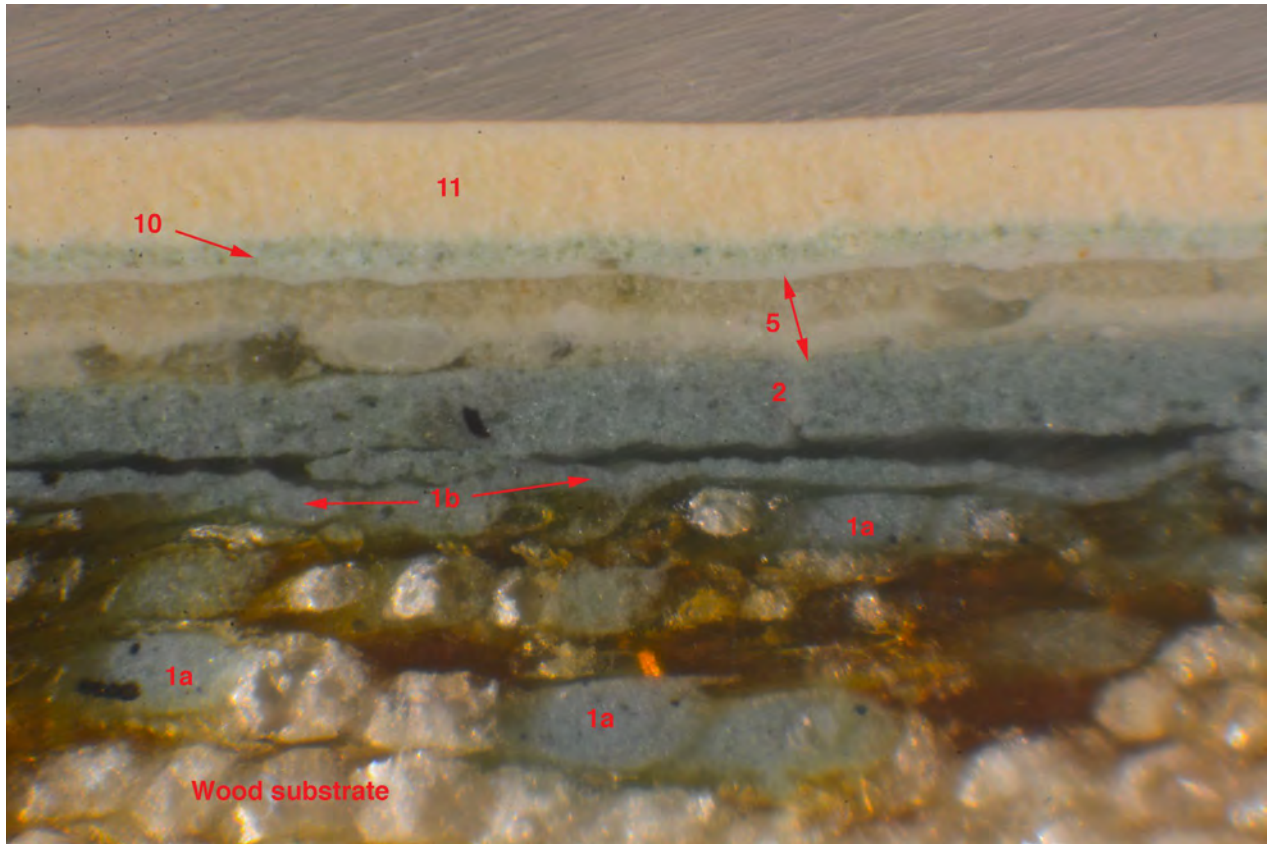
Sample 105-14: Cabinet: door stop installed for cabinet door

Note: The sample has been mounted in polymer resin, cut and polished to 10,000 micron grit polishing cloth for additional examination. As in the case of the door, the door stop that was installed at the same time as the door was painted with the prussian blue color as the first finish: note that the first application of the prussian blue color [1a, made with lead white and prussian blue] has penetrated into the wood. The second layer of this first application of the prussian blue color [1b] was the exposed finish. The second application of a prussian blue color [2] is clearly seen. This is followed by a white finish [5] prepared with two layers of lead white: the second is an enamel finish and appears translucent. This may be the Cole period finish.

Layers 10 and 11 are modern finishes, and appear to date to the period of public ownership.

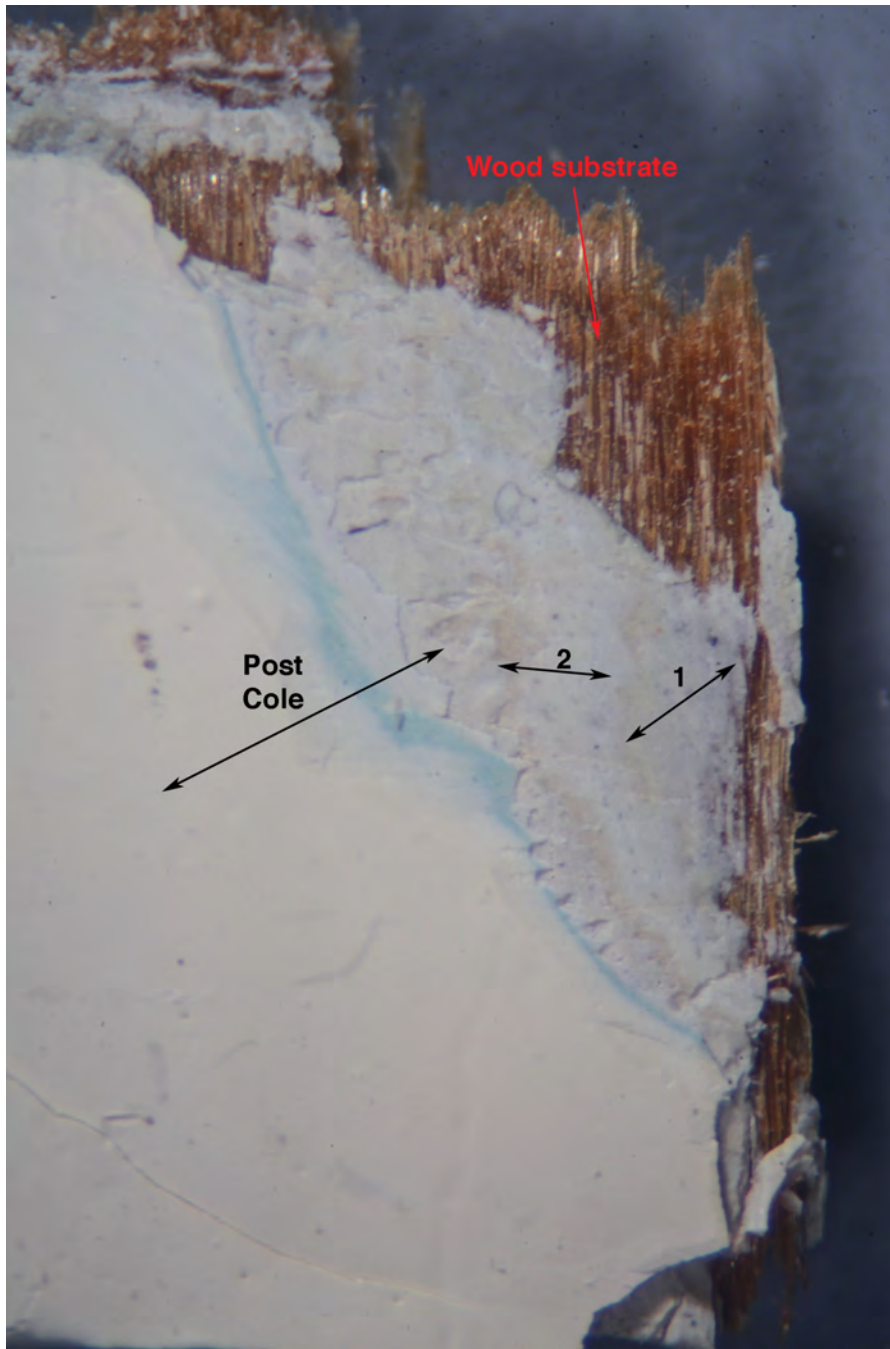
Sample 105- 16: Shelf edge Shelf 7

Note: The view of this sample is looking down onto the finish surface, the sample has been trimmed to permit this view. The wood substrate is clearly seen and noted. The diagonal slicing permits a wide view of the early finishes. The first finish [1] was prepared with lead white pigment and would date to the period of construction [presumably ca. 1815]. Note the slight discoloration of the finish surface. The second finish, [2] may be from the Cole period: it also is prepared with lead white. As in the case of the first finish, the second finish shows a distinct discoloration of the finish surface. The later finishes, which would post date the Cole era, i.e. after 1848 are also visible.

This sample indicates that when the frame, drawers and the cabinet doors were painted with the prussian blue color, the open shelving areas

were painted with a lead white finish.

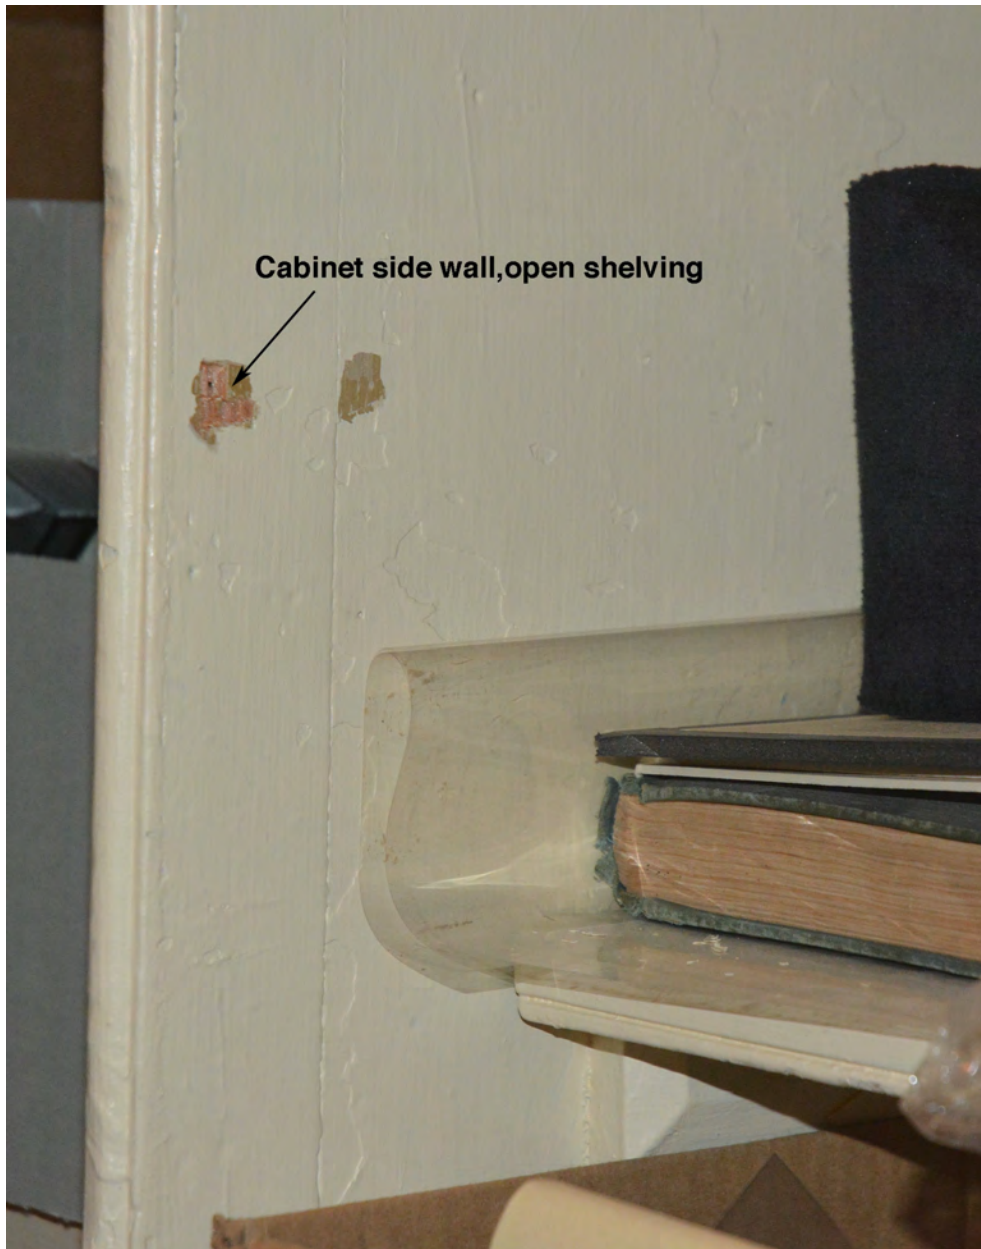
Sample 105- 17: Cabinet, open shelving side wall

Note: The samples of these side walls show that these surfaces were painted with the same paint layers as observed on the top of the cabinet. Refer to Sample 105-18: Cabinet, top: Location A

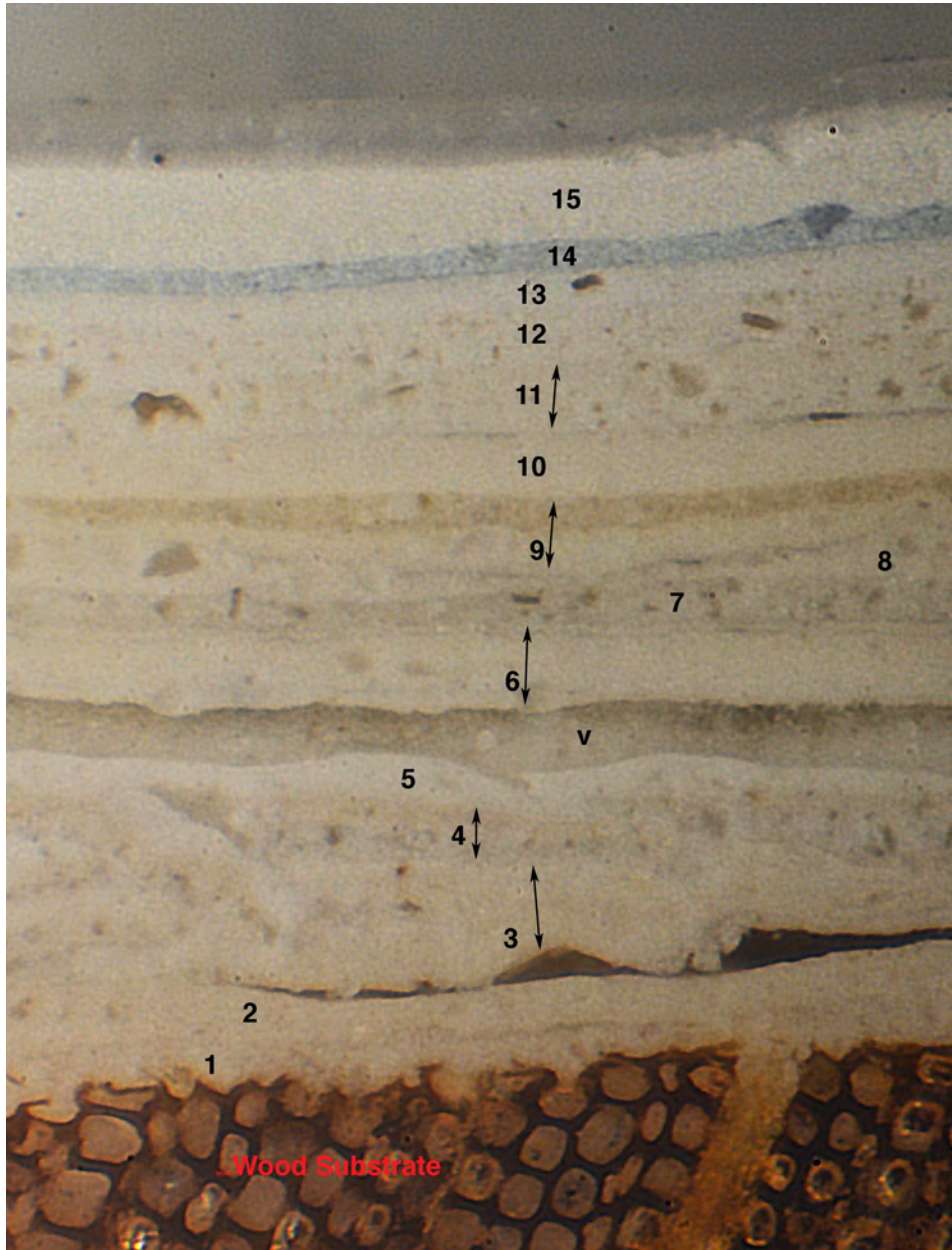
Sample 105-18: Cabinet, top Location A

Note: The sample has been mounted in polymer resin, cut and polished to 10,000 micron grit polishing cloth for additional examination. Note that the top was painted with lead white finishes regardless of the prussian blue color applied to the drawers, frame and the doors. It may be that the fifth finish [white] is the Cole period finish. It is followed by a void [v, filled with mounting medium] that may coincide with the long period following the Cole period.

Layers 1-10 were prepared with lead white pigment.

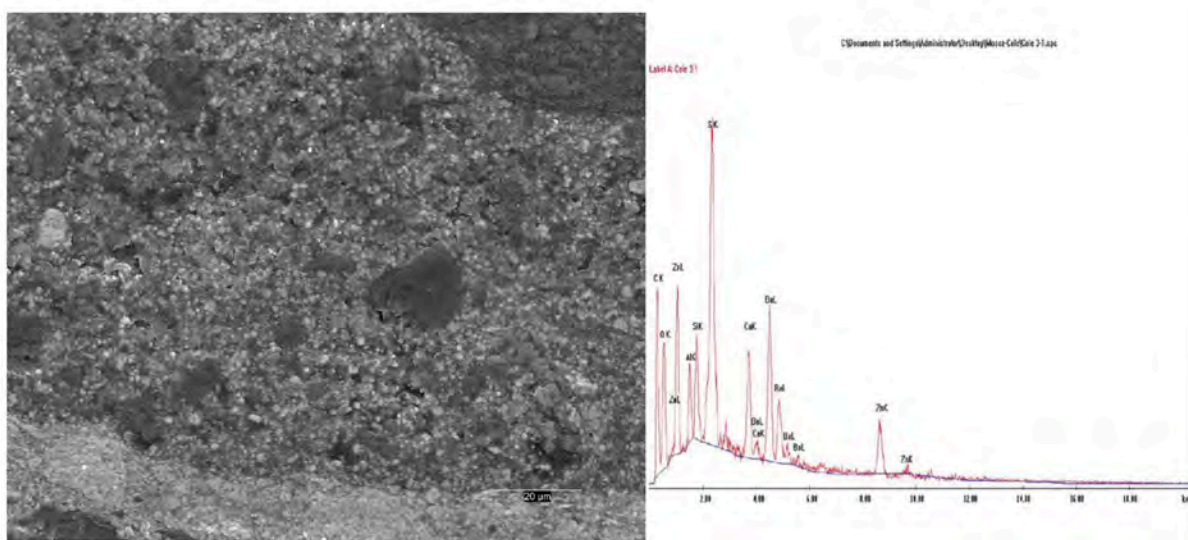
Scanning Electron Microscopy: Examination of the Light Yellow paint layer of Sample 105-9, layer 4

The results show the presence of components associated with Lithopone, a white pigment first introduced in 1874 that was in very widely used for interior paint in the first half of the twentieth century¹. While it is possible that this light yellow could have been used in the redecoration after ca. 1884, it is more likely to have been used in the early twentieth century, in a more “Colonial Revival” context.

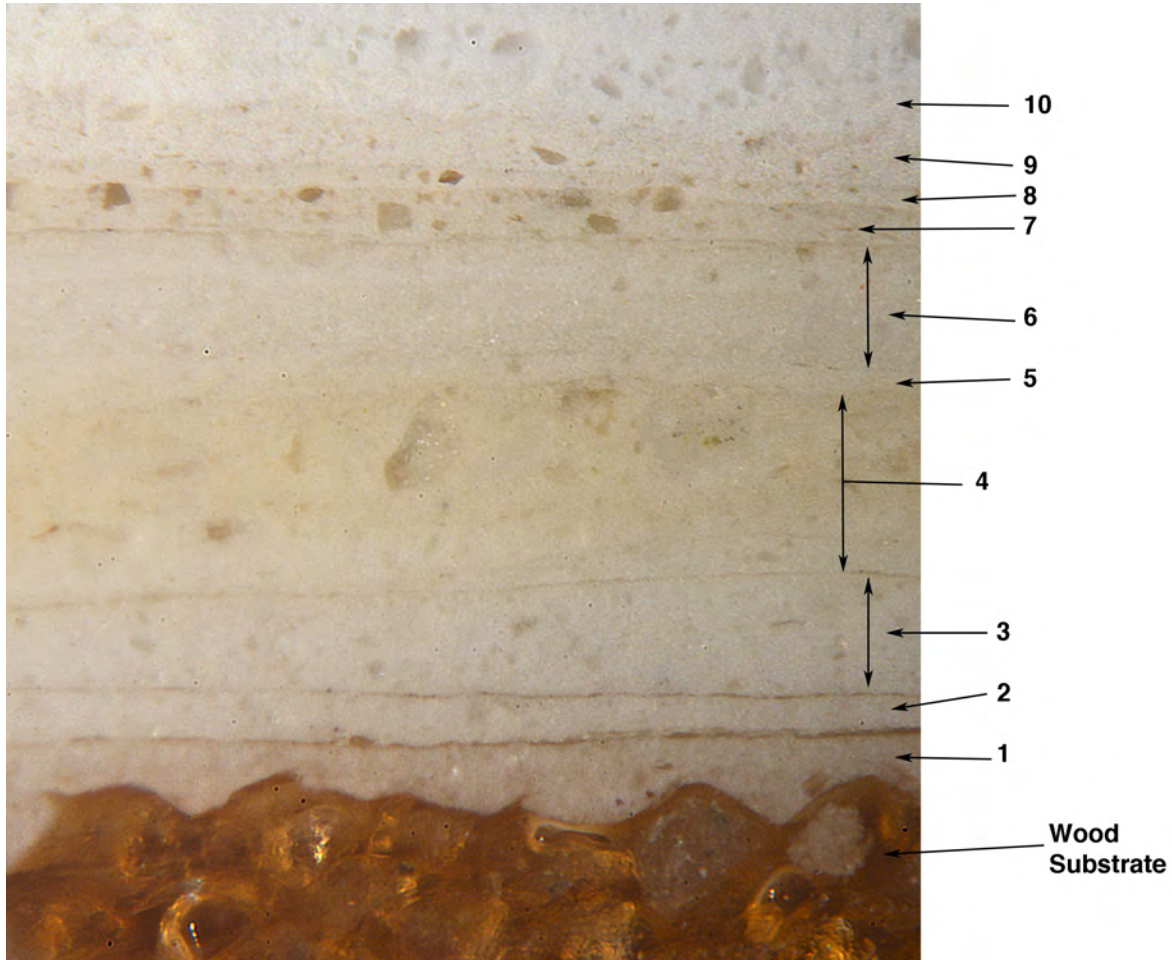
Sample 201-1: Door Frame, Door to Room 203

Note: The sample has been mounted in polymer resin, cut and polished to 8000 micron grit polishing cloth for additional examination. The wood substrate is seen at the base of the sample, and is indicated. The first finish [1] is clearly seen; this would date to construction. The second finish [2] probably dates to the Cole period redecoration. The third finish [3] may indicate the redecoration ca. 1884. All of these finishes were prepared with lead white pigment. Finishes 4, 5 and 6 are also prepared with lead white pigment. The last four finishes [7,8,9 and 10] were prepared with non-lead pigments, and indicate the mid-late twentieth century.

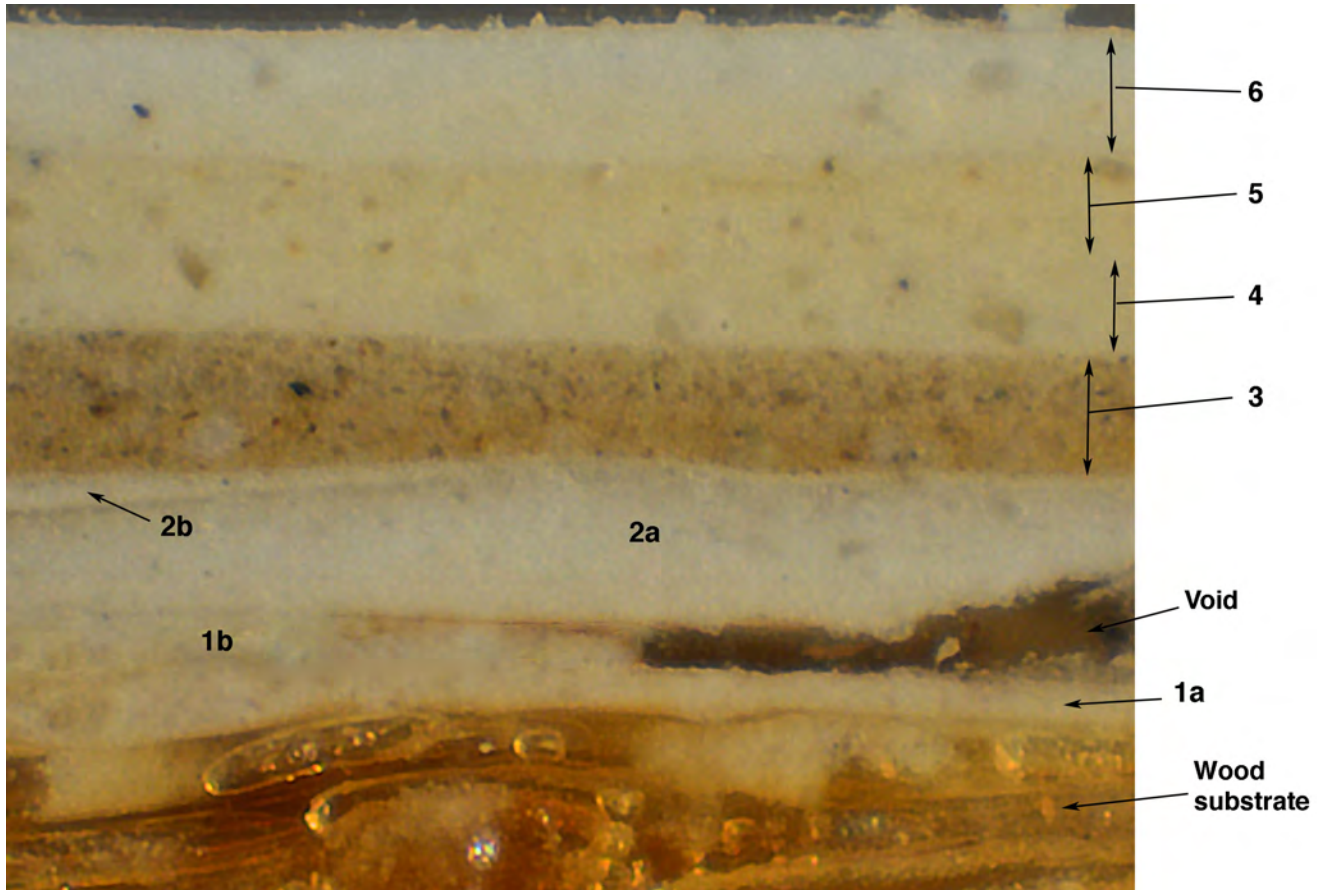
Sample 201-5: Stair, Riser [Stair to third floor]

Note: The sample has been mounted in polymer resin, cut and polished to 8000 micron grit polishing cloth for additional examination. The wood substrate is seen at the base of the sample, and is indicated. The first finish comprised of two layers [1a, 1b] is clearly seen: this would date to construction. The second finish is also made of two layers of lead white paint [2a, 2b]. This is probably the first finish of the Cole period. The third finish is the light brown finish, which may be the second finish applied during the Cole period. The later finishes are also prepared with lead white base, and would date to the post-Cole period and later.

Finish 3: this light brown finish is also seen on the tread, as Finish 3 and was identified as the Cole period finish for the First Floor staircase to the Second floor tread. This may indeed be the appropriate finish for restoration.

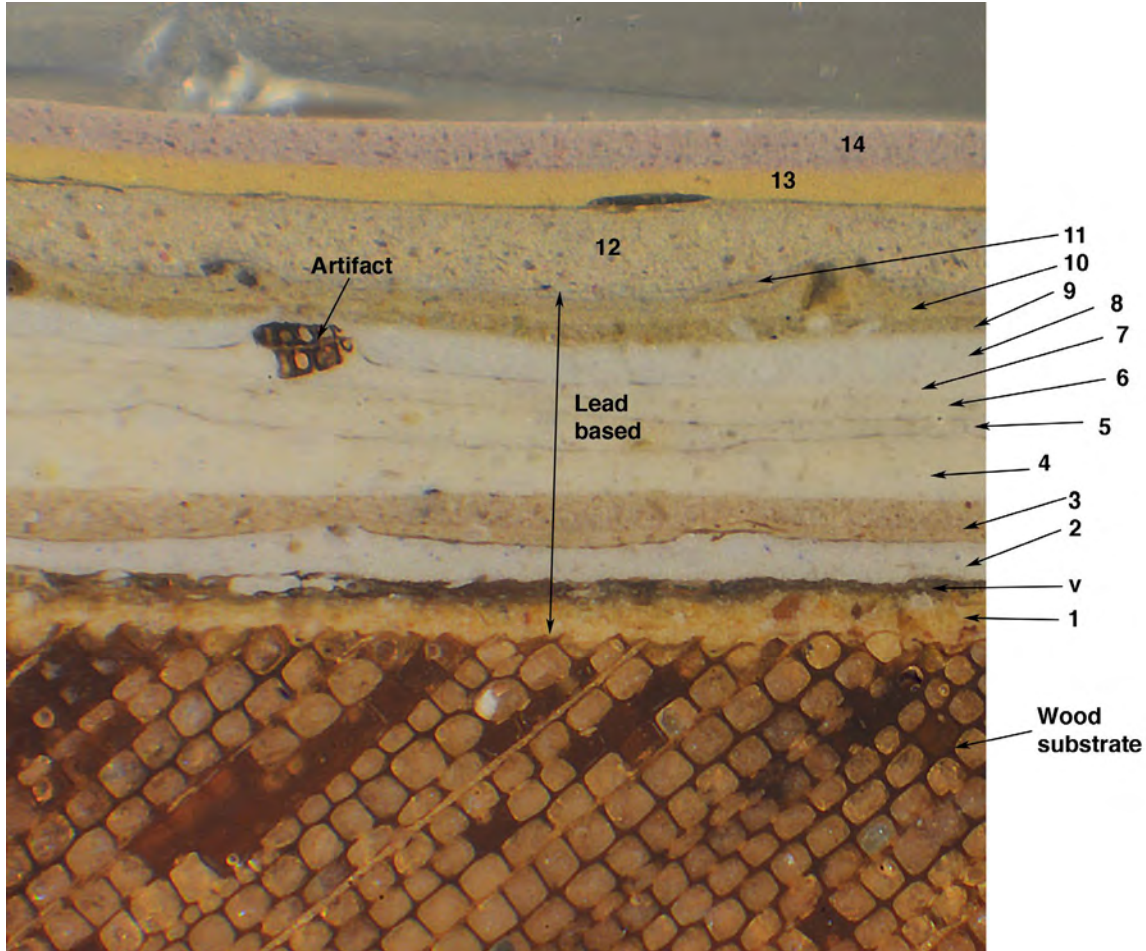
Sample 201-6: Tread

Note: The sample has been mounted in polymer resin, cut and polished to 8000 micron grit polishing cloth for additional examination. The wood substrate is seen at the base of the sample, and is indicated. The first finish [1] is clearly seen; this would date to construction: as on the first floor, a yellow ochre finish [1] that was later varnished [v]. The second finish [2, lead white] does appear to be the same lead white used elsewhere that dates to the Cole period. The light brown finish [3] is also likely to date to the Cole period. This color is also found on the first floor stair treads. Note the sequence of white finishes 4 through 7 that may date between 1848 and 1884. Note the wood fragment [artifact] caught in Finish 6. A series of tan- light brown finishes 9 through 11 probably date from ca. 1884 through the early 20th century. The layer 12 is non-lead, including titanium dioxide white. Finishes 12-14 are all non-lead.

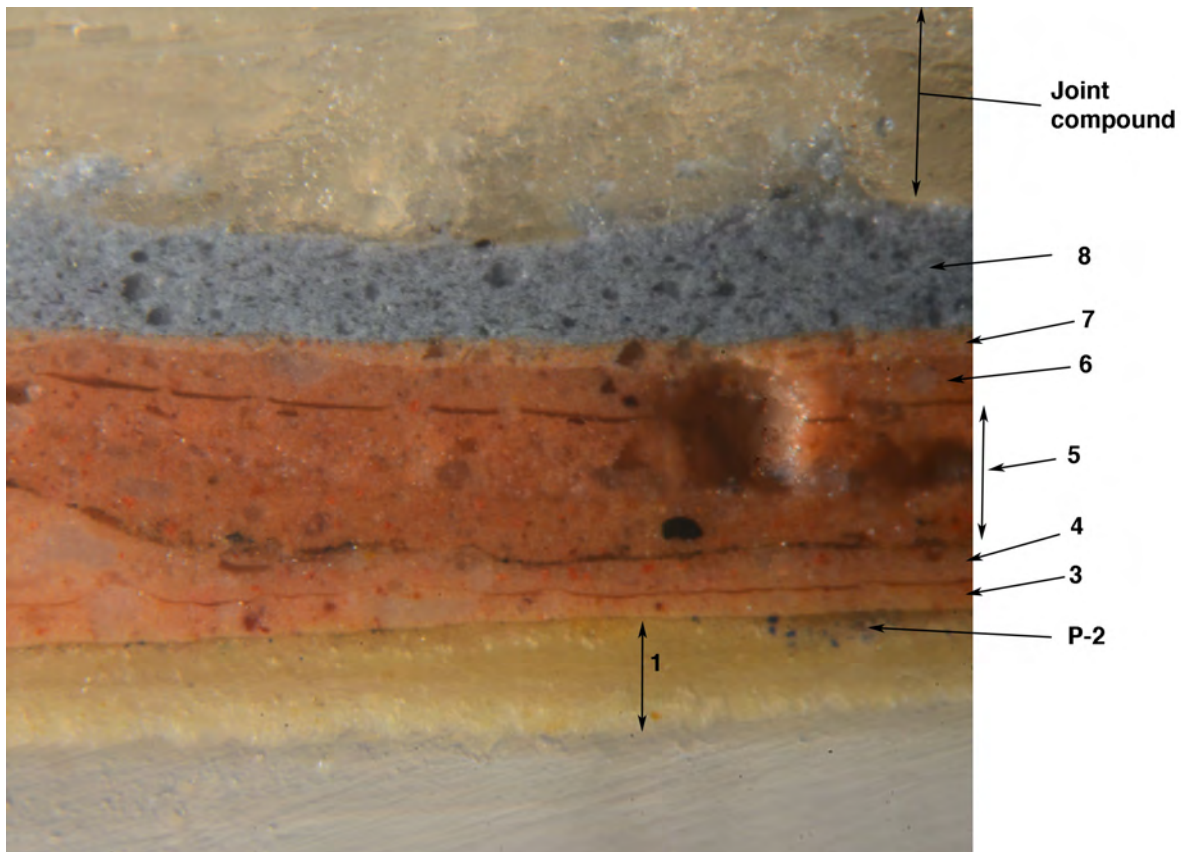
Sample 201-7: Wall: above Door frame, Door to 203

Note: The sample has been mounted in polymer resin, cut and polished to 8000 micron grit polishing cloth for additional examination. The plaster substrate has delaminated from the sample. The first layers [1] are actually lime whitewash layers that have been stabilized with a drying oil mixture that has yellowed. Note the remnants of a finish, and the pigment particles are artificial ultramarine blue [P-2] that supports that the artificial ultramarine blue was indeed used on the second floor. The sequence of the red finishes [3 through 7] are also seen on the first floor and it appears that these date to the redecoration following the death of Maria Bartow Cole in 1884. The preparation of the walls was very thorough, particularly on the first floor. This general red color was repeated well into the twentieth century. The blue finish [8] is associated with Edith Cole Silberstein. The joint compound, applied in 2000, completes the photomicrograph.

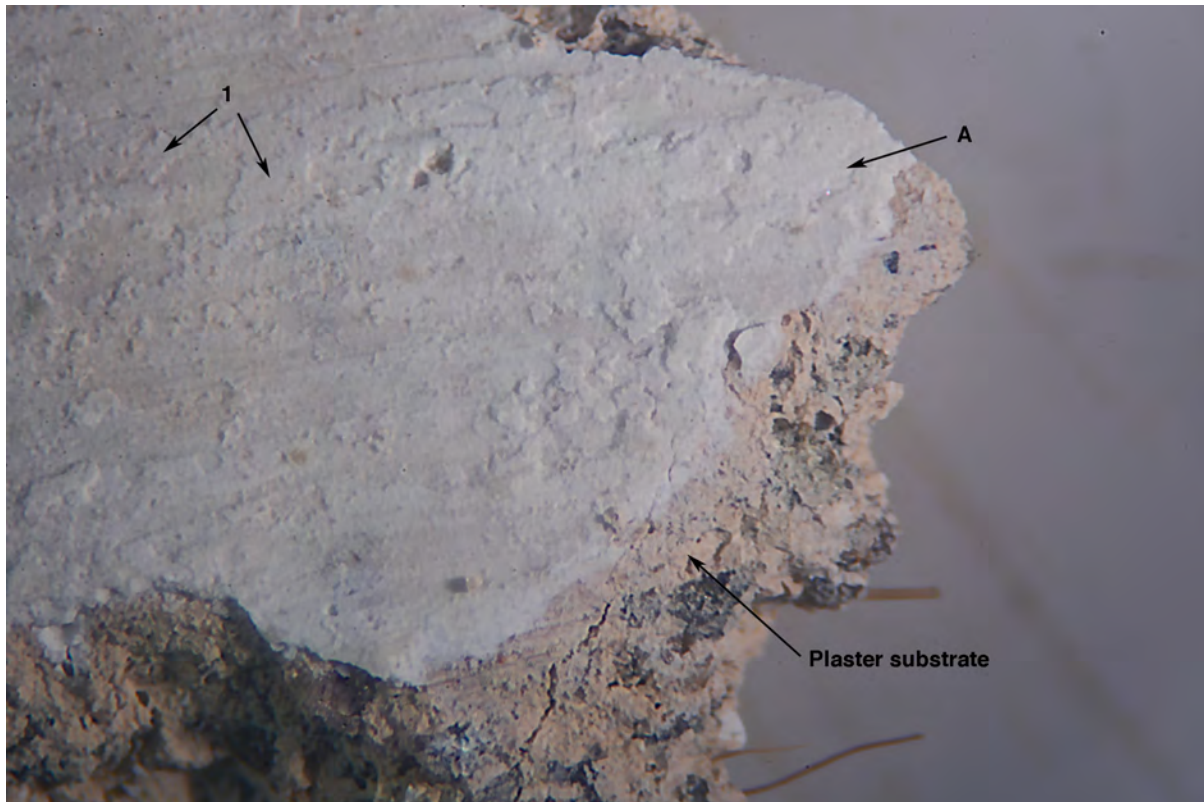
Sample 201-14: Ceiling, above Door to 203

Note: The view of the sample is looking down onto the finish surface and the side of the sample. The plaster substrate, the characteristic sand-finish plaster, is clearly seen [note also the hog bristles]. Note the thin white lime finish plaster [A] that was at first exposed. Later, as necessary, the surface was lime whitewashed [1]. Later lime coating [] have delaminated. It is likely that a number of layers were removed during subsequent painting campaigns.

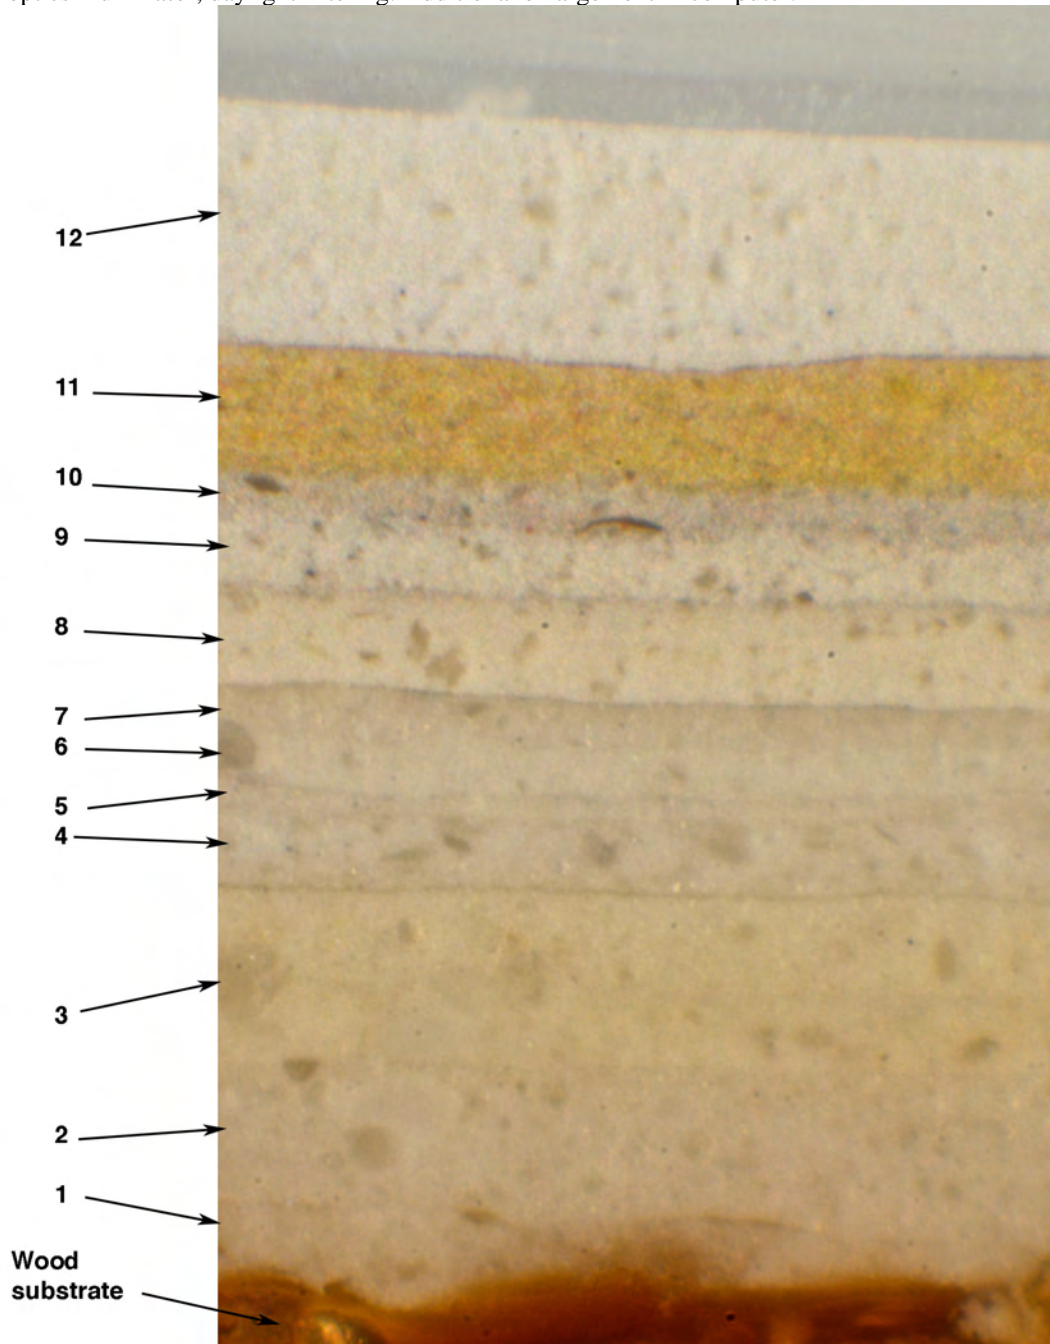
Sample 201-17: Door to Room 302

Note: The sample has been mounted in polymer resin, cut and polished to 8,000 micron grit polishing cloth for additional examination. The wood substrate is seen at the base of the sample. The first finish [1] clearly dates to the period of construction. The second finish [2] appears to date to the Cole period

redecoration. There is a sequence of white finishes: finishes 1 through 7 were prepared with lead white finishes. Finishes 8 through 12 are from the twentieth century.

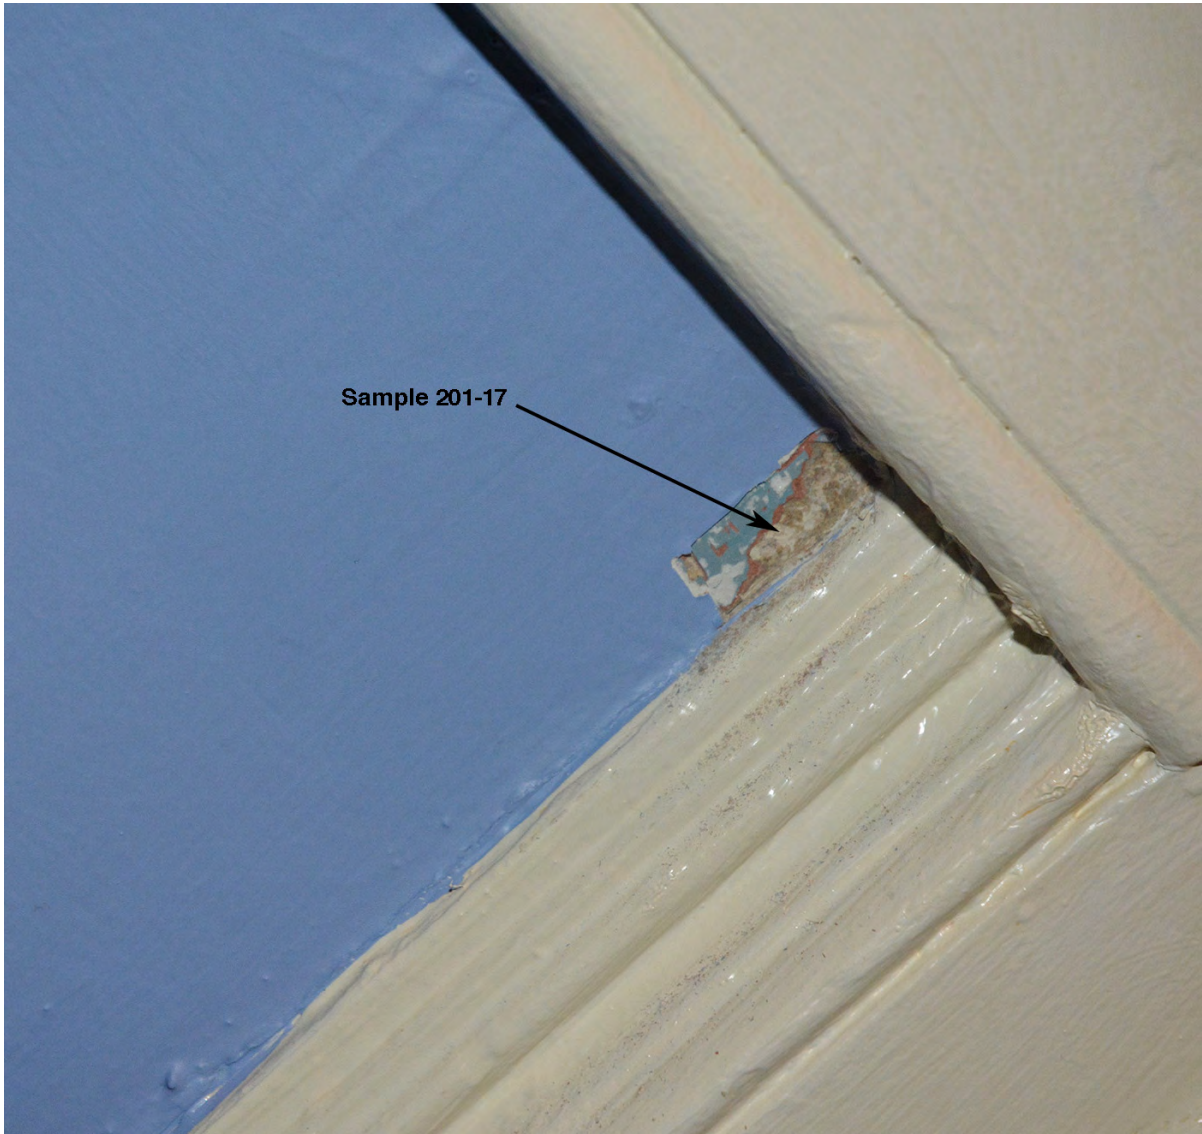
Sample 201-18: Plaster next to Door frame to Room 302

Note: The Sample 201-17 was extracted from this protected location near the corner of the baseboard on the staircase and the large angled door frame to Room 302. The later red finishes and the twentieth century blue finish are clearly visible.

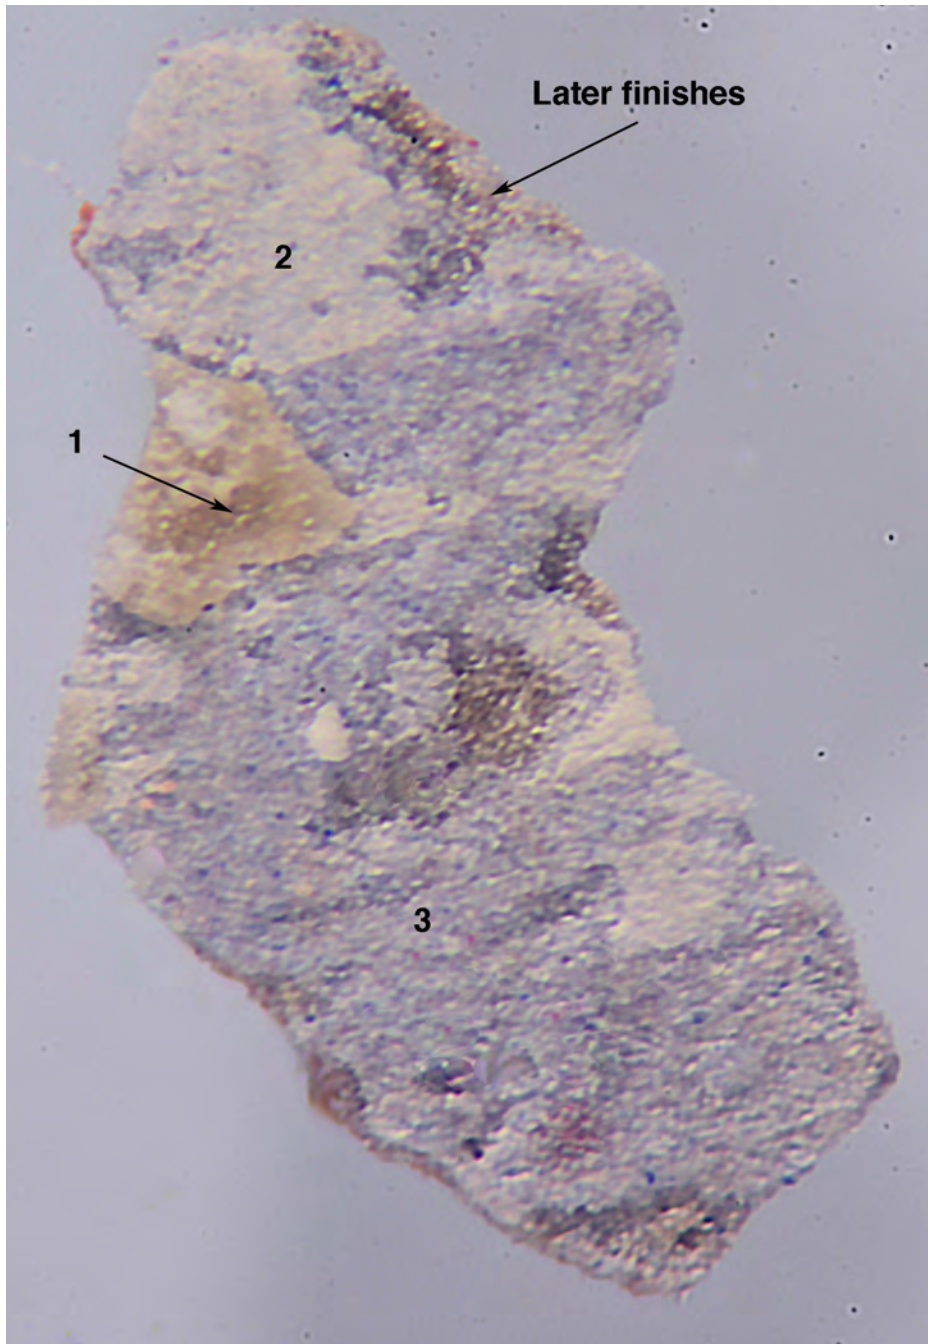
Sample 201-18: Plaster next to Door frame to Room 302

Note: The view of the sample is seen in reverse: it has been turned over to achieve this view. The lime coatings that were treated with the boiled oil treatment are clearly seen [1]: Note the later white fragments [2] and the light blue, prepared with artificial ultramarine blue pigment. This is the best surviving example. The later finishes are under the plane of finish 3.

This sample also indicates that the artificial ultramarine blue finish was carried up to the Door to Room 302.

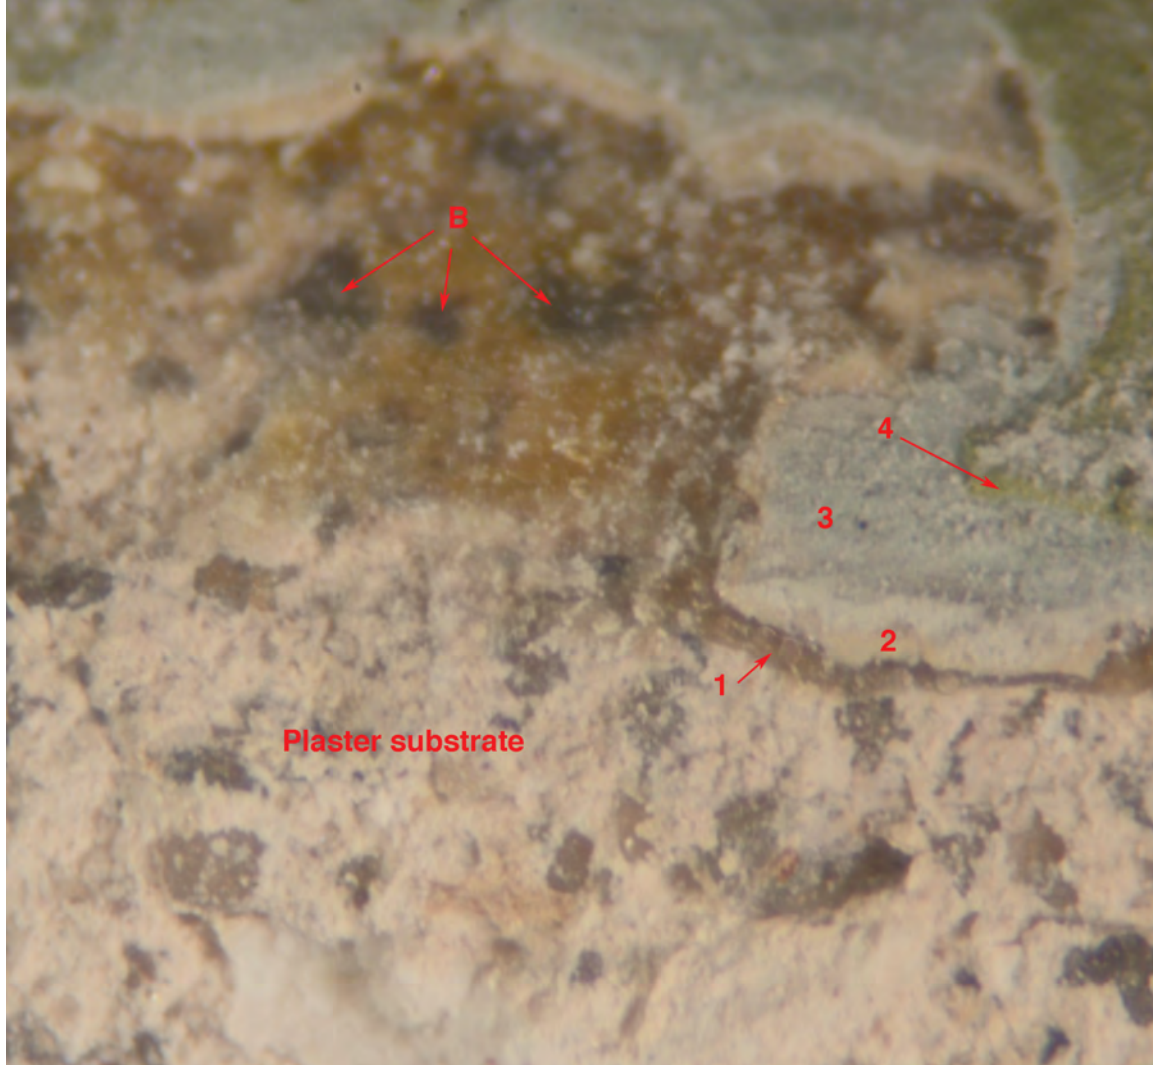
Sample 203-1: Wall plaster, above Door to Hall 201

Note: This unmounted view of the wall plaster shows certain important features. The plaster substrate, which is characteristic of the original plaster of Cedar Grove is clearly seen: the overall color is a light brown, due to presence of clay. Note the dark small coarse sand particles. The surface of this plaster is covered with a transparent yellowish layer of adhesive, which may be associated with the use of wallpaper. Note that the dark small stones of the plaster substrate is visible immediately under the adhesive layer. The later, post Cole period paint layers are also seen [2, 3, 4]. Refer to the mounted cross section that follows this page.

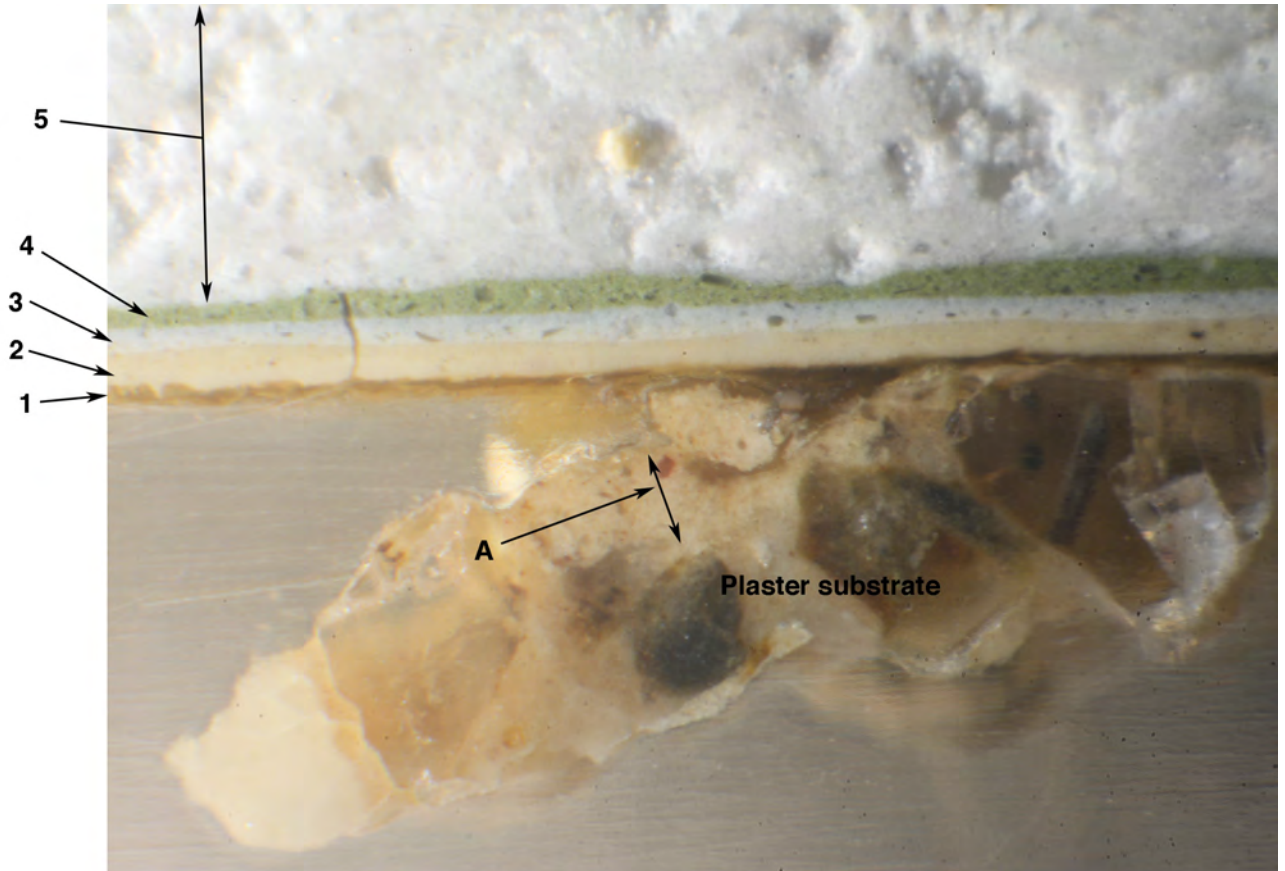
Sample 203-1: Wall plaster, above Door to Hall 201

Note: This sample piece is from the same general area as the unmounted sample seen above. This piece was mounted in polymer resin, cut and polished to 10,000 micron grit polishing cloth for additional examination. The plaster substrate is clearly seen and indicated. Note that there is a thin layer of a lead based light brown paint [A]! This coating precedes the application of the adhesive layer [1].

The adhesive for wallpaper is clearly seen, and heavily applied in this location. The yellowish white finish [2] is prepared with lead white and may date to after ca. 1884. The light blue [3] and green [4] finishes are from the twentieth century. The thick white coating is a modern joint compound.

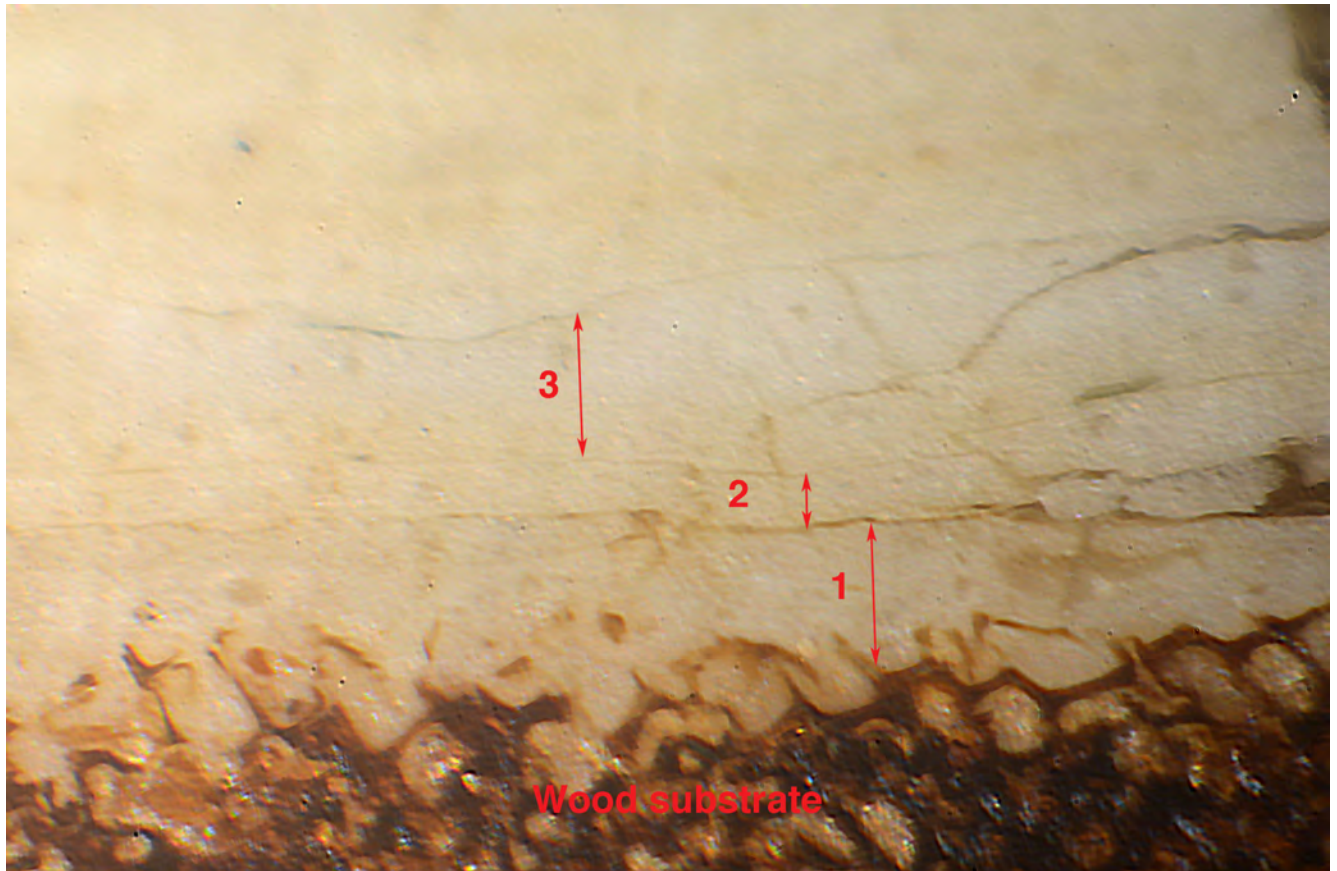
Sample 203-2: Door Frame, Door to Hall [detail]

Note: The sample was mounted in polymer resin, cut and polished to 10,000 micron grit polishing cloth for additional examination. The wood substrate is clearly seen and indicated. The first finish [1] appears to have been prepared with three very thin layers of a lead white paint. The surface is clearly seen. The second finish is also prepared with lead white [2]: this would be the ca. 1836 Cole period painting. The third finish, which may date to post ca. 1884 is also visible. All of the paint layers observed are prepared with lead white as the basic pigment.

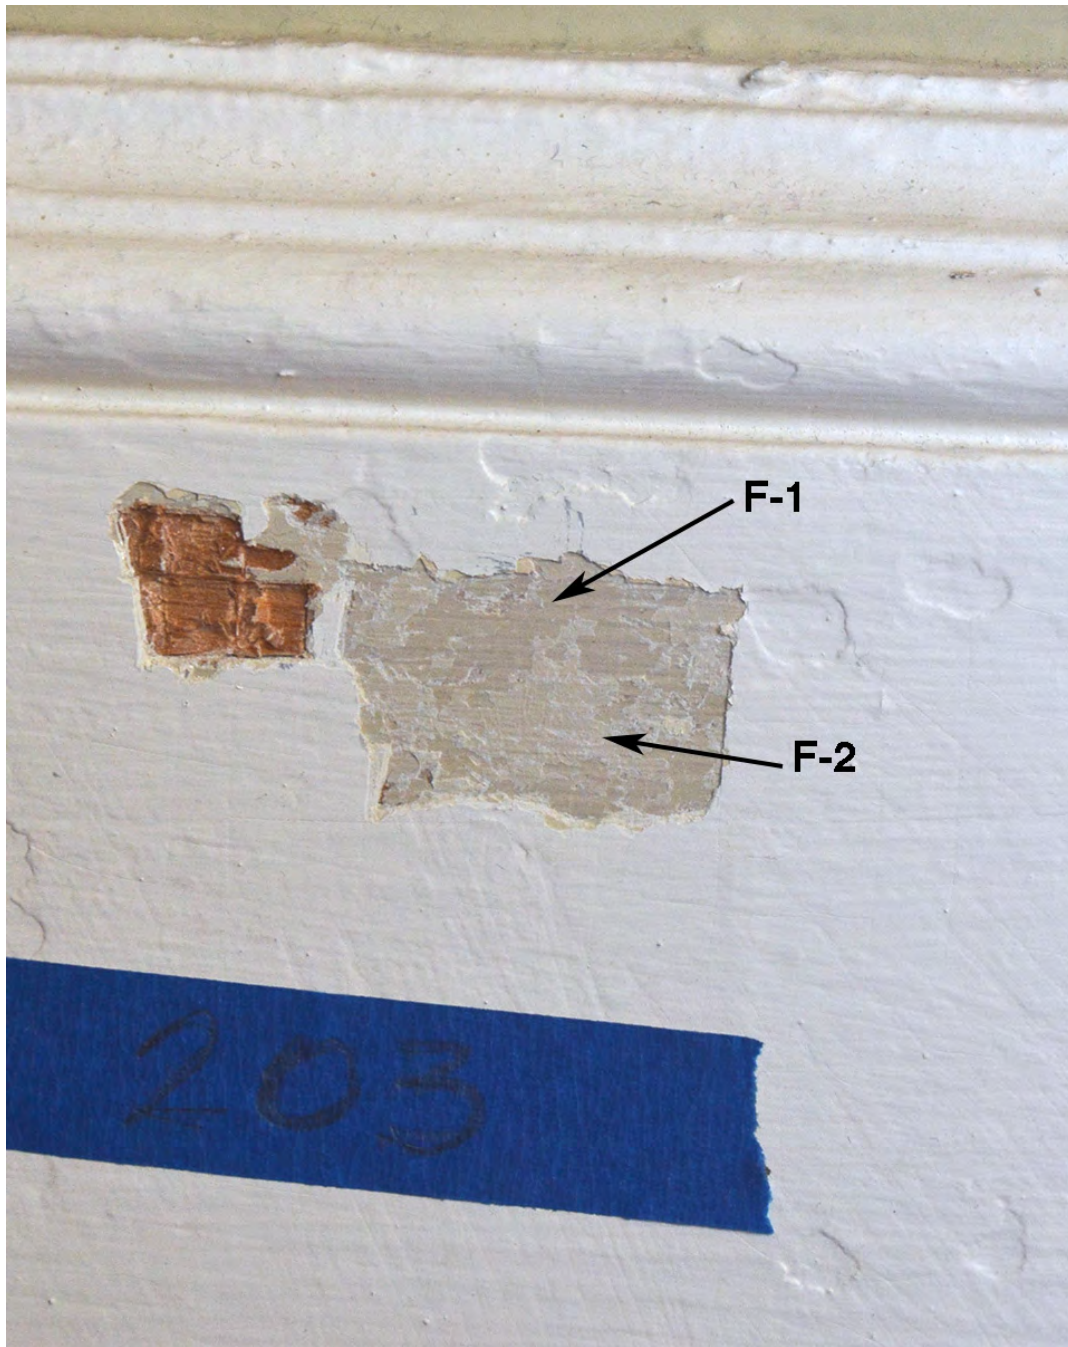
Baseboard:

Note: The photograph above shows an exposure of the baseboard fascia exposing the first and the second finishes. There is no indication of any of the marbling that was found on the surface of the baseboard fascia of the East Parlor during the first finish period. This is characteristic of the second floor rooms.
