Thomas Cole National Historic Site Historic Structure Report

Volume II: Appendices
October 2019

THOMAS COLE NATIONAL HISTORIC SITE
THOMAS COLE HOUSE
HISTORIC STRUCTURE REPORT
PMIS 216977

VOLUME II
APPENDICES

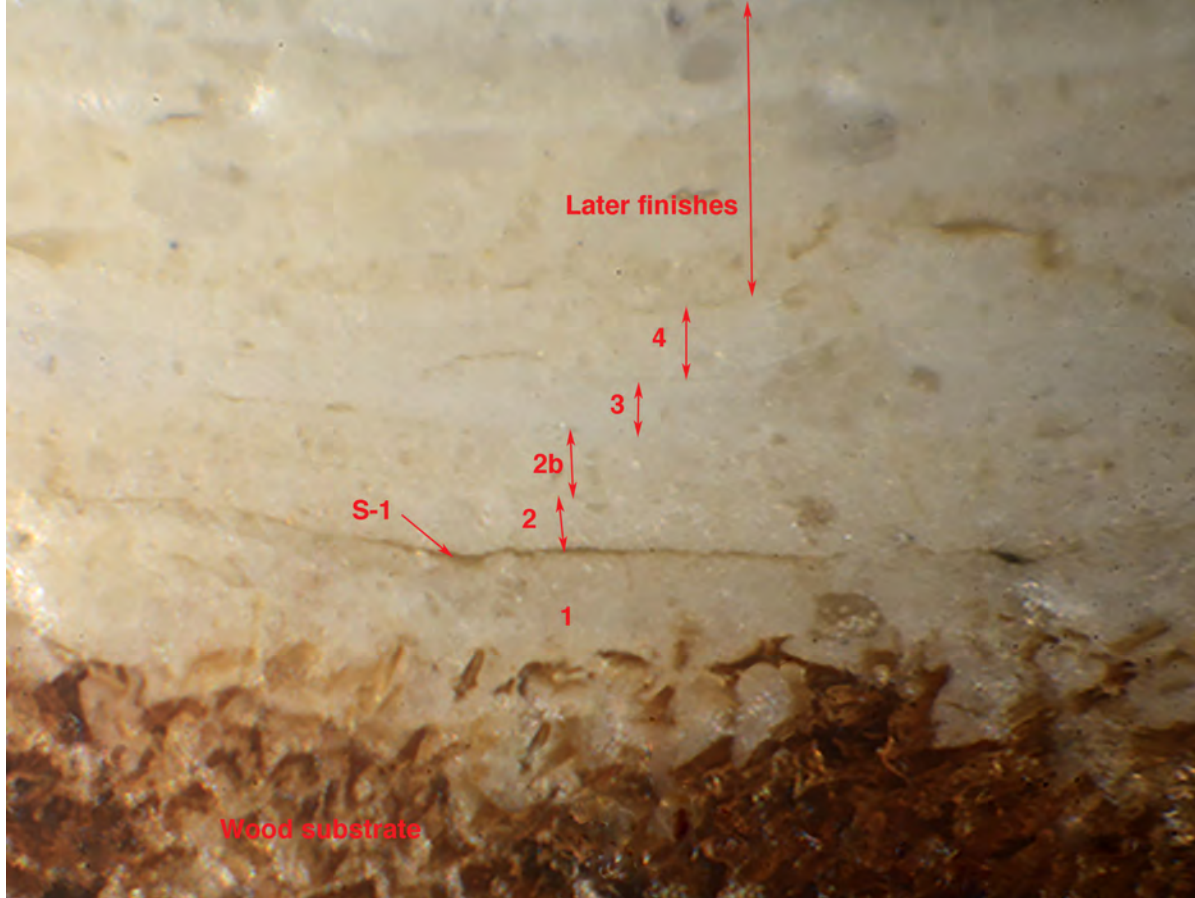
Sample 203-10: Mantel plinth block

Note: The sample has been mounted in polymer resin, cut and polished to 10,000 micron grit polishing cloth for additional examination. The paint finishes are the same as seen on Sample 203-2: Door Frame, Door to Hall [detail]. The wood substrate is seen at the base of the sample and is so indicated. The first finish is clearly seen [1] the surface of this finish is distinctly seen [S-1]. The second finish [2] appears to be the finish applied for the redecoration carried out in ca. 1836. There is a “touch up” repainting on the plinth block [2b] that is not seen on the Sample 203-2: Door Frame, Door to Hall. The whiter finish, [3] and [4] are also clearly seen. Based on the paint sequence of the Wall plaster, finishes 3 and 4 date to the early twentieth century. All of these early finishes are prepared lead white pigment.

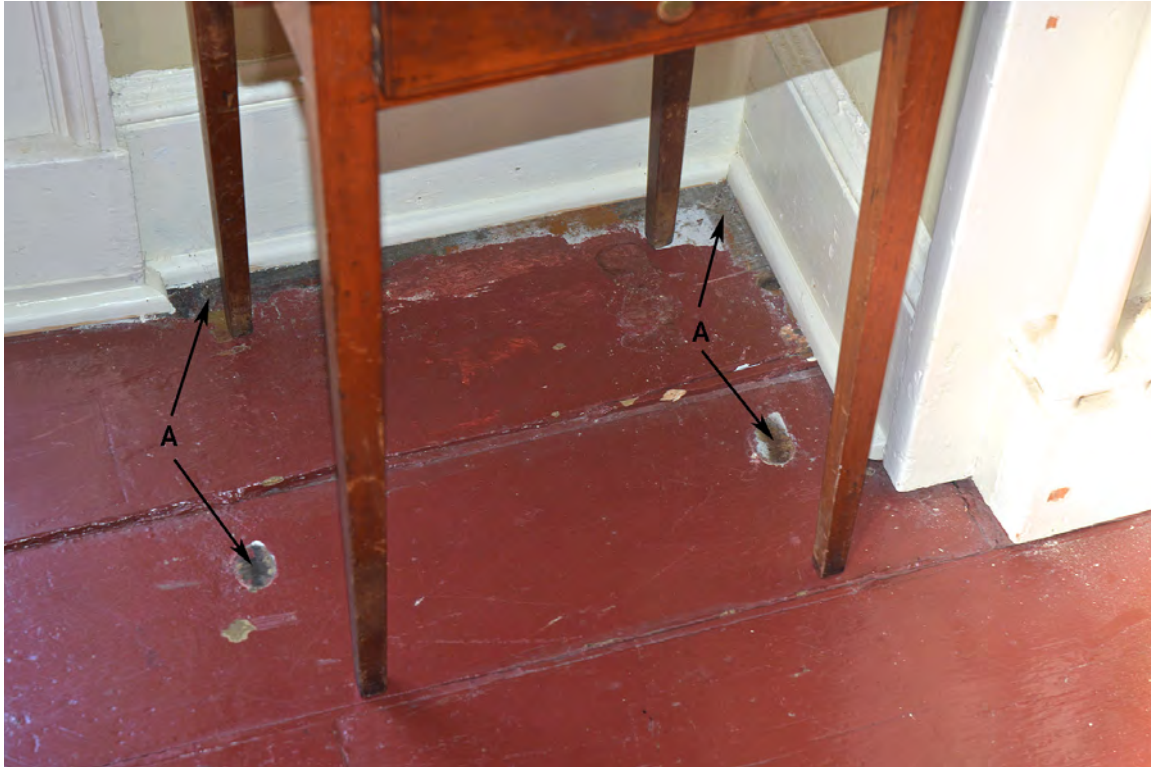
Historic Interiors consultant Jean Dunbar provided information on the floors: they were covered during the period before Thomas Cole came to Cedar Grove and continued to be covered during the Cole era. Thus: all of the floor enamels appear to be late in date: long after the Cole era, which ended in 1848. This can be ascertained by examining the floor in the Cole Sitting Room, Room 203.

The photograph above shows the floor in Room 203, the marks of a piece of furniture that was painted around during the earlier periods: the feet of this furniture piece sits on bare wood. It is likely that the painted floors began during the “Colonial Revival” period in the earlier twentieth century.

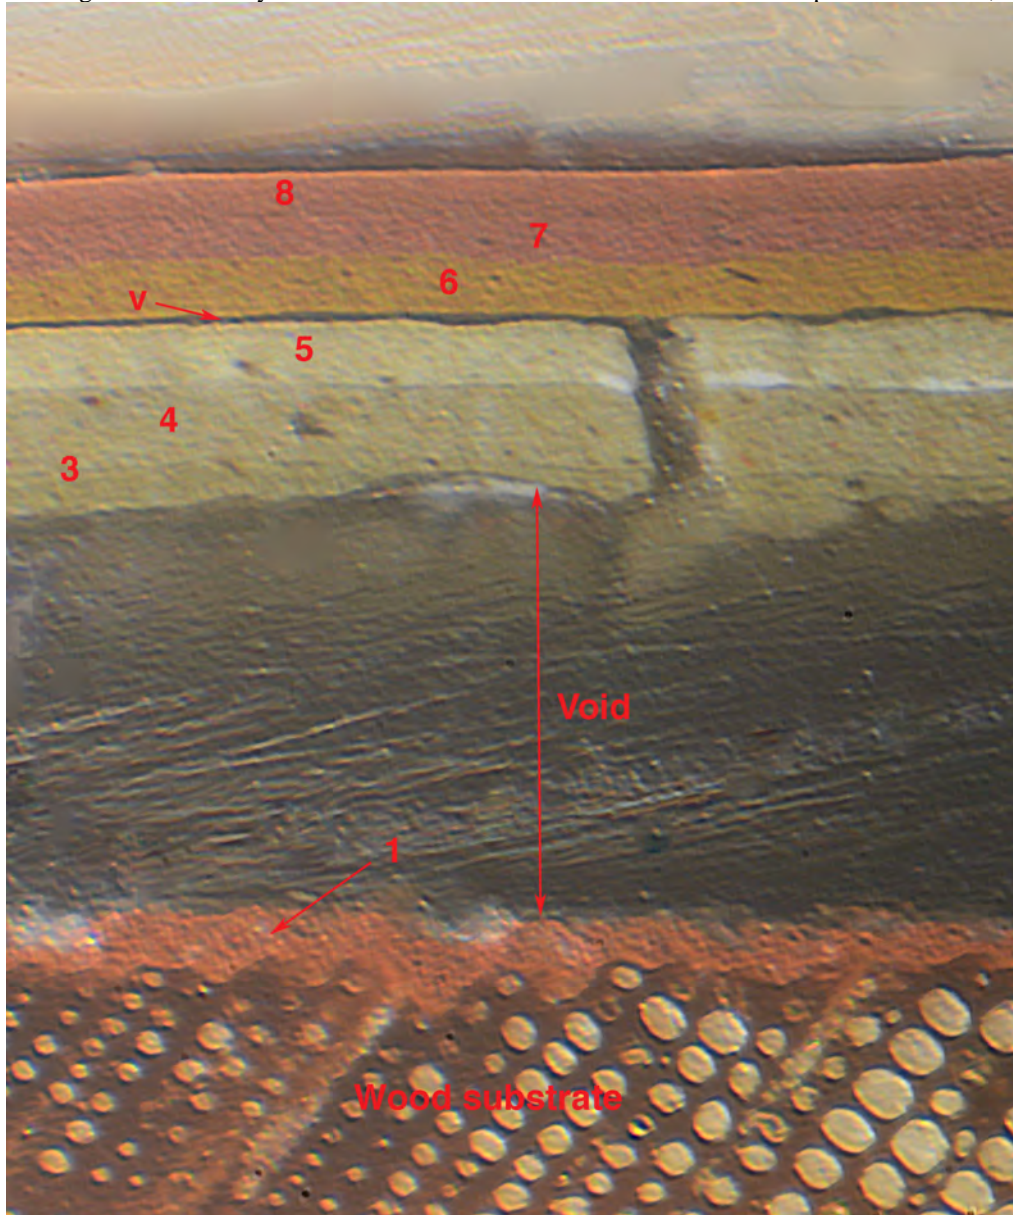
Sample 203-14: Floor Enamel

Note: The sample has been mounted in polymer resin, cut and polished to 10,000 micron grit polishing cloth for additional examination. While finishes 1-5 are prepared with lead components, all appear to date to after the Cole era: Room 203 was carpeted during the period, 1836-1848. The wood substrate is seen at the base of the sample. Note that the subsequent finishes are not well adhered and have delaminated, opening a void. The floor paint relating to layers 3, 4, and 5 are similar to the first two finishes in Room 204. A second void is visible. Modern floor finish enamels follow: layers 7 and 8 are matched to the first surviving red ochre finish enamel. At the earliest, these finishes would date to sometime after ca. 1884.

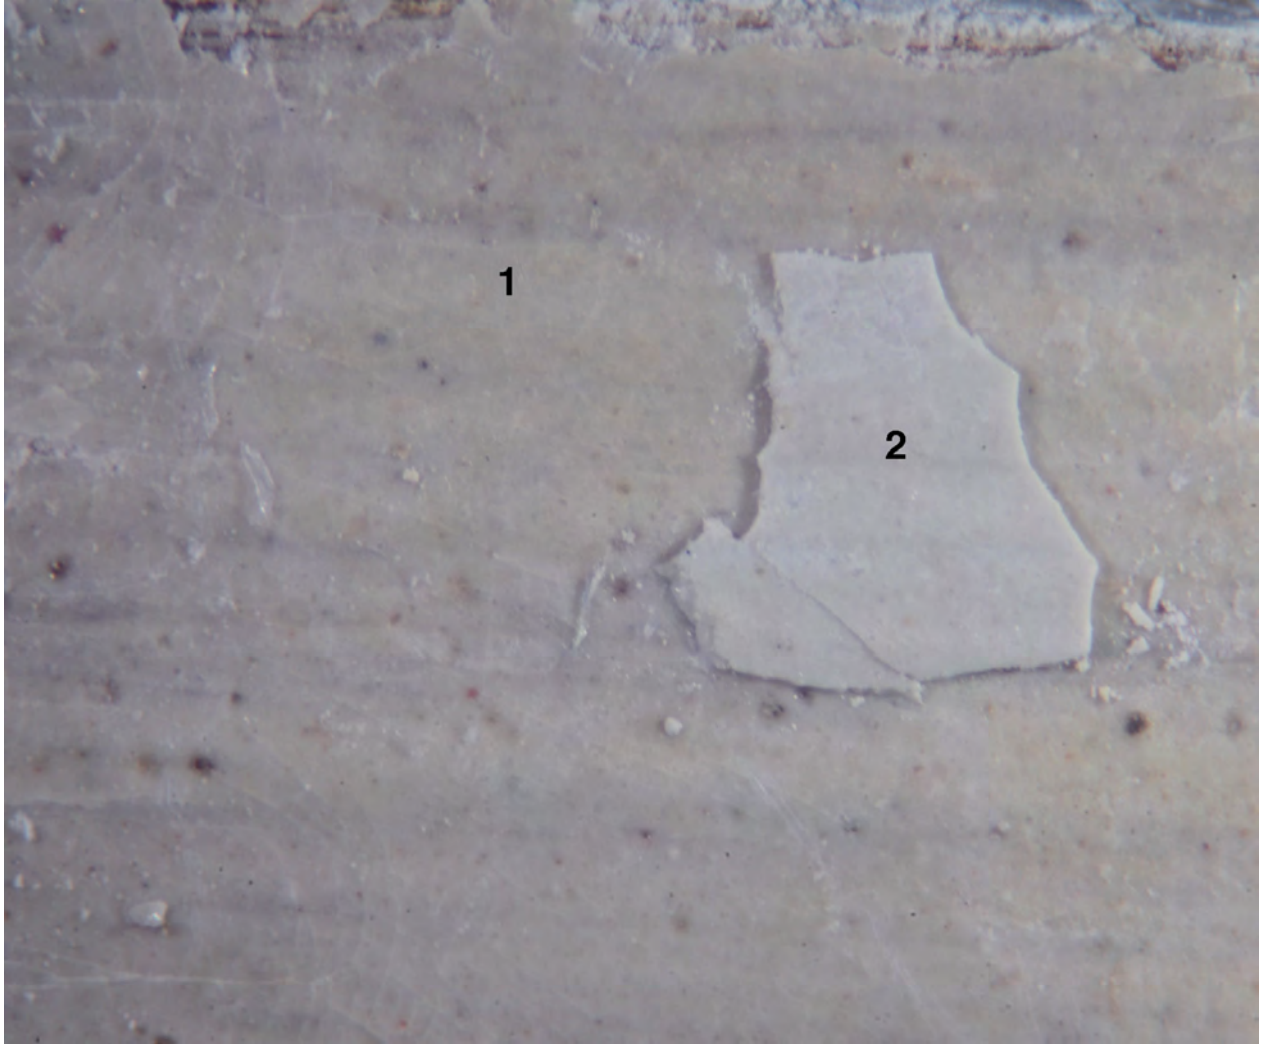
Sample 203-2: Door Frame, Door to Hall [detail]

Note: The sample is seen showing the finish surface of the sample. The paint layers have been removed, including most of the second finish. The first finish exposed shows the grain visible through the paint finish: this is due to chemical change in the paint that reduces the opacity of the lead white. The first finish [1] is clearly visible. The second finish, which is also made with lead white shows a slightly whiter and more opaque condition. This second finish will be restored, as it appears to date to the ca. 1836 period when Thomas Cole moved into the house.

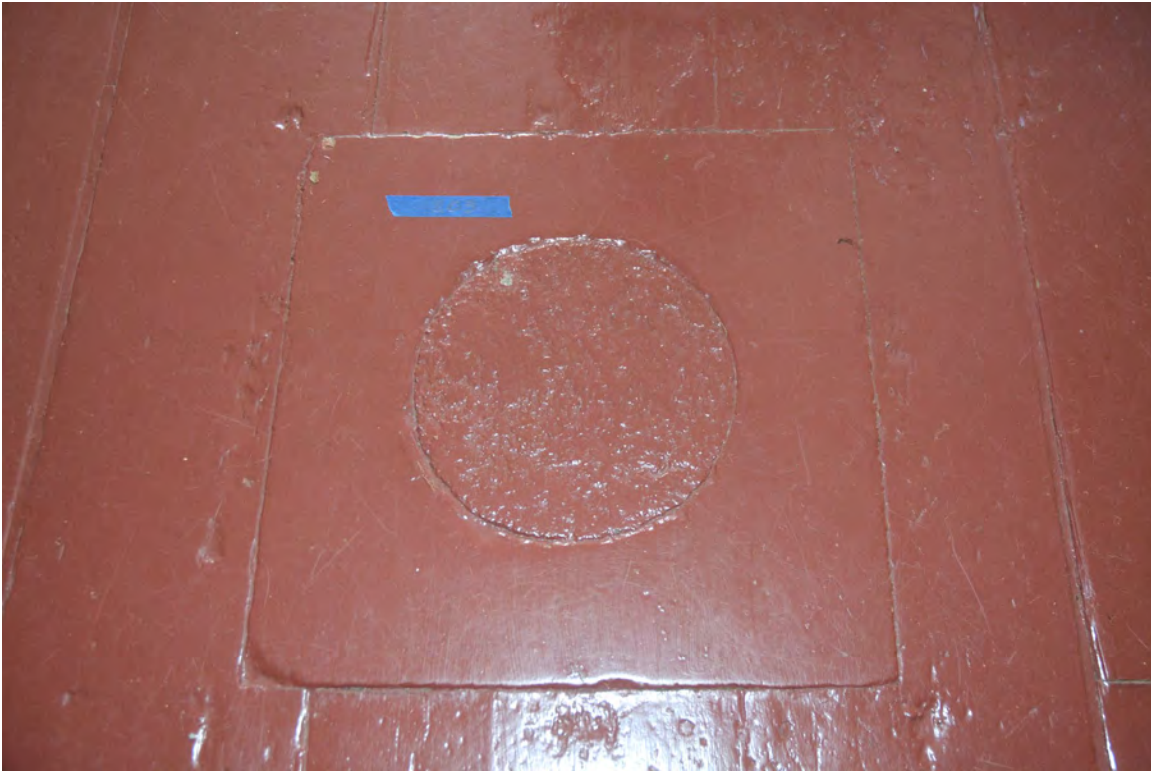
Floor: Stone inset

Note: The stone inset, seen above, was originally unpainted: only twentieth century finishes are seen on the stone inset.

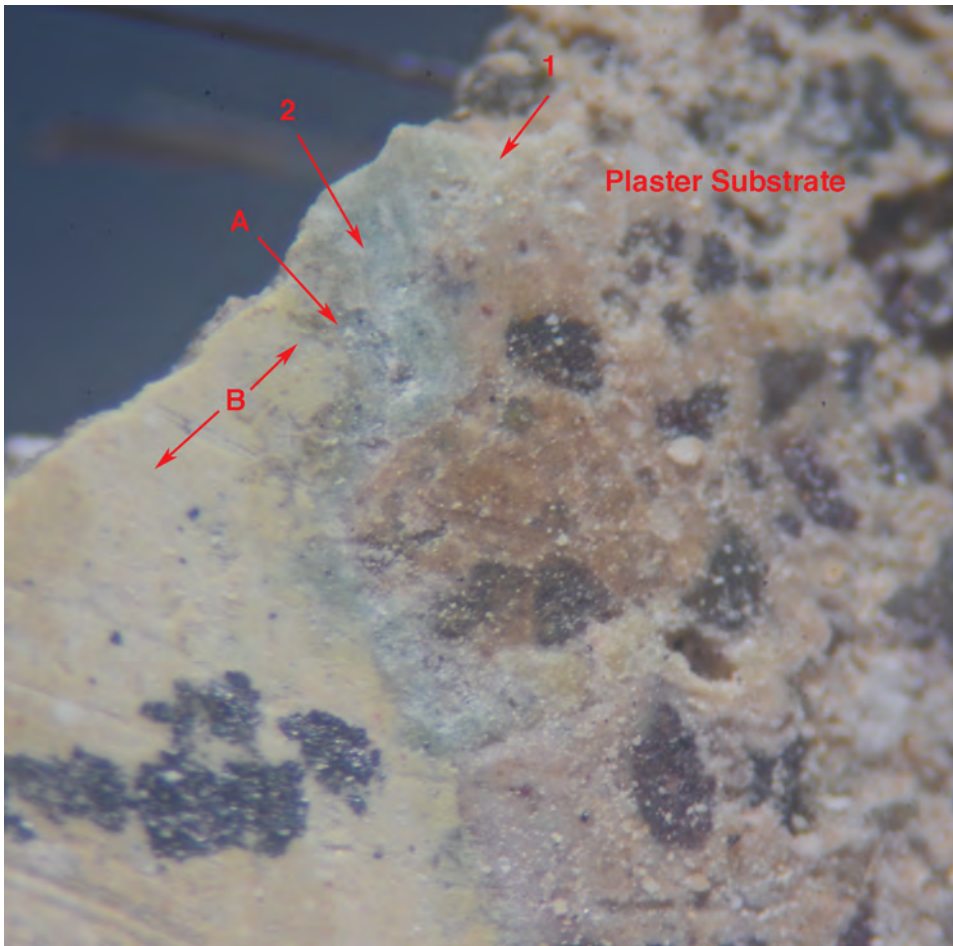
Illustration 204-A

The presence of these relatively friable coatings under later oil based paints made for poor adhesion of the oil paint, subject to removal by later scraping of the walls. Initial examination of the wall, with in situ magnification suggested that there was a light green line near the top of the wall. This was actually a fragment of the light blue lime coating that remained [Illustration 204-A].

Note: The sample at the left is from approximately $\frac{3}{4}$ " below the ceiling where the fragment of the light blue. The sand-plaster substrate is clearly seen and indicated. The first lime whitewash is visible [1], followed by the remarkable light blue lime wash [tinted with indigo]. The surface of the light blue has discolored, and has some surface particulate. The oil-based paint from the Thomas Cole period is not present. The light

yellow finish, [B] may be from the extensive redecoration ca. 1884 or from the early twentieth century.

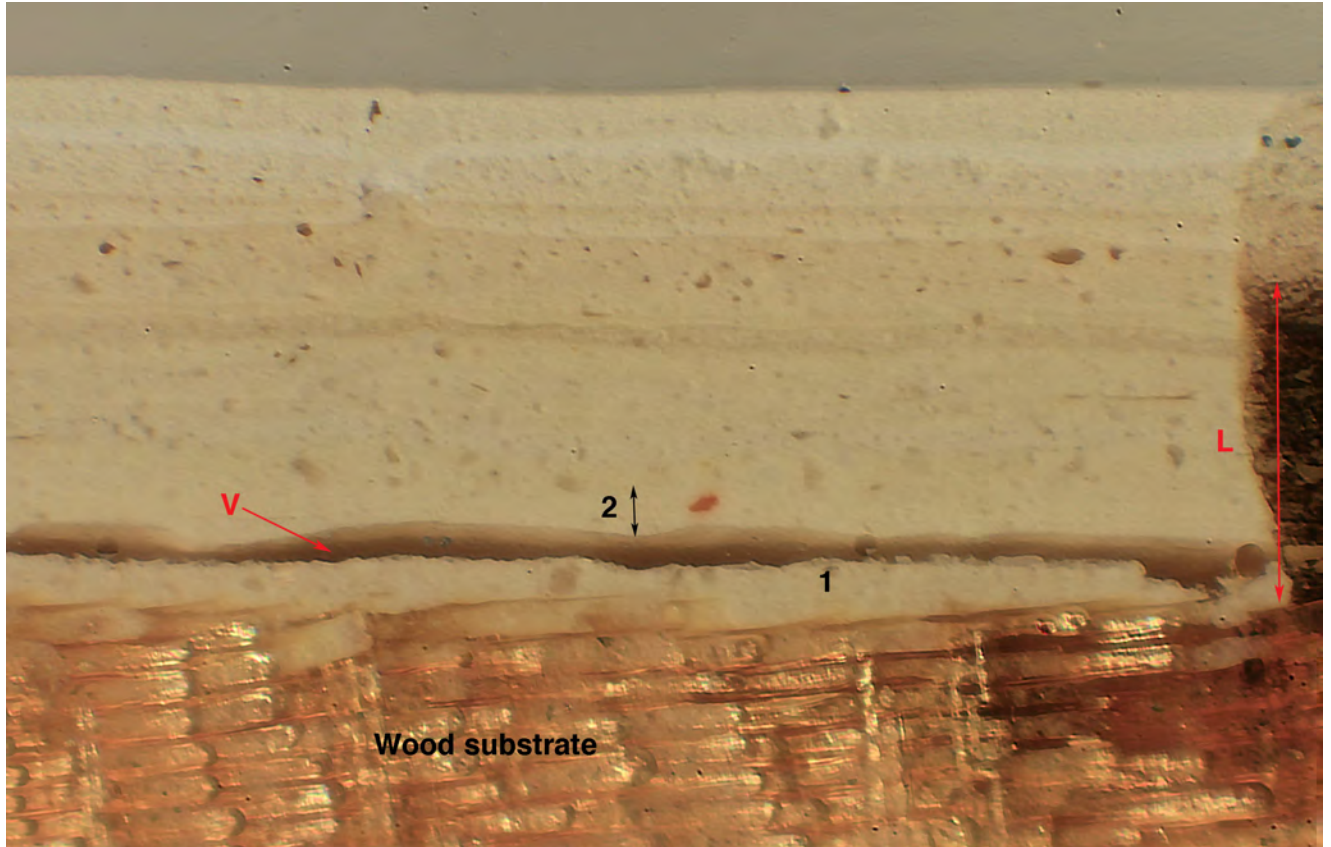
Sample 204-1: Door Panel, Door to Room 101 Entrance Hall

Note: This sample has been mounted in polymer resin, cut and polished to 10,000 micron grit polishing cloth for additional examination. The wood substrate is seen at the base of the sample as noted. The first finish, prepared with lead white is clearly seen: note the void that opened at the finish surface of the first finish [V]. This is followed by the second finish, also prepared with lead white: the second finish is believed to be that of the Cole period: ca. 1836. The later finishes are also visible: note the area that has been exposed to sodium sulfide solution at the right, which has blackened all of the lead white compounds. The use of lead appears to continue into the twentieth century.

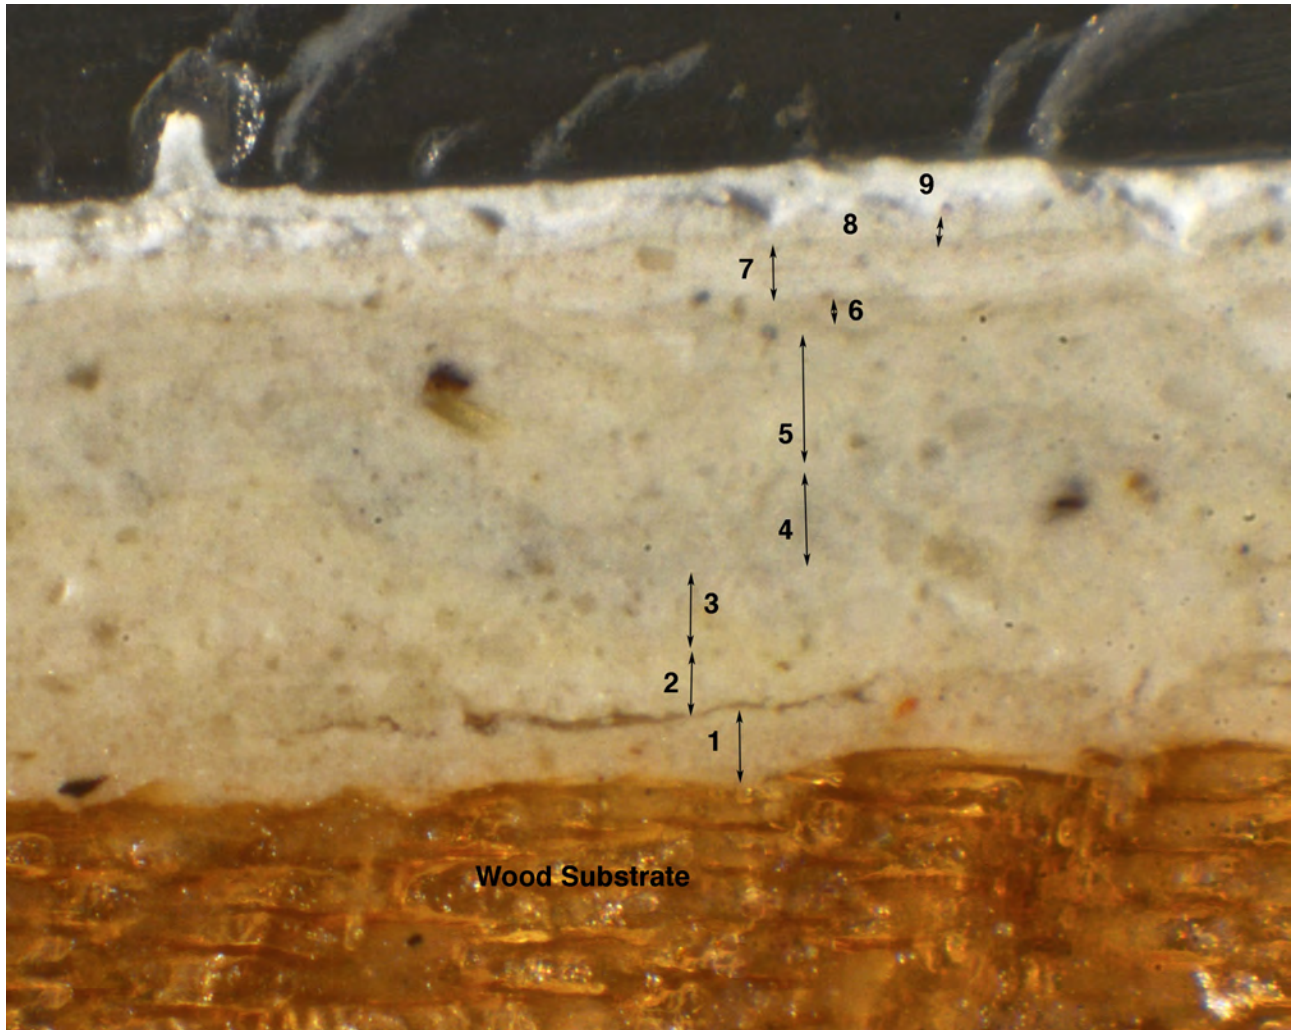
Sample 204-2: Window frame, East Window [W 23]

Note: This sample has been mounted in polymer resin, cut and polished to 10,000 micron grit polishing cloth for additional examination. The wood substrate is seen at the base of the sample as noted. The first finish, prepared with lead white is clearly seen. This is followed by the second finish, also prepared with lead white: the second finish is believed to be from the Cole era, the redecoration of ca. 1836. The third finish probably dates to ca. 1884 following the death of Maria Barstow Cole. Later painting campaigns were carried out and a total of nine different finish periods appear on this sample.

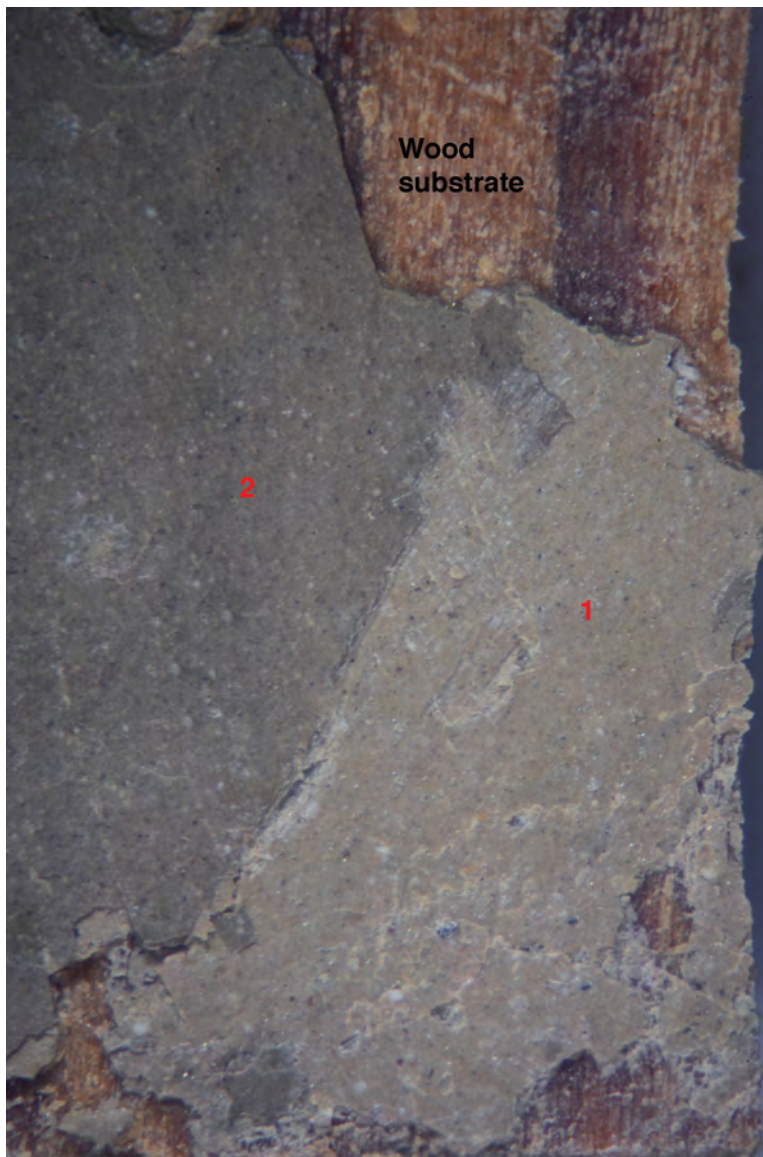
Sample 204-9: Floor Board: 2" from east wall, north of East window

Note: During the historical period the floor of this room was carpeted, over the bare floor boards. The paint finishes, though prepared with lead compounds, date to after the historic period. Note that these finishes are contemporary with floor paint finishes 3, 4, and 5 in Room 203; these finishes are nearly certainly from the twentieth century.

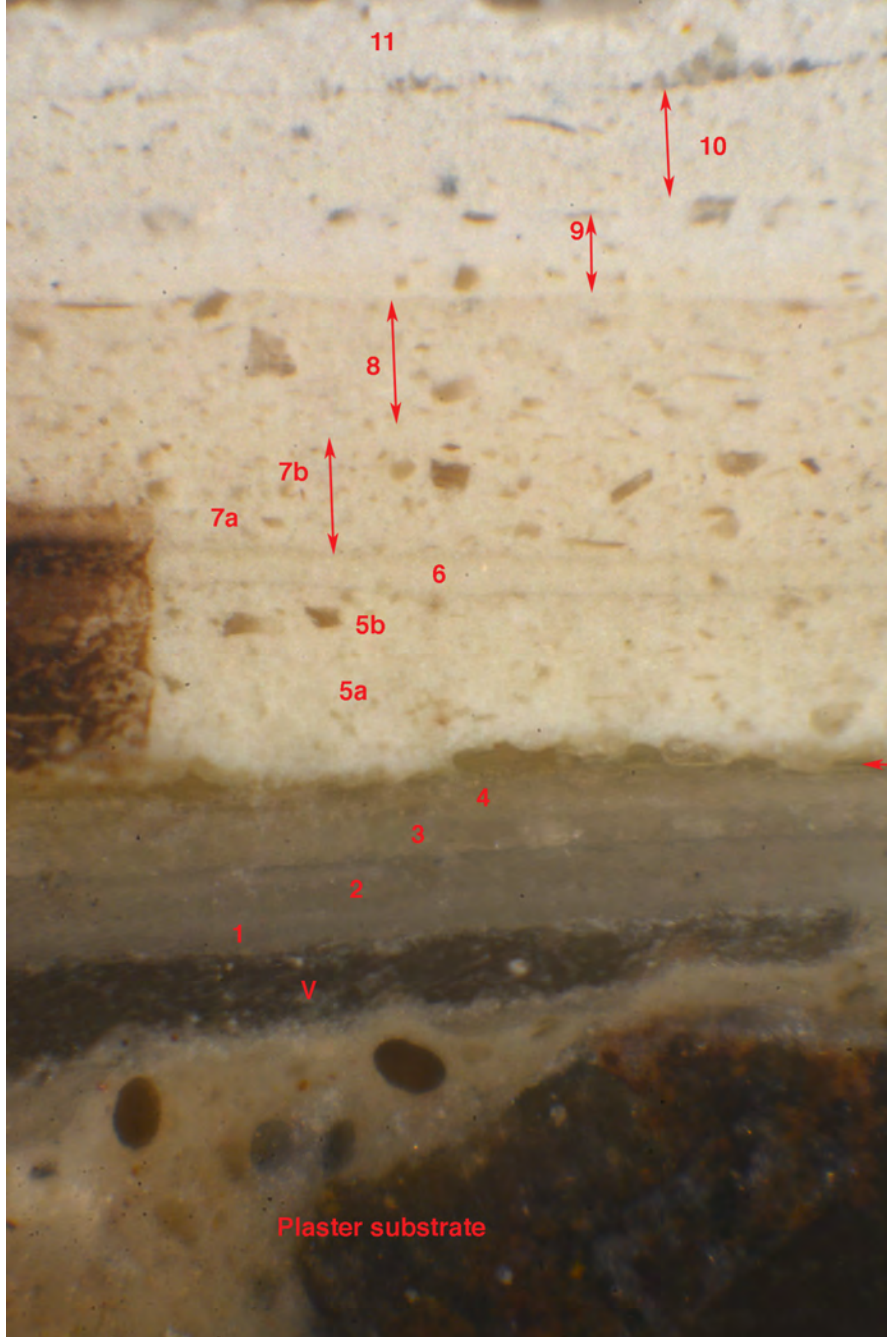
Sample 204-10: Ceiling 2" from the east wall

Note: The sample has been mounted in polymer resin, cut and polished to 10,000 micron grit polishing cloth. The plaster substrate is seen at the base of the sample and is indicated. There is a void separating the paint accumulation from the substrate [except for a few areas where the lime coating is still adhered to the substrate]. **The mounting medium has altered the appearance of the porous lime coatings.**

Layers 1-4 are lime whitewash coatings. There is a distinct delamination plane [D] observed where the lime whitewash coatings are followed by the oil based finishes. Note that there is also a glue size [adhesive] layer here, that may have been applied to stabilize the whitewash layers. It may also indicate the use of a ceiling paper. The fifth finish, 5 [5a, 5b] may be from ca. 1884 and the lime white finish 4 may be from the

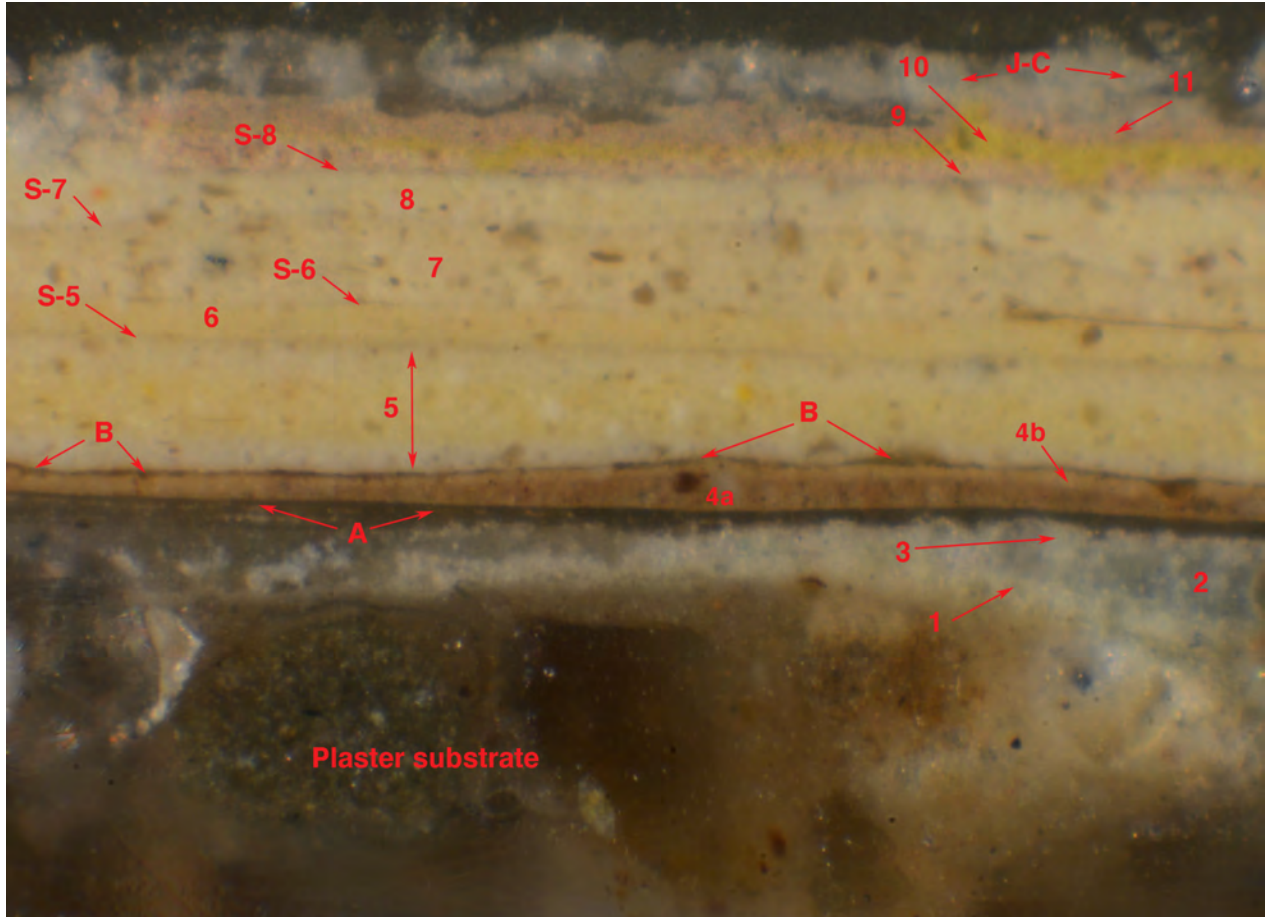
Sample 204-11: Wall plaster, at base of the East Wall

Note: The sample has been mounted in polymer resin, cut and polished to 8,000 micron grit polishing cloth. The plaster substrate is seen at the base of the sample and is indicated. The wall sample shows 3 lime coatings: note that the second, [2] is blue, tinted with indigo. The other lime coatings, 1 and 3 are white lime coatings. Note the thin adhesive layer [A] that may have been applied for the installation of wallpaper or may have been applied to stabilize the earlier lime coatings. If that is the case, it may be that the wallpaper was installed prior to ca. 1836.

The fourth finish [4a, 4b finish] may be the Cole period. This is a moderate grayish brown color: this color may be very significant [refer to: "The moderate grayish brown color of Room 204"] and would become very popular when brownstone becomes a principal building material. These colors, however, were very popular in the 1880's. Of considerable importance, is the evidence of a second adhesive layer [water soluble] that follows the fourth finish. This indicates that the redecoration of Room 204 appears to have used wallpaper in ca. 1884 after the death of Maria Barstow Cole.

Returning to the photomicrograph of the wall cross section, **Sample 204-11: Wall plaster, at base of the East Wall**, the fourth finish is prepared with two layers the first darker than the second, which is the finish color. The first layer is a near exact match to the darker brownstone color for the arch, seen at the left. It appears that Thomas Cole determined that the darker color was too dark for the room, and lightened the color. Both layers appear to have the same type of pigments.

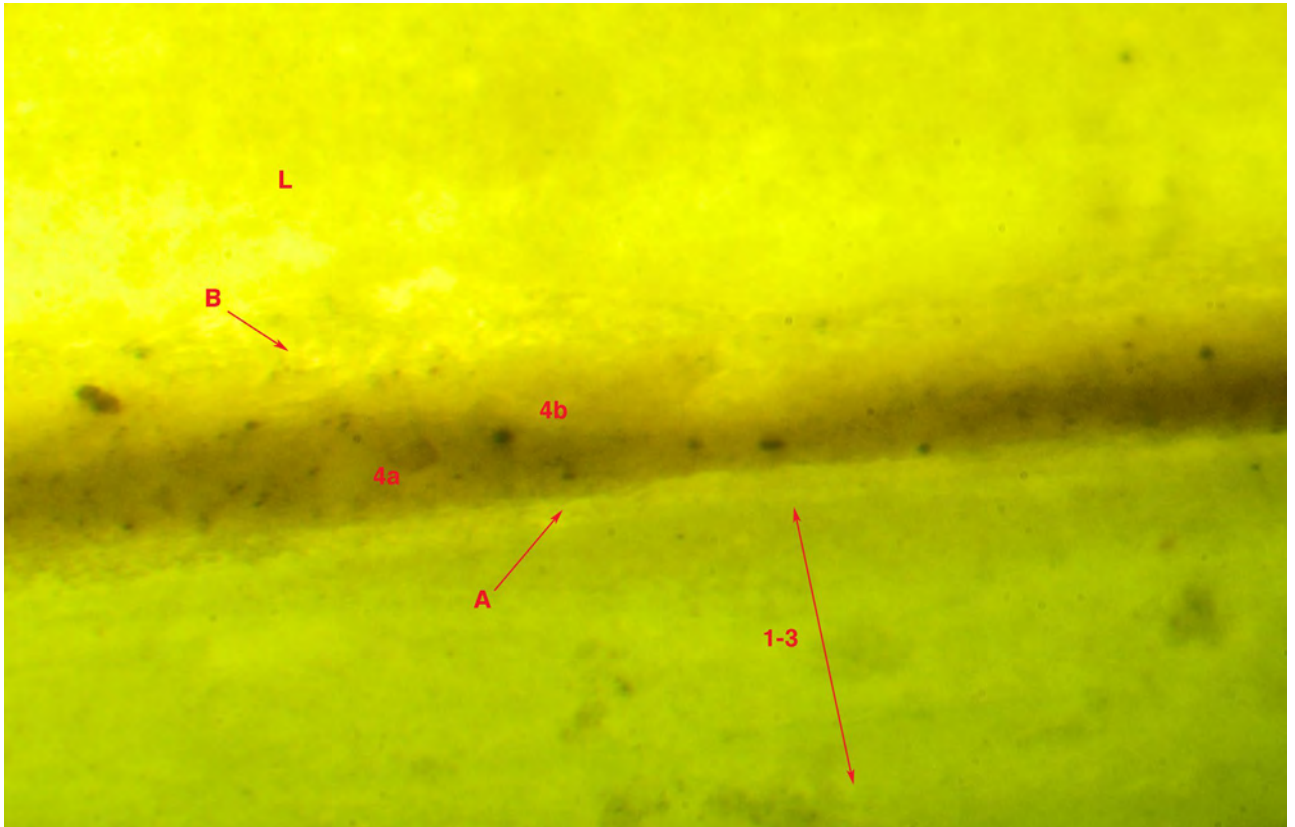
Sample 204-11: Wall plaster, at base of the East Wall

Note: The sample has been mounted in polymer resin, cut and polished to 10,000 micron grit polishing cloth. The plaster substrate is seen at the base of the sample and is indicated. The sample is viewed under ultraviolet light, as indicated. The initial lime coatings are clearly seen [1-3]. This is followed by the thin glue size that may have been applied as an adhesive for wallpaper, or as a stabilizing coating for the application of the oil based moderate brown finish [A]. The moderate grayish brown is clearly seen [4a, 4b]. The second layer of adhesive [B] is also visible.

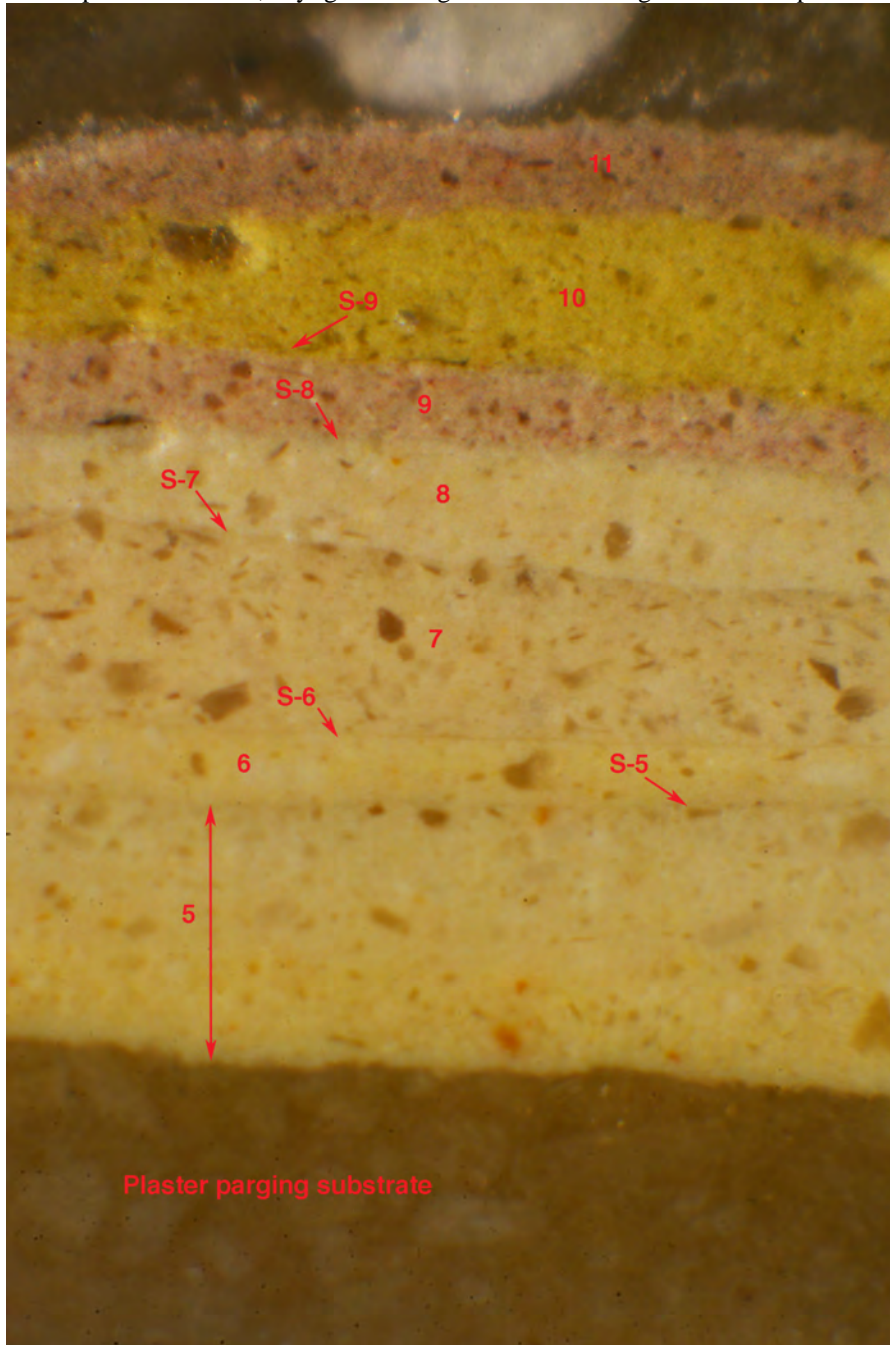
Sample 204-12: Wall plaster, East Wall 4'-10" above floor

Note: The sample has been mounted in polymer resin, cut and polished to 10,000 micron grit polishing cloth. The plaster substrate is a white parging plaster that was applied for the redecoration ca. 1884. The sequence of finishes are numbered using the numbering from **Sample 204-11: Wall plaster, at base of the East Wall** and begins with the fifth finish is the overall sequence of paint finishes.

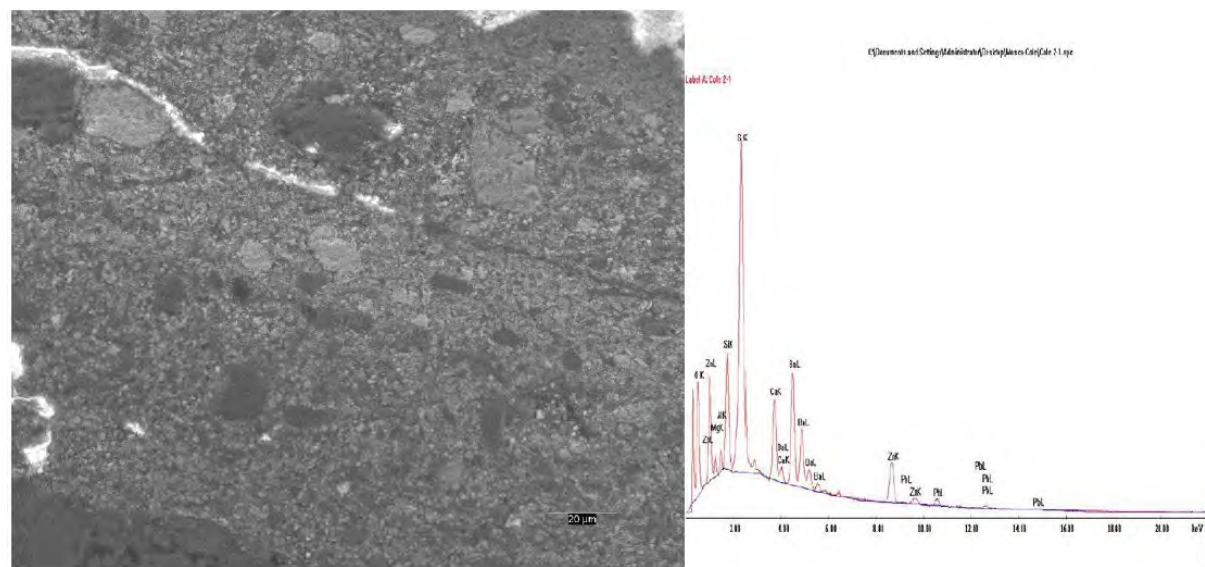
Sample 204-12: Wall plaster, East Wall 4'-10" above floor was sent to Dr. Carol Heckman, of the Electron Microscopy Core Facility [through Science Exchange], for identification of the elements of the paint material by Scanning Electron Microscopy. The results are indicated below.

Note: The elemental identification is significant in that it indicates the presence of zinc and barium among the components along with a high percentage of sulfur. This indicates the presence of lithopone a white pigment composed of barium sulfate and zinc sulfide. Lithopone was first introduced in ca.1870 in England, however, it became very widely used for interior paints in the early twentieth century, reaching a peak of production in the 1920's. The yellow pigment appears to be a lead yellow: lead oxide.

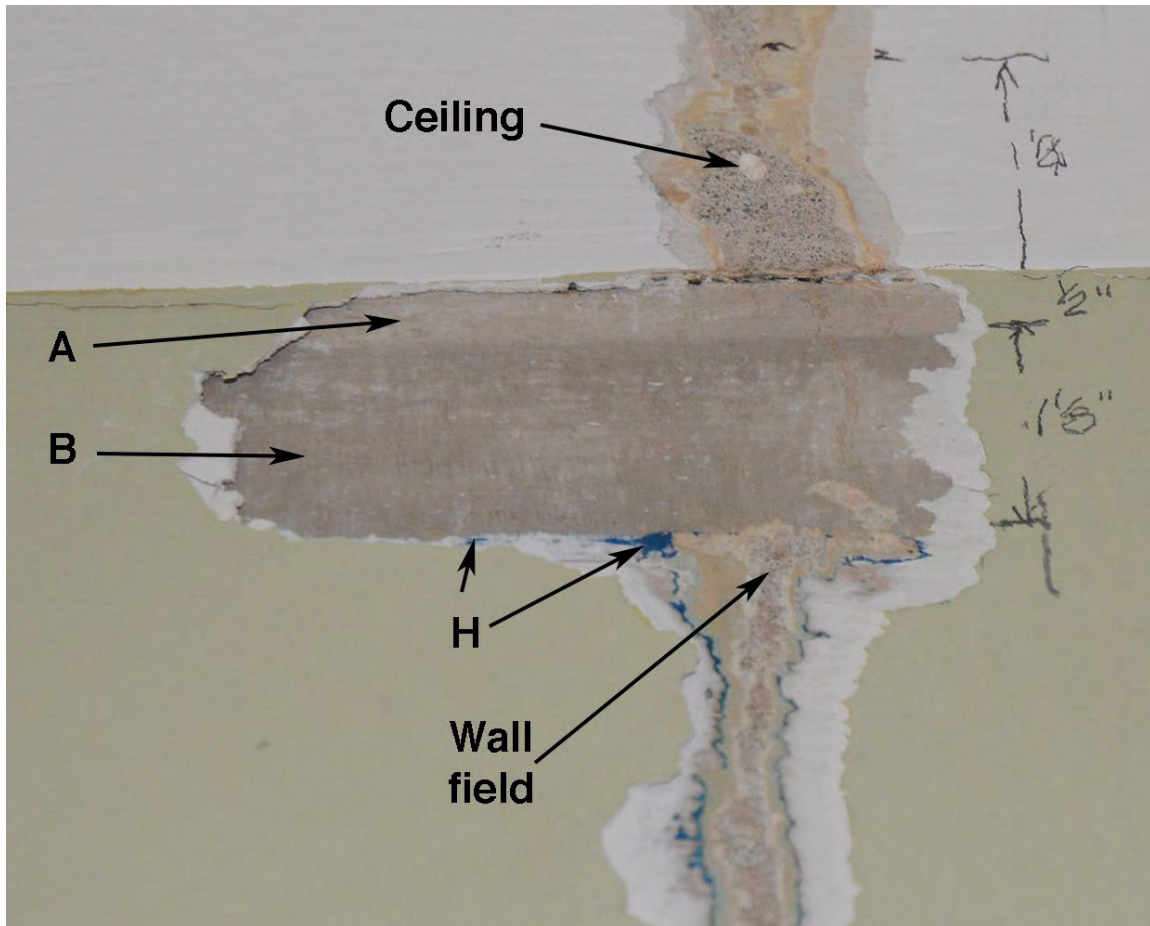
The room shows a painted band at the top of the wall which appears to be from the Cole period: ca. 1836-1848.

A large exposure was uncovered in this room, disclosing the Cole period finish. The $\frac{1}{2}$ " band, A, is the basic wall color which is articulated with a simple painted band, B, $1 \frac{1}{8}$ " in width. The color is a light brownish gray. Note that the later wall finishes retained exposure of this band: the deep blue finish, H, seen at the edge of the light brownish gray band does not continue up to the ceiling, nor do the later finishes. Only after the re-parging with joint compound, [Restoration in the year 2000] does the band B get buried and over-coated. Much like the other rooms, the woodwork appears to have been painted with lead white finishes during the historic period.

This room provides a possibility of using in situ matching of the color, as was done for the West and East Parlor friezes. It is advised that this be done for Room 205. The exposed banding is in good condition in terms of color.

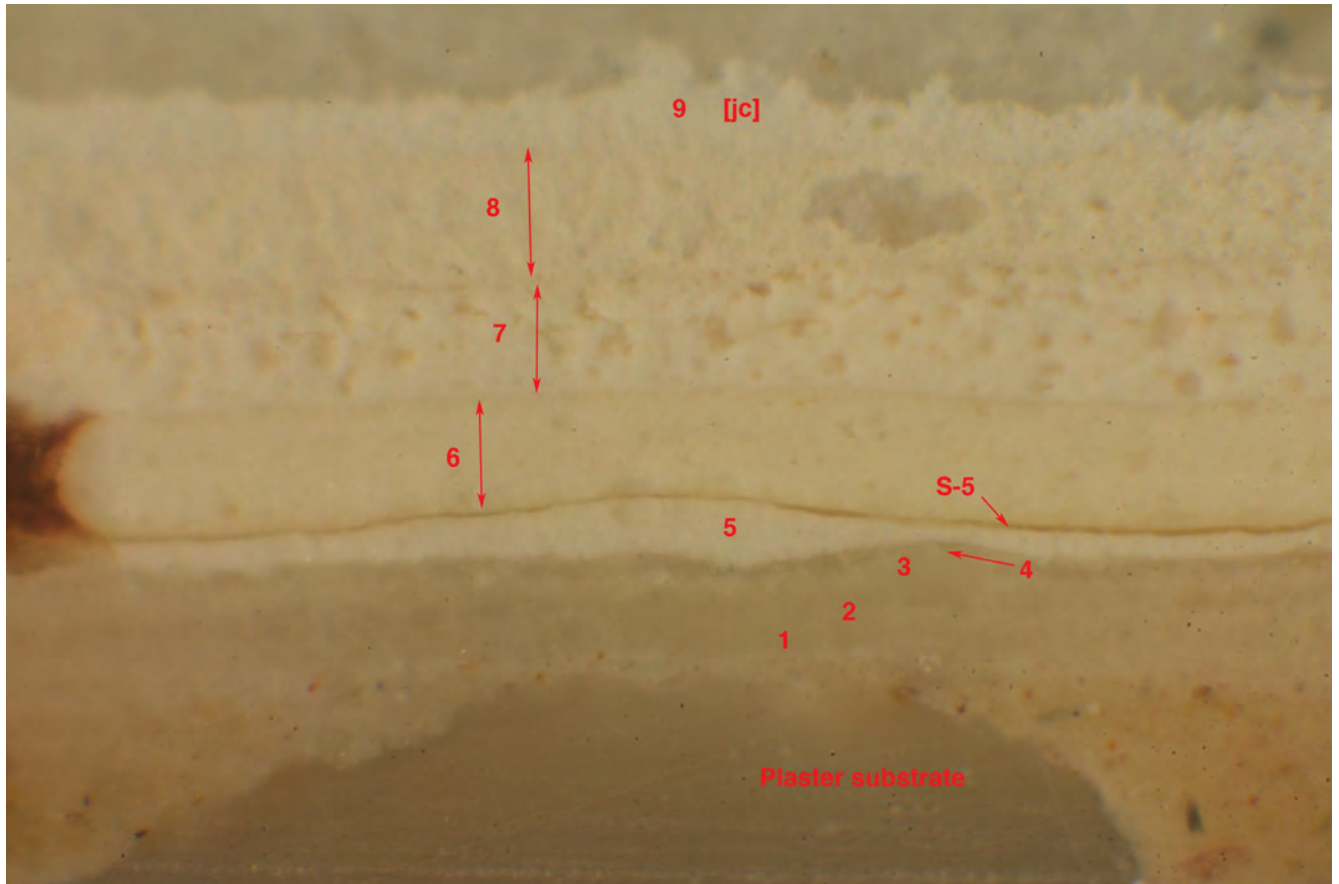
Sample 205-1: Ceiling

Note: The sample has been mounted in polymer resin, cut and polished to 10,000 micron grit polishing cloth for additional examination. The plaster substrate is seen at the base of the sample. The first four layers are lime white applications: these are smooth lime coatings, however, they appear translucent due to the mounting medium. The last of the lime white applications may indicate the Cole period. Finishes 5 and 6 are oil bound paints, prepared with lead white pigment. Finishes 7 and 8 are relatively new: they are twentieth century finishes prepared with titanium dioxide white pigment, the principal white pigment used today. Layer 9 is actually joint compound, applied ca. 2000 for the restoration at that time.

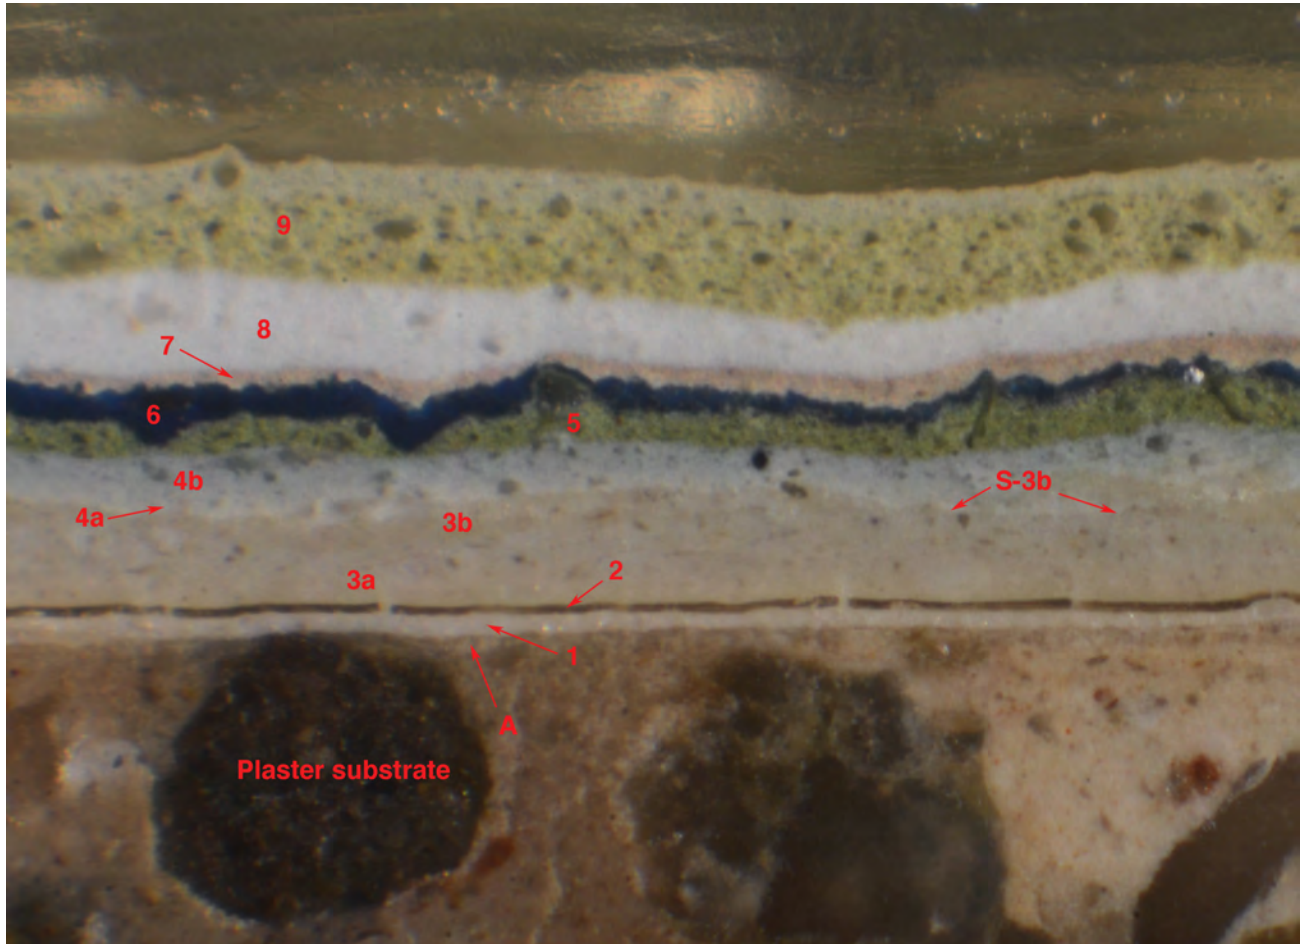
Sample 205-2: Wall [south wall, west of Door to Room 203

Note: The sample has been mounted in polymer resin, cut and polished to 10,000 micron grit polishing cloth for additional examination. The plaster substrate is seen at the base of the sample and is indicated. On the surface of the plaster there is a thin application of an adhesive that probably indicates the use of wallpaper during the early period, 1815-1836 [A]. The remnants of the adhesive are better shown in subsequent photomicrographs [Refer to Sample 205-3, Location A]. The first layer [1] is a lead white layer, which is covered with a natural clear resin coating [2]. The purpose of this coating is not known, however, it would have made the surface glossy. Layers 3a and 3b are prepared with lead white pigment, with tinting pigments [natural ochres, carbon black]. The finish surface S-3b appears to be the Cole period finish, which was exposed.

Following the Cole period, there is a thin white [lead white] undercoat and a light blue finish coat [4b]: this may be from the twentieth century. Finishes 4b through 9 all appear to contain titanium dioxide white and are thus twentieth century.
