Thomas Cole National Historic Site Historic Structure Report

Volume II: Appendices
October 2019

THOMAS COLE NATIONAL HISTORIC SITE
THOMAS COLE HOUSE
HISTORIC STRUCTURE REPORT
PMIS 216977

VOLUME II
APPENDICES

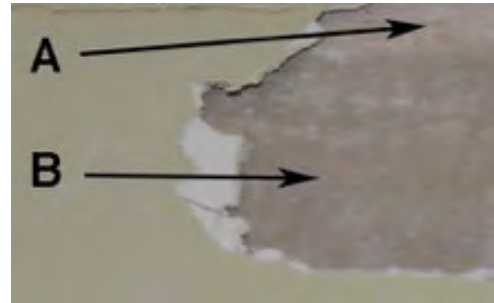
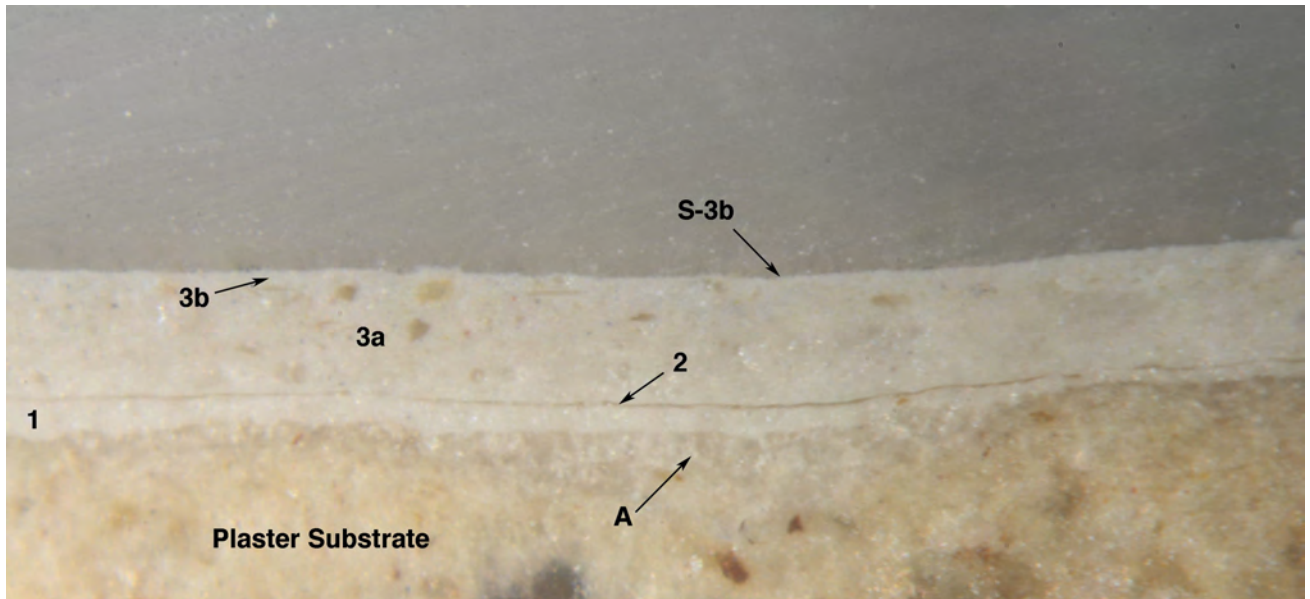
Sample 205-3: Wall above Door to 203, Location A

Note: The sample has been mounted in polymer resin, cut and polished to 10,000 micron grit polishing cloth for additional examination. This sample has had the post Cole era finishes removed. The plaster substrate is seen at the base of the sample. The thin remnant of adhesive is seen retained in a slight depression of the substrate [A]. The first layer is a lead white layer [1], which is covered with a very thin clear resin [2]. The layers 3a and 3b are lead white based and appear to be the Cole period applications. As indicated in the location illustration above, the surface of the wall has the grayish brown band on the surface [B].

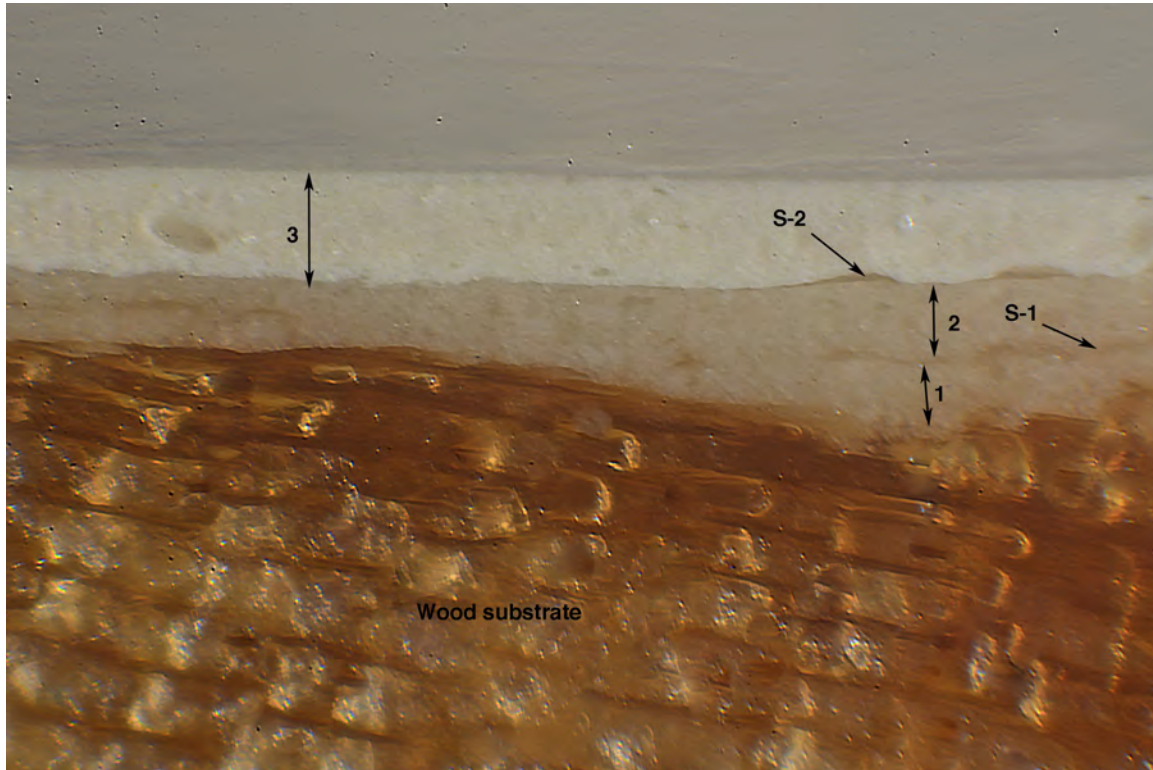
Sample 205-1: Door, Panel

Note: The sample has been mounted in polymer resin, cut and polished to 10,000 micron grit polishing cloth for additional examination. The wood substrate is clearly seen at the base of the sample. There are three finishes observed. The first finish [1] is a lead white finish, note the finish surface [S-1] that is clearly seen. The second finish [2] is also seen: also prepared with lead white. The second finish S-2 is also visible. The last in the sequence is a twentieth century white finish, prepared with titanium dioxide white [3].

The relatively few layers seen on this sample is due to the extensive scraping or removal at the time of the third finish, which, may be ca. 1884 or post, following the concept that the redecoration of the house following Cole's death in 1848 did not happen until after Maria Barstow Cole's death in 1884. Some other samples showed far more finishes.

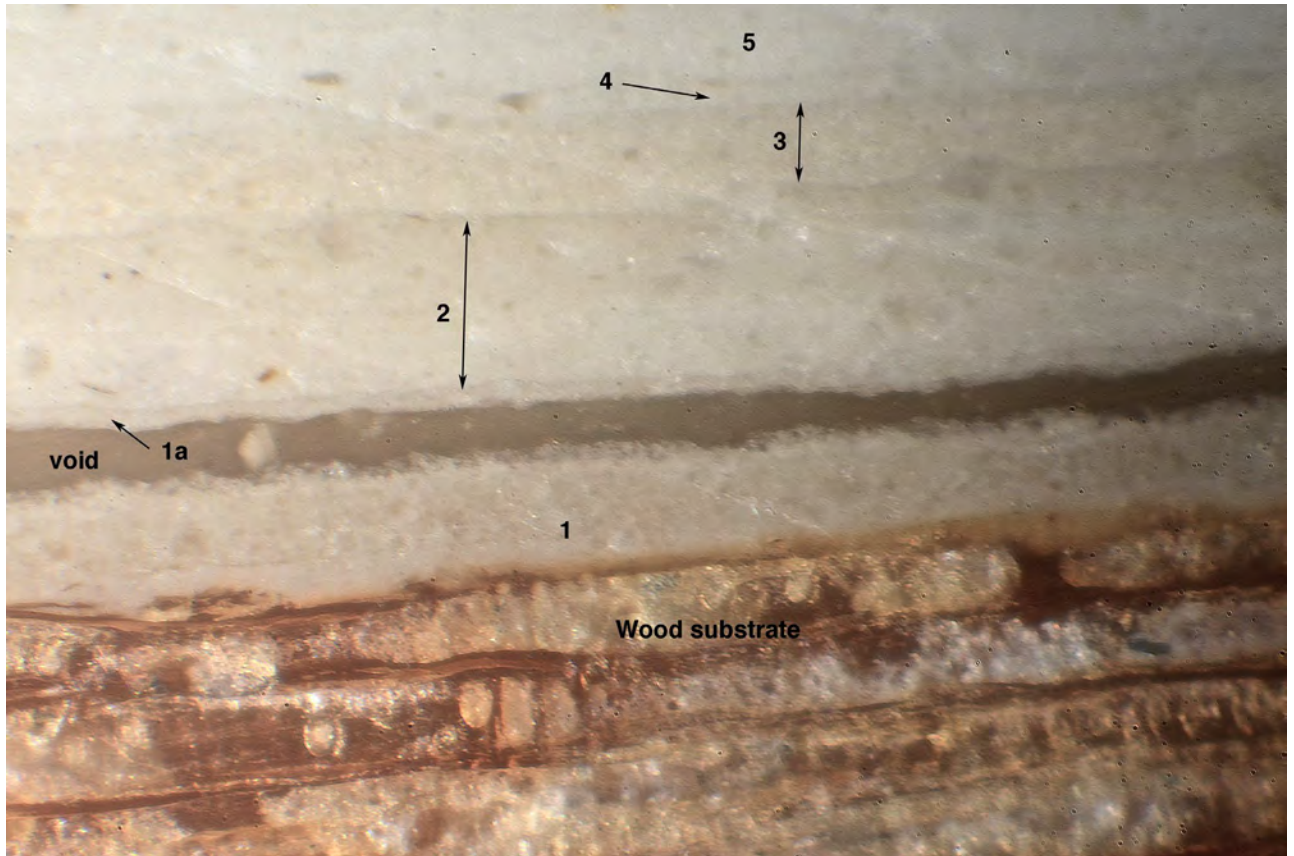
Sample: 205-2 : Door Frame

Note: The sample has been mounted in polymer resin, cut and polished to 8000 micron grit polishing cloth for additional examination. The wood substrate is seen at the base of the sample, as indicated. The first finish [1] is prepared with a lead white pigment. There is an additional coating that followed shortly after [1a] also made with lead white. Finish 2 appears to be the Cole period finish, created with three layers. The third finish may be from the Cole period as well. The later layers probably date to the post-Cole period. Layers 1-

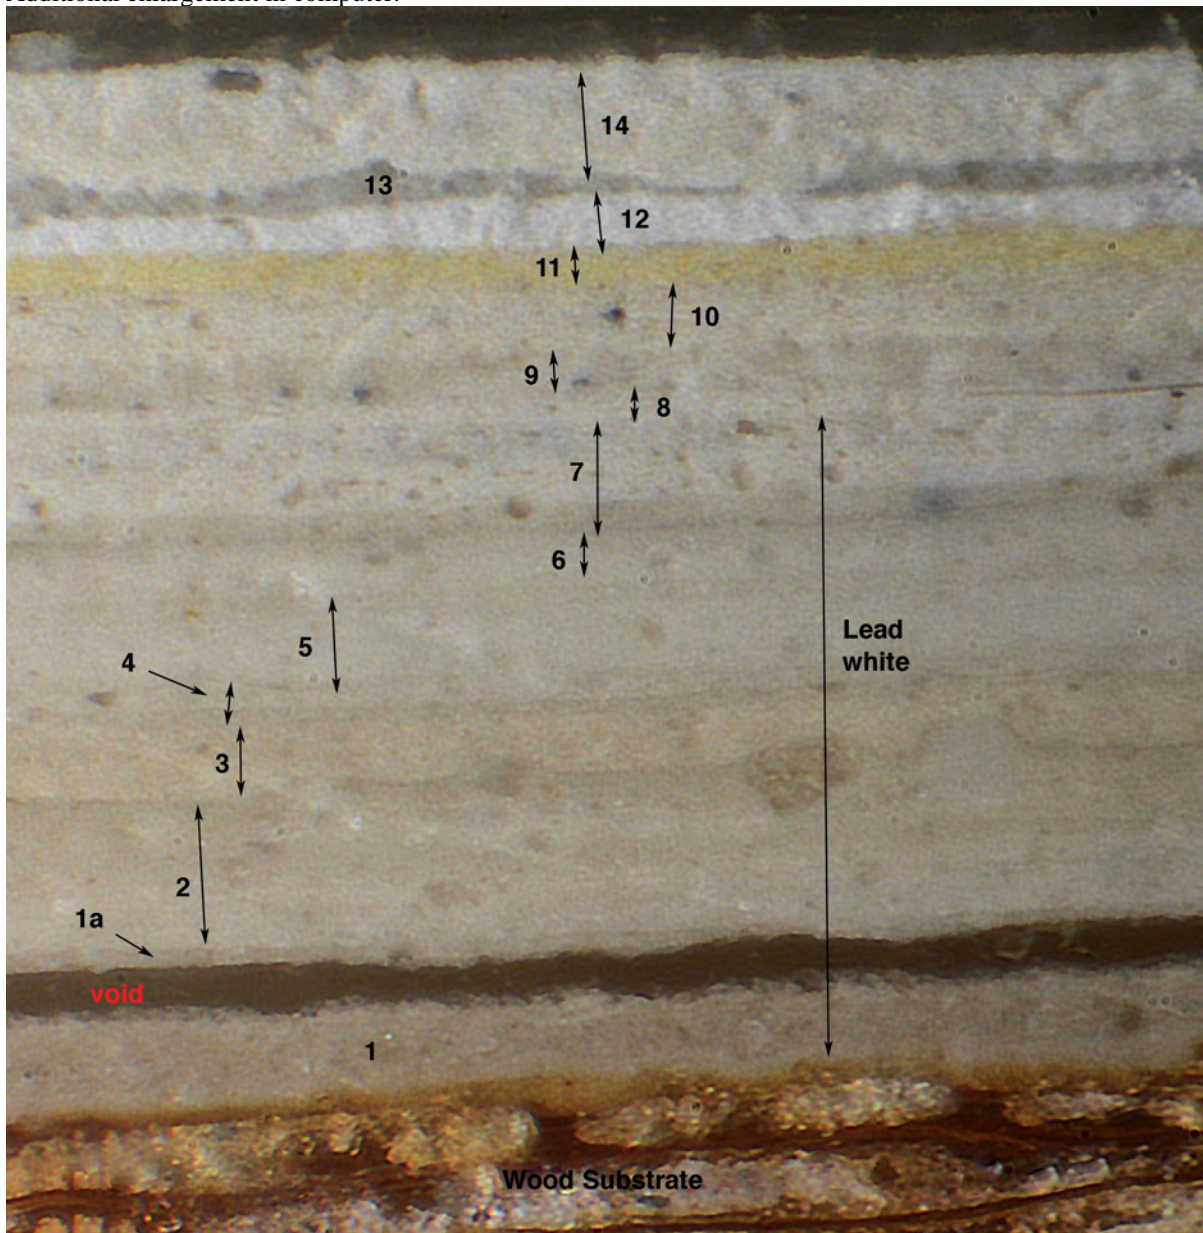
Sample 205-3: Window Sash

Note: The sample has been mounted in polymer resin, cut and polished to 8,000 micron grit polishing cloth for additional examination. The wood substrate is clearly seen at the base of the sample. This sample shows a sequence of fourteen paint finishes. The first finish [1] is a lead white finish, note the finish 1a that appears to be a repair to the surface. Finish 2, which is most likely the Cole finish period 1836-1848 is clearly seen: it is built up, using three layers. Finishes 1- 7 are lead white based finishes.

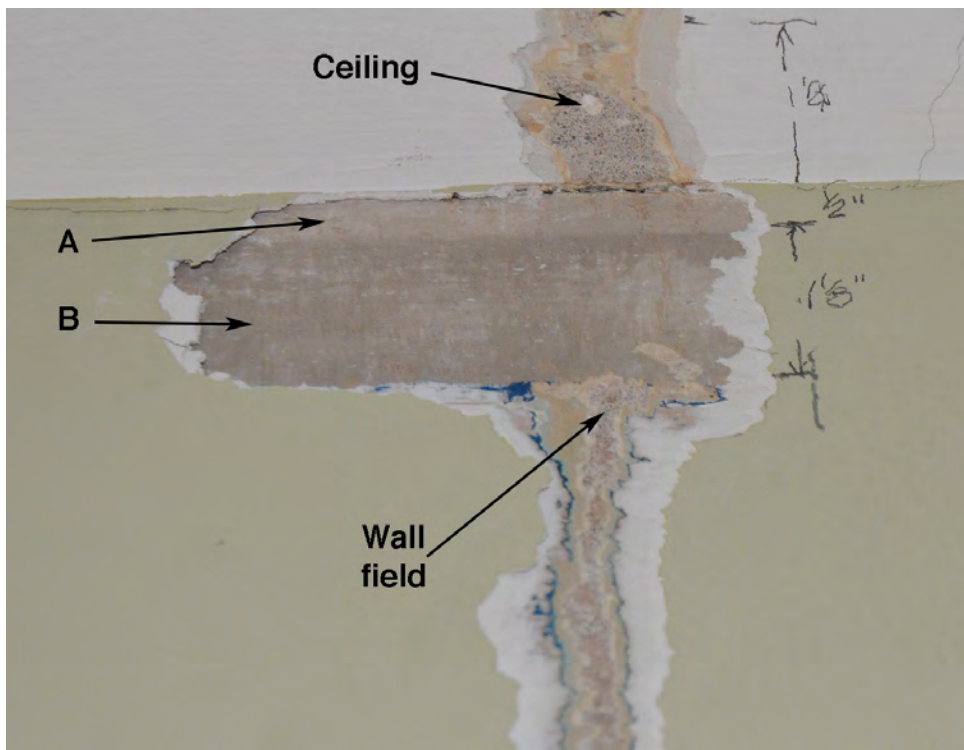
In situ color matching: the Walls

This room provides a possibility of using in situ matching of the color, as was done for the West and East Parlor friezes. It is advised that this be done for Room 205. The exposed banding is in good condition in terms of color.

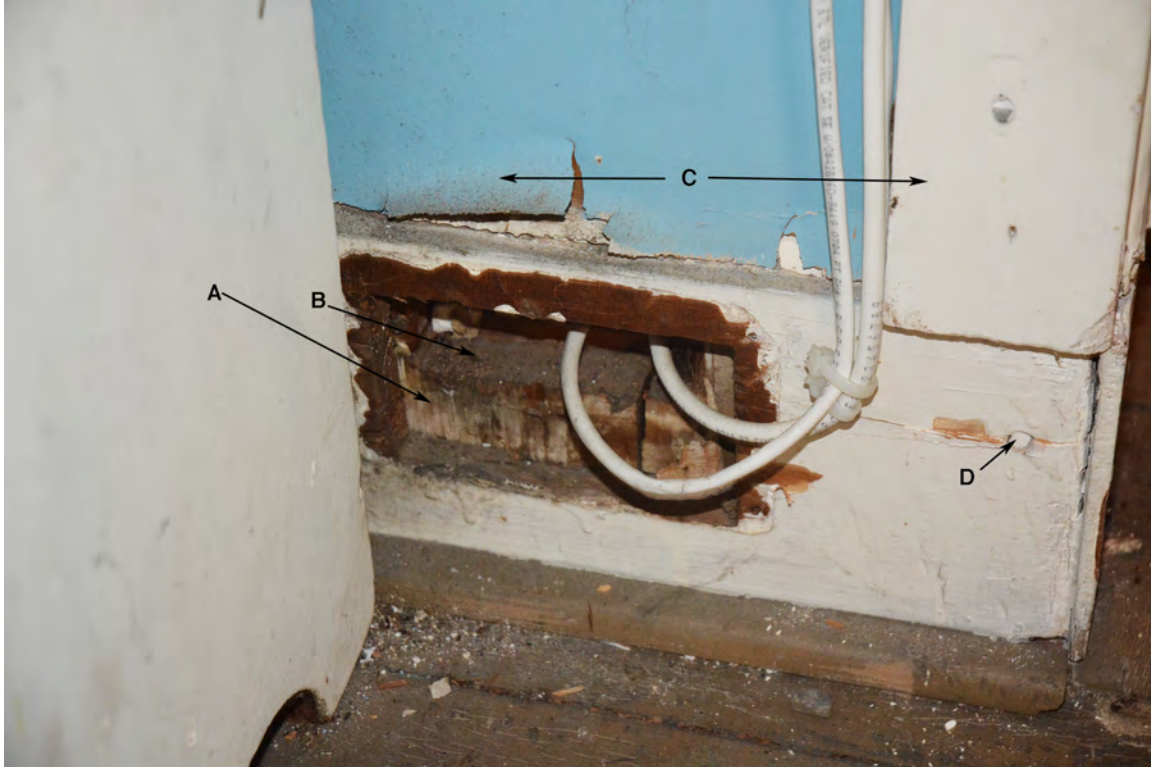
The configuration of these two rooms, as indicated on the floor plan of the preceding page, appears to date to the construction of the house: the earlier board wall separating the two rooms may be perceived under the twentieth century renovations. Note the site photograph below:

The access opening for the new wiring discloses the original vertical board wall underneath the present wall [A] and that it is covered with a late wallpaper, made with pulp paper that has turned brown over time due to the acid content of the paper [B], augmented by contact with the wood. The present wall, C, encases the earlier wall: the detailing of this partition is characteristic of the rooms. The nails [D] are wire nails, indicative of later construction.

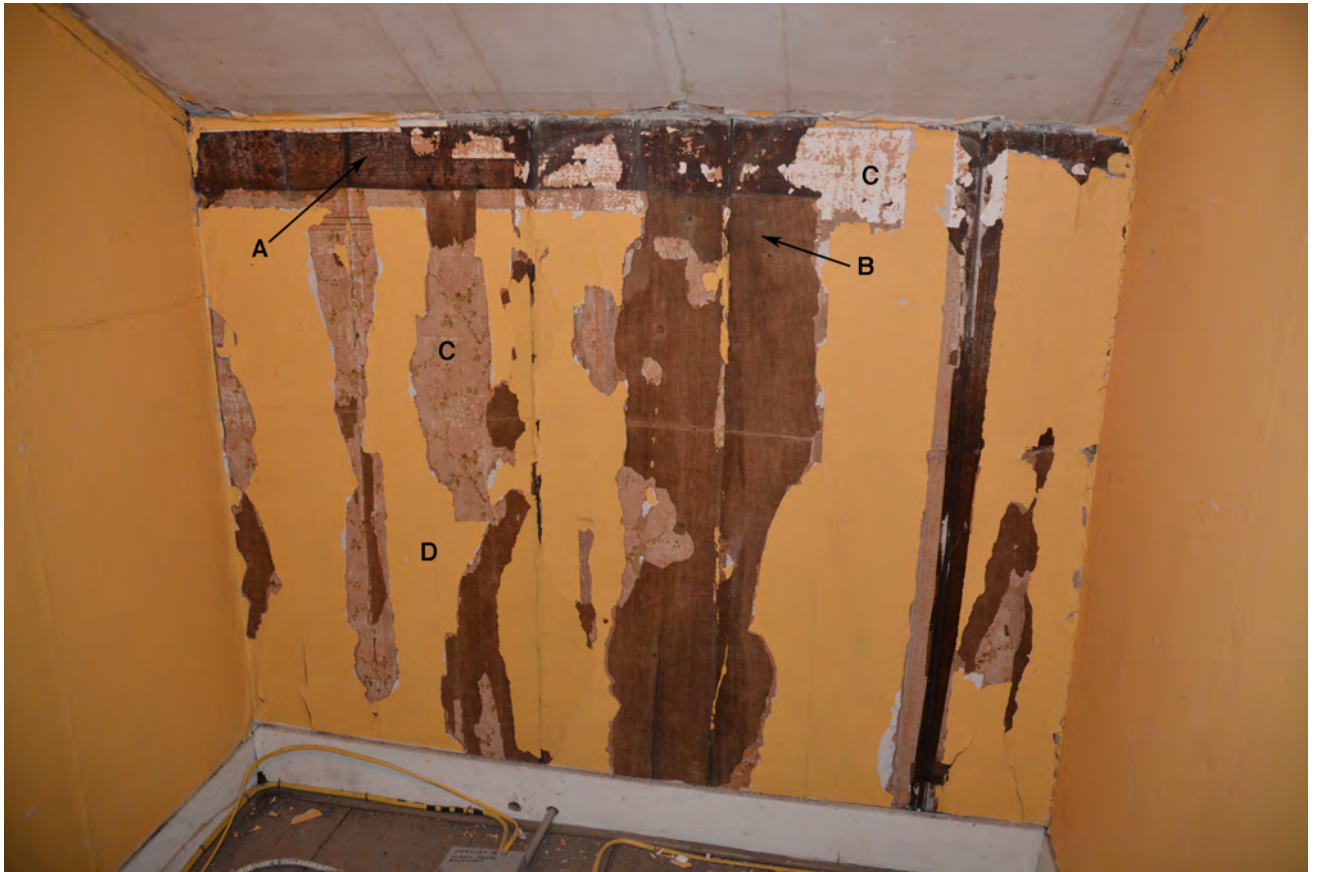
Room 302 Illustration: South wall

Note: The earliest condition would be the unpainted vertical boards that have turned brown over time from the natural tannins. There is a curious mesh that was mounted on the boards [leaving an approximately 6" gap from the ceiling!] in preparation for the wallpapers [B]. There is a series of wallpapers, all appear to be from the later nineteenth century [C] followed by paint [D]. The canted ceiling is plaster and would have been whitewashed occasionally; it is now covered with paper that has been painted over.

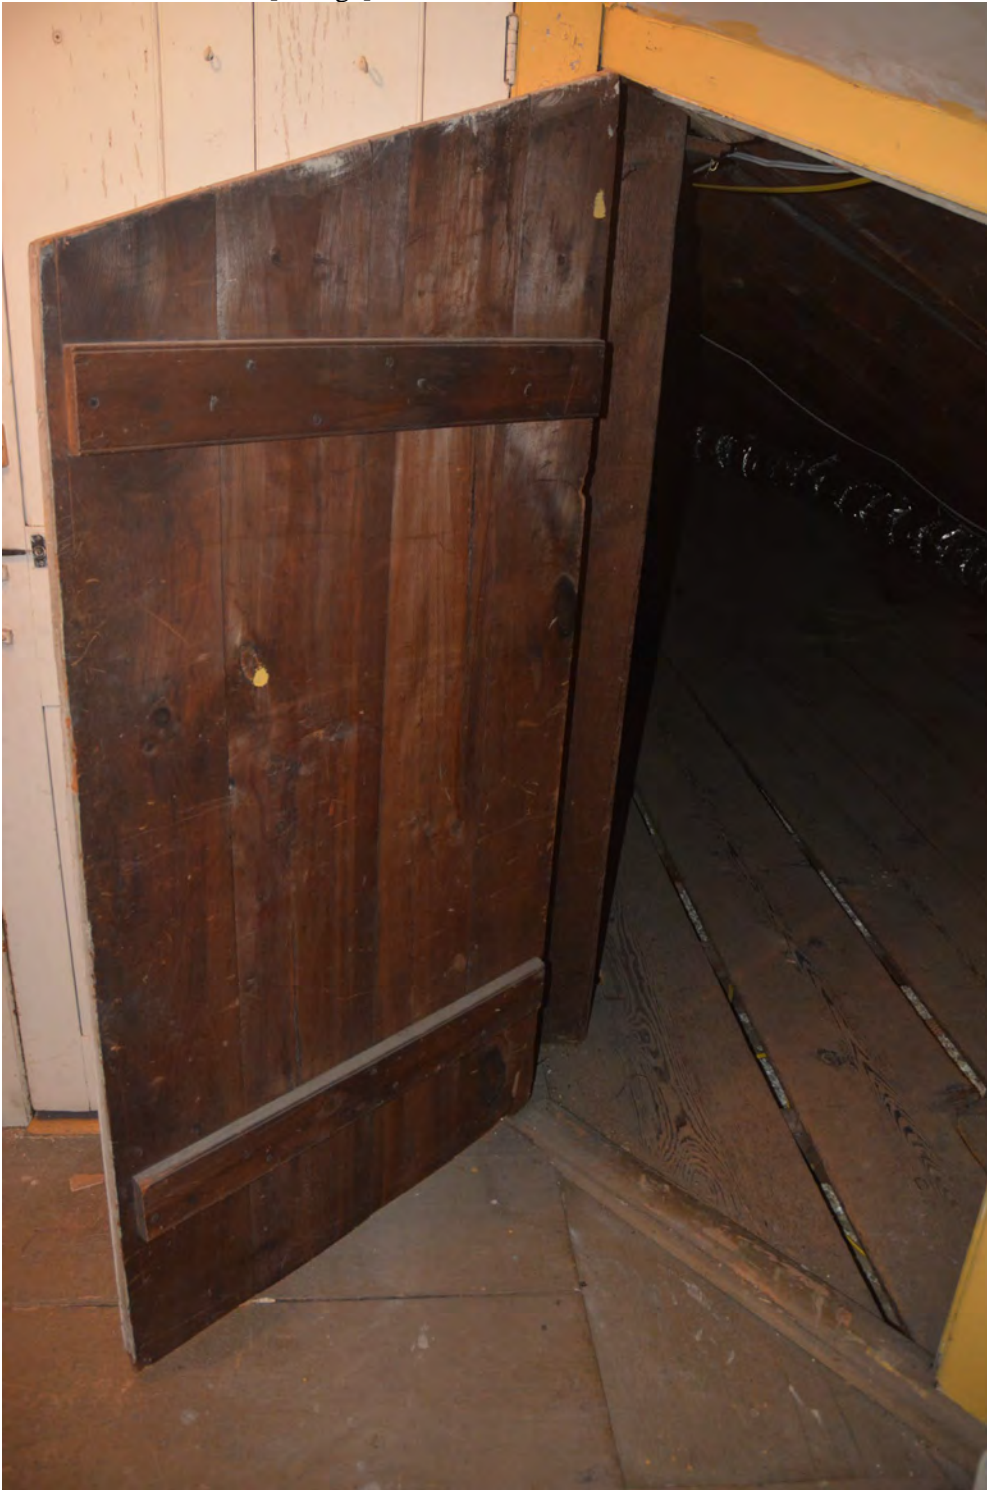
302: Door to the Attic [storage]

Note: The door to the attic storage was never painted or treated, and indicates the darkening of the wood is natural; the room side would have been the same during the Cole period.

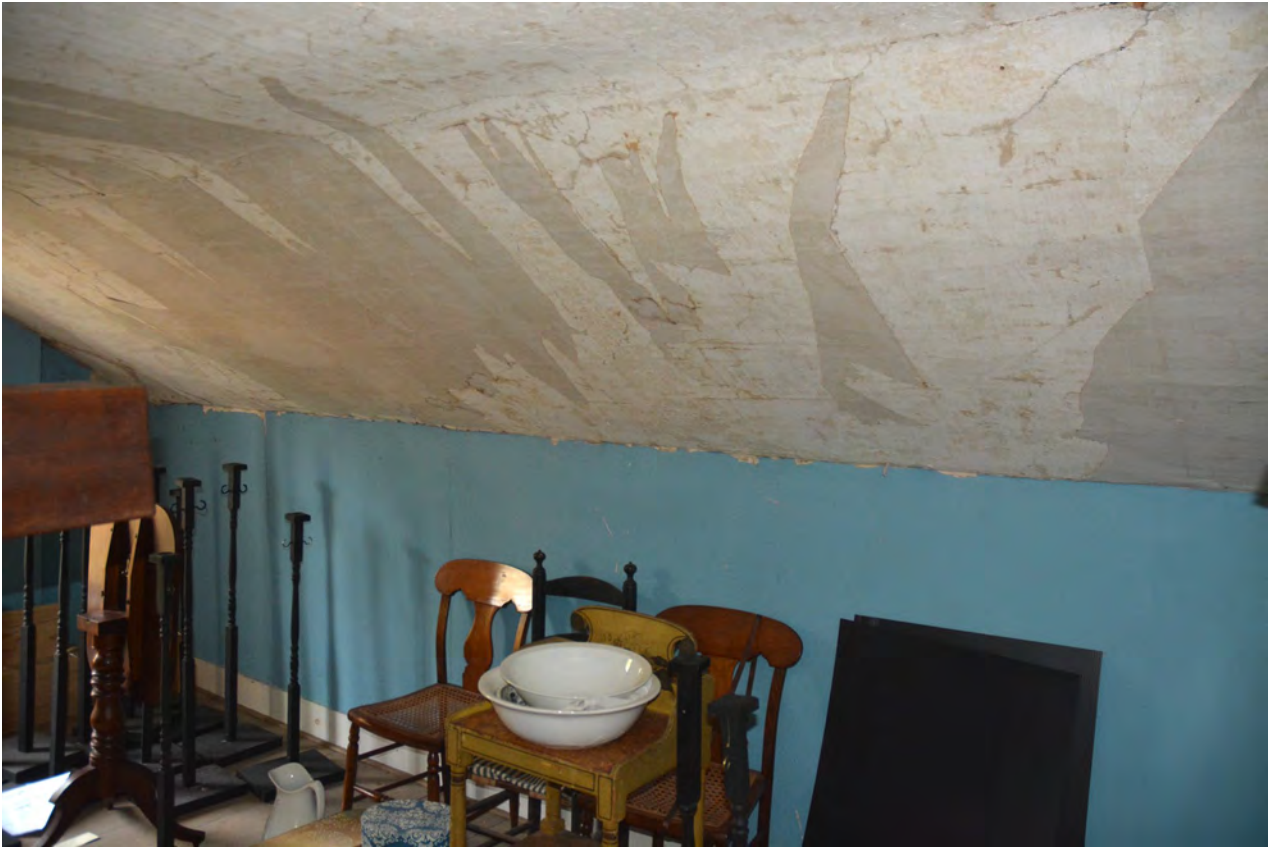
301:General view

The canted ceiling is plaster with lime whitewash layers; it has been papered over.

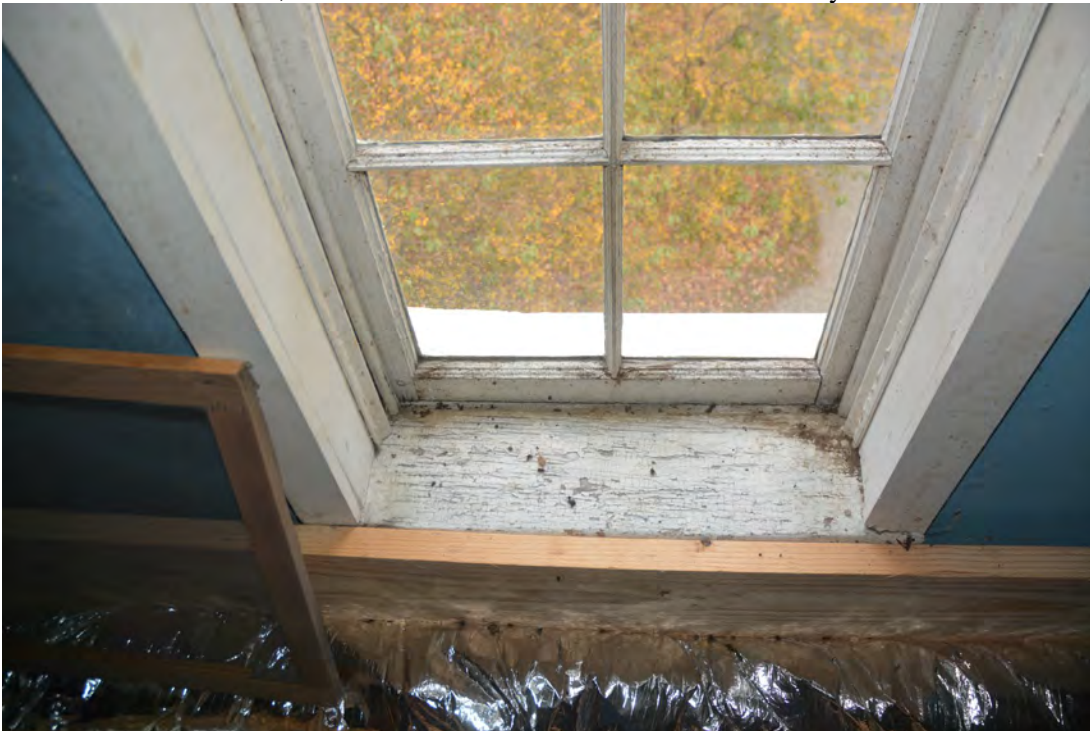
Room 301: Window 25, window sill: the window sill and sash are early elements.

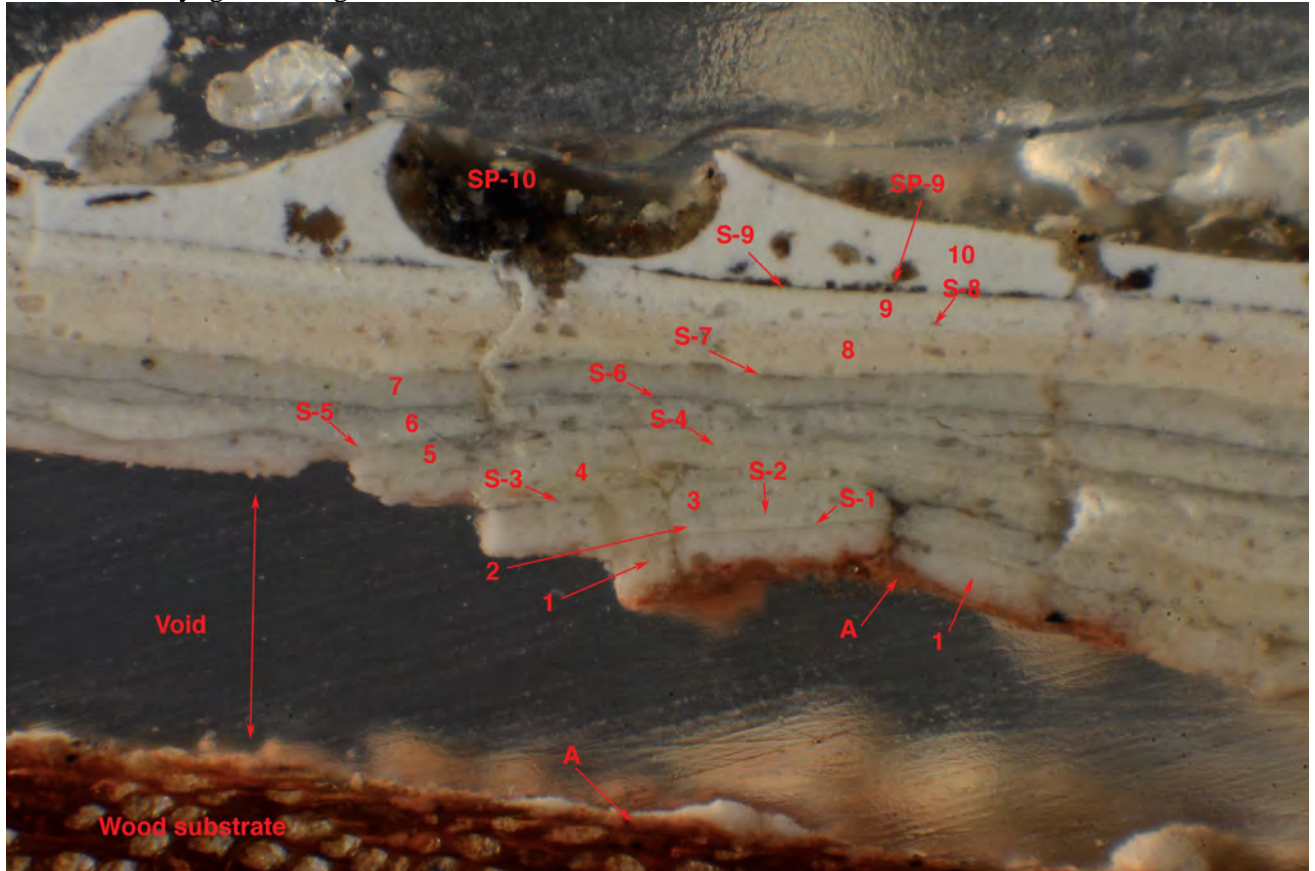
Sample 301-1: East wall, Window W 25: Window sill

Note: The sample has been mounted in polymer resin, cut and polished to 8,000 micron grit polishing cloth for additional examination. The wood substrate is clearly seen at the base of the sample. Note that this is one of the rare areas where a red ochre primer was used [A] under the original finish, which is a lead white [1]. The second finish [2] may be the finish of the Cole era, that is also prepared with a lead white pigment [2]. Note the sequence of lead white finishes, separated by distinct surface particulate accumulations on the surface of the paint layers. The surfaces are noted [S-1 through S-10]. The heavy surface particulate is particularly seen on finishes 9 and 10 [SP-9 and SP-10].

Finishes 1-7 were prepared with lead white pigment.

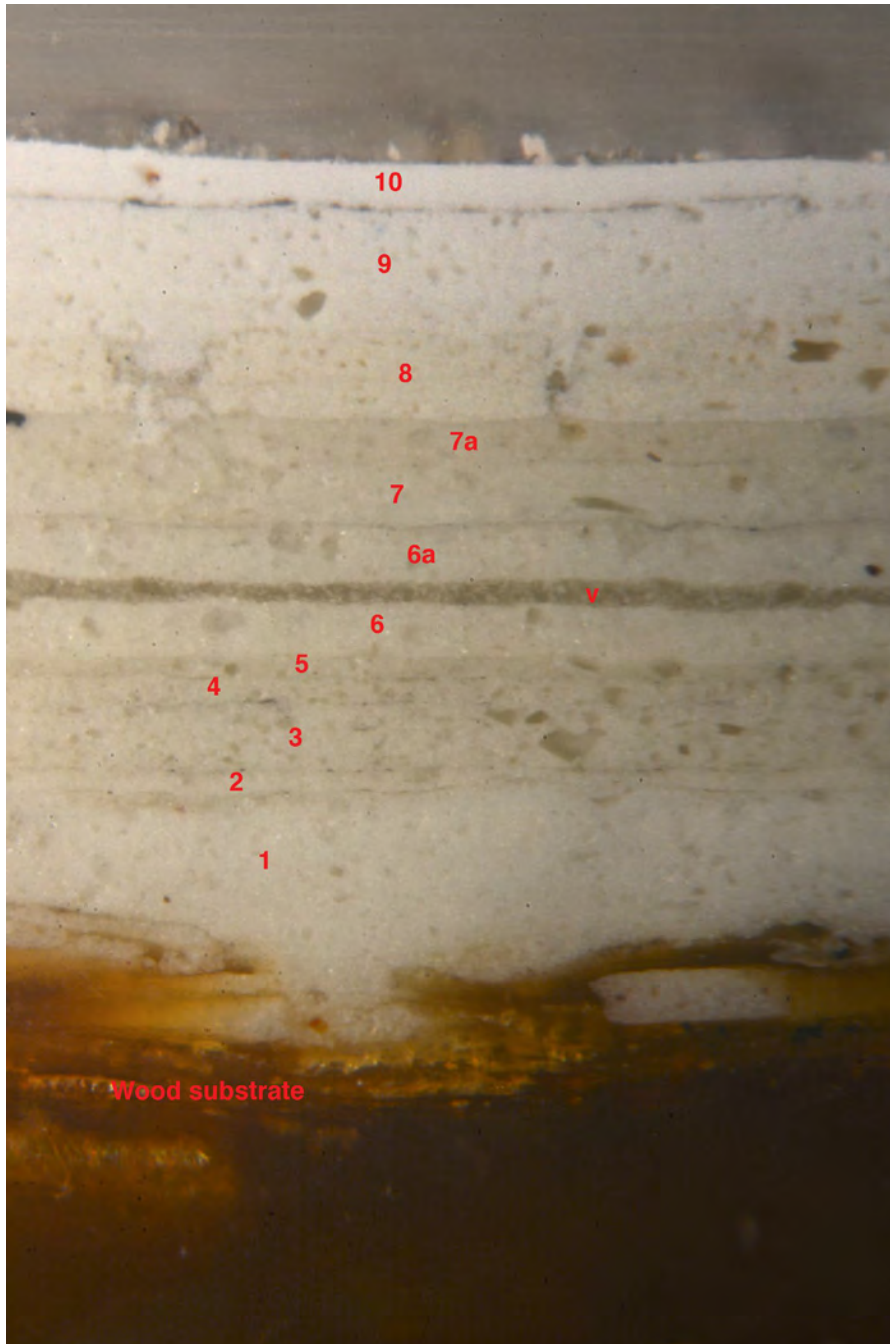
Sample 301-2: East wall, Window W 25: Window sash

Note: The sample has been mounted in polymer resin, cut and polished to 8,000 micron grit polishing cloth for additional examination. The wood substrate is clearly seen at the base of the sample. Unlike the sill, there is no initial red ochre primer. The first finish [1] appears to date to construction. The second finish may date to the Cole period. The paint sequence is essentially the same as that seen on **Sample 301-1: East wall, Window W 25: Window sill:** except that there are two additional “touch up” applications: 6a, and 7a. Finishes 1 through 7a are lead based finishes.

The last three finishes are from the twentieth century: finish 8 contains titanium dioxide white, first introduced in 1917.

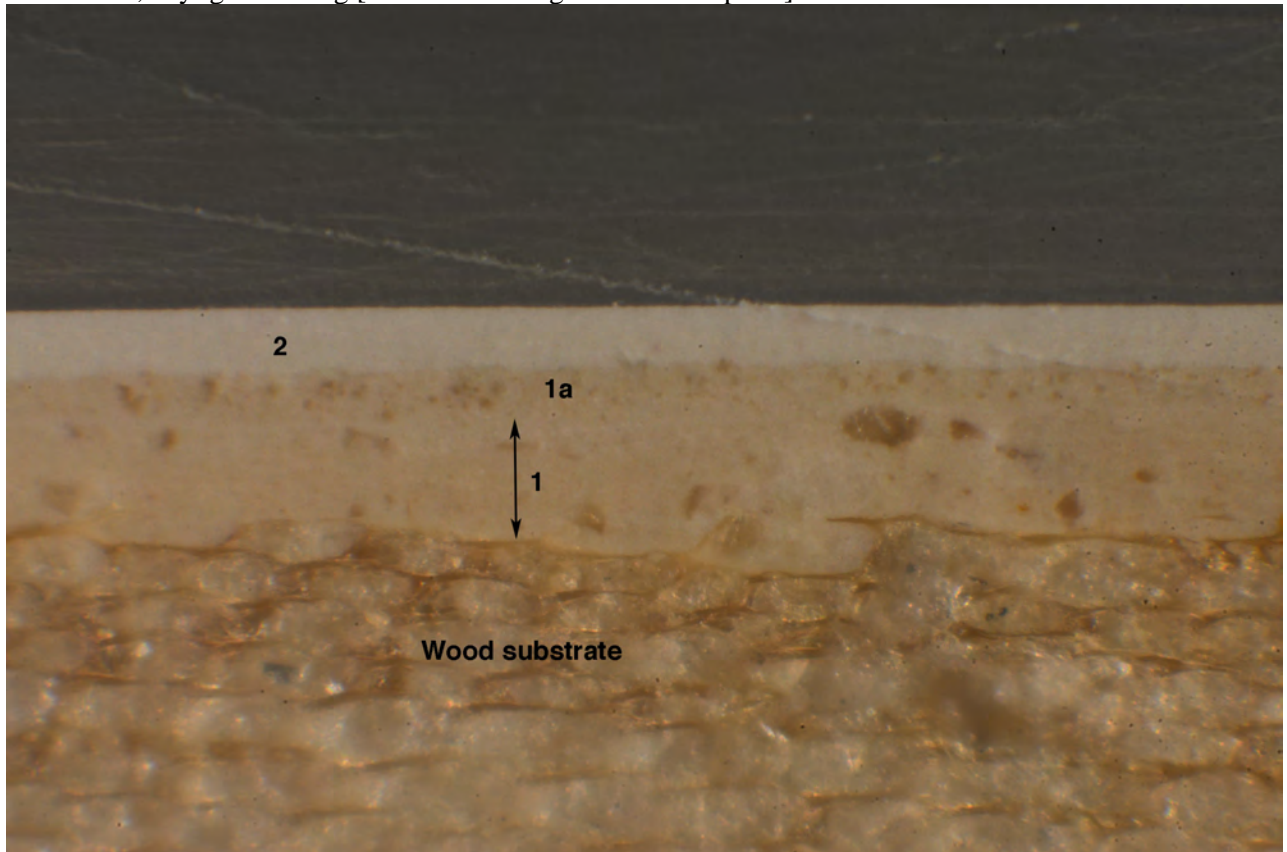
Sample 301-4: West wall, Baseboard

Note: The sample has been mounted in polymer resin, cut and polished to 8,000 micron grit polishing cloth for additional examination. The wood substrate is clearly seen at the base of the sample: note that the wood retains a white coloration. The first finish [1] is prepared with titanium dioxide white, indicating that the baseboard dates to the twentieth century. There is a “touch up layer” [1a] that was applied at a later date. The second white finish [2] is the last finish on this sample.

These layers would coincide with the Finishes 8 and 10 of Sample 301-2: East wall, Window W 25: Window sash

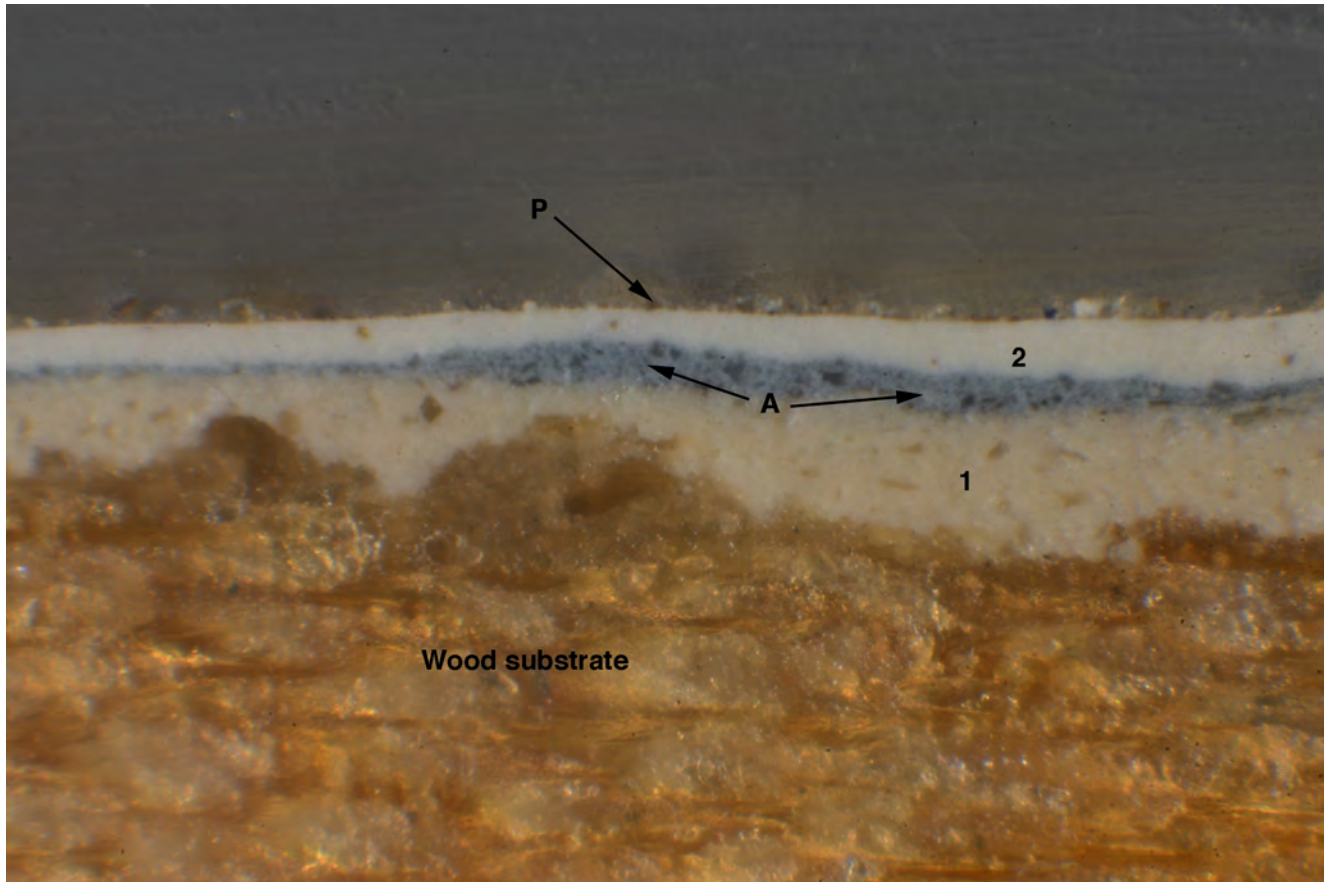
Sample 301-5: East wall, Baseboard: Near South-east Corner

Note: The sample has been mounted in polymer resin, cut and polished to 8,000 micron grit polishing cloth for additional examination. The wood substrate is clearly seen at the base of the sample. The first finish [1] is prepared with titanium dioxide white, indicating that the baseboard dates to the twentieth century. The blue layer [A] is the blue from the adjacent wall that may have been applied in error to this return of the baseboard woodwork. The second white finish [2] is the last finish on this sample.

Finish 1 would coincide with the Finish 8 of Sample 301-2: East wall, Window W 25: Window sash.

Note: Comparisons indicate that the baseboards are contemporary and both date to the twentieth century since the first finish contains titanium dioxide white, which was not available until ca. 1917.

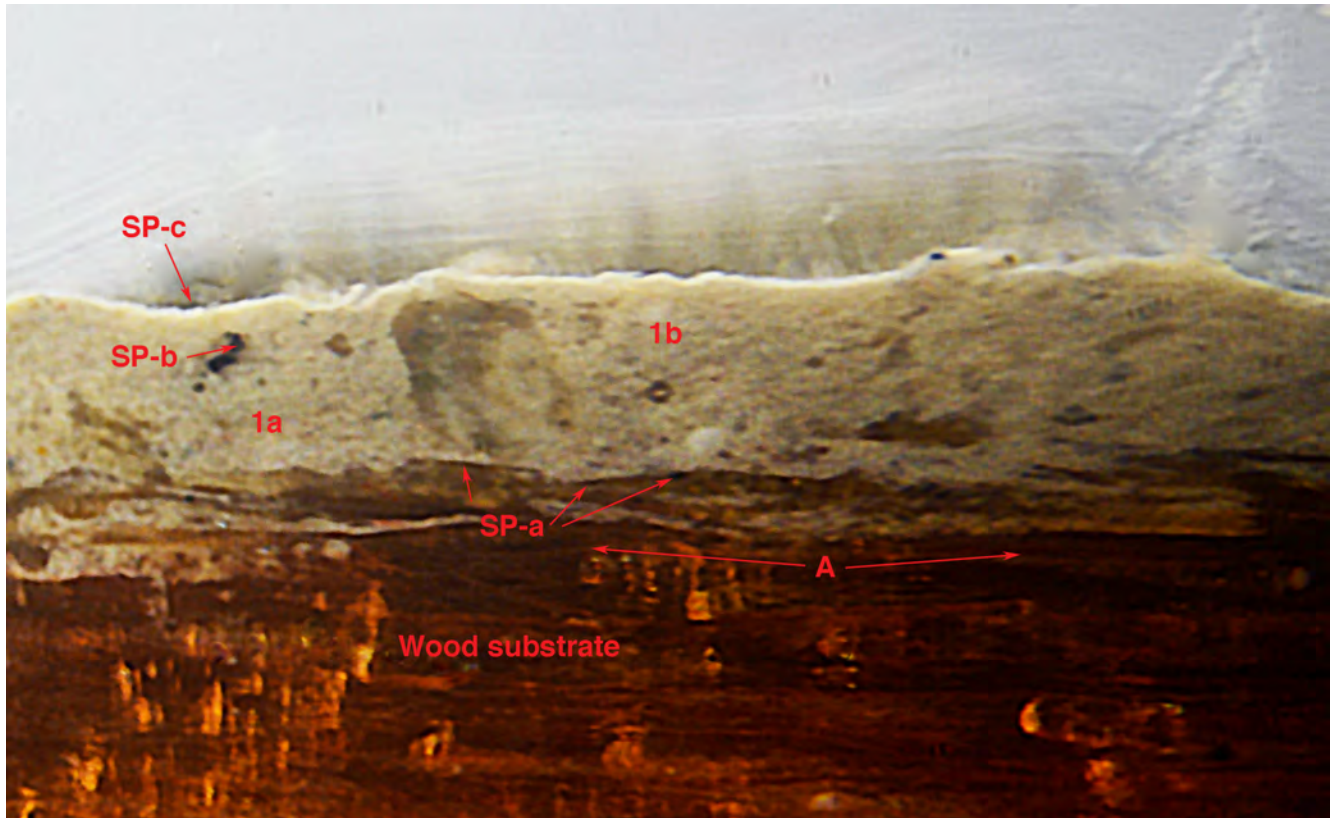
Sample 301-9: West end of floor, near west wall

Note: The sample has been mounted in polymer resin, cut and polished to 8,000 micron grit polishing cloth for additional examination. The wood substrate is clearly seen at the base of the sample. Note the dark color of the wood [A] and the presence of surface particulate [SP-a] that is imbedded into the surface of the wood indicating a [long] period of unpainted condition. There is one paint finish, prepared with two layers of a moderate-light yellowish grayish color paint. Note that some of the copious surface particulate that had accumulated on the wood boards was swept up into the paint [SP-b]. Additional surface particulate is seen on the surface of the paint [SP-c].

This paint is prepared with titanium dioxide white base and is thus from the twentieth century.

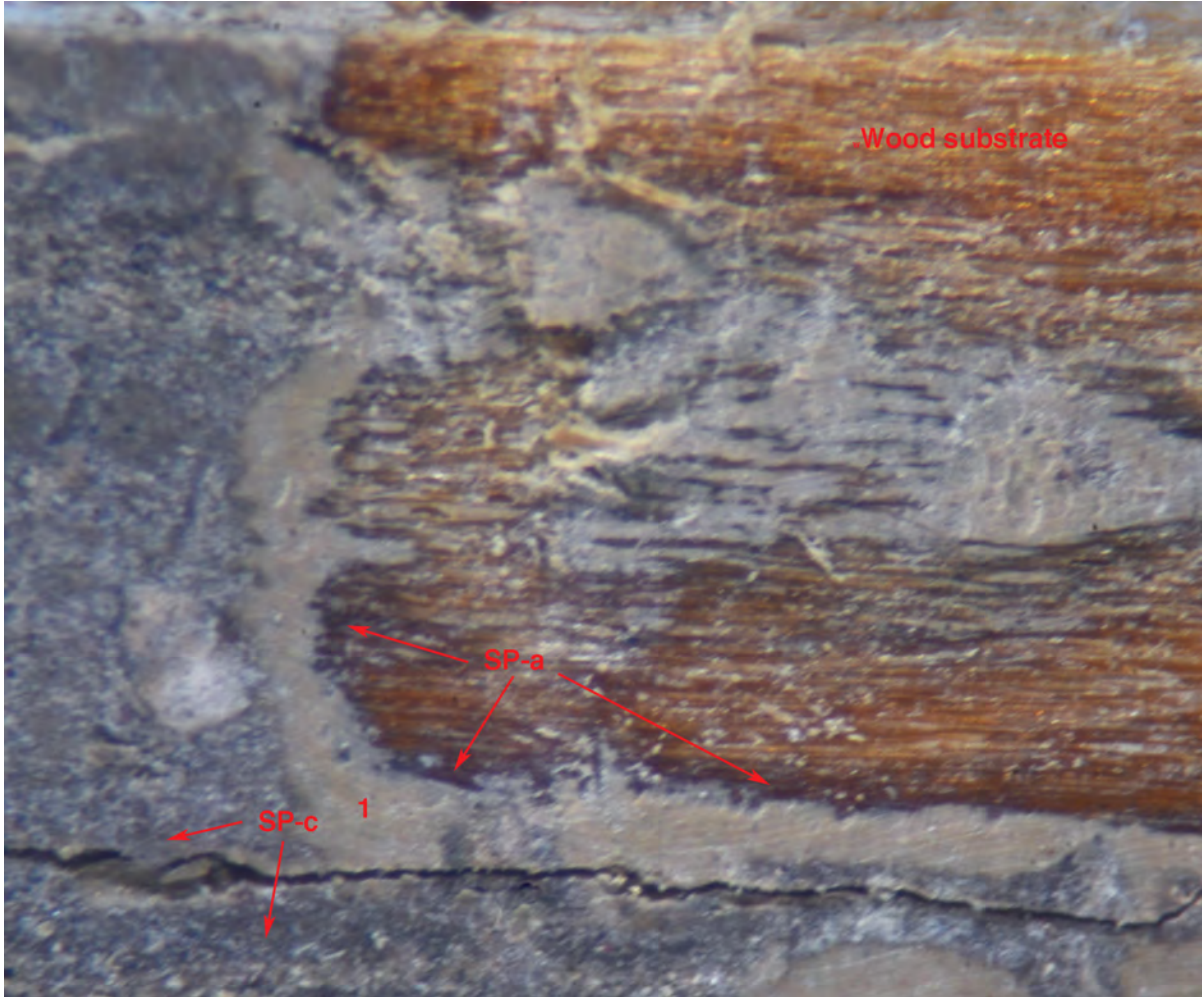
Sample 301-10: East end of floor, near east wall

Note: The view of the sample is looking down onto the finish surface. The sample has been shaved, using a micro-scalpel to permit this view. The wood substrate is clearly seen and noted. The surface of the wood is darkened with surface particulate [SP-a; appears to be soot]. The single paint finish: the same moderate-light yellowish grayish color paint seen at the west end of the room. There is a heavy accumulation of particulate on the surface of the paint [SP-c]: and discoloration of the surface.

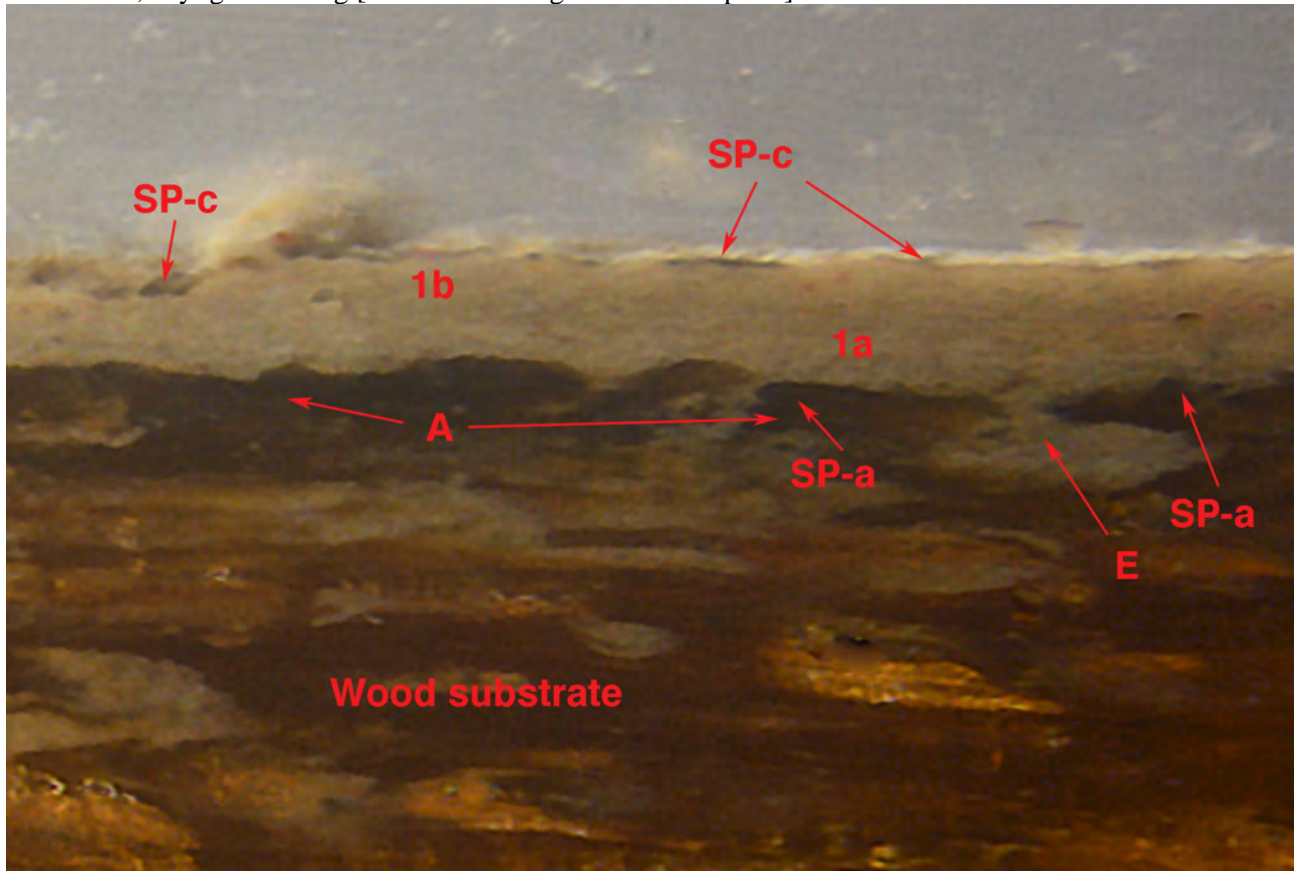
Sample 301-10: East end of floor, near east wall

Note: The sample has been mounted in polymer resin, cut and polished to 8,000 micron grit polishing cloth for additional examination. The wood substrate is clearly seen at the base of the sample. Note the dark color of the wood [A] and the presence of surface particulate [SP-a] that is imbedded into the surface of the wood indicating a [long] period of unpainted condition. Note that the surface of the floor board is not smooth, but, rough from wear prior to the application of paint [E]. The floor paint, the moderate-light yellowish grayish color paint was applied in two coats [1a, 1b], is titanium dioxide white based paint, from the twentieth century.

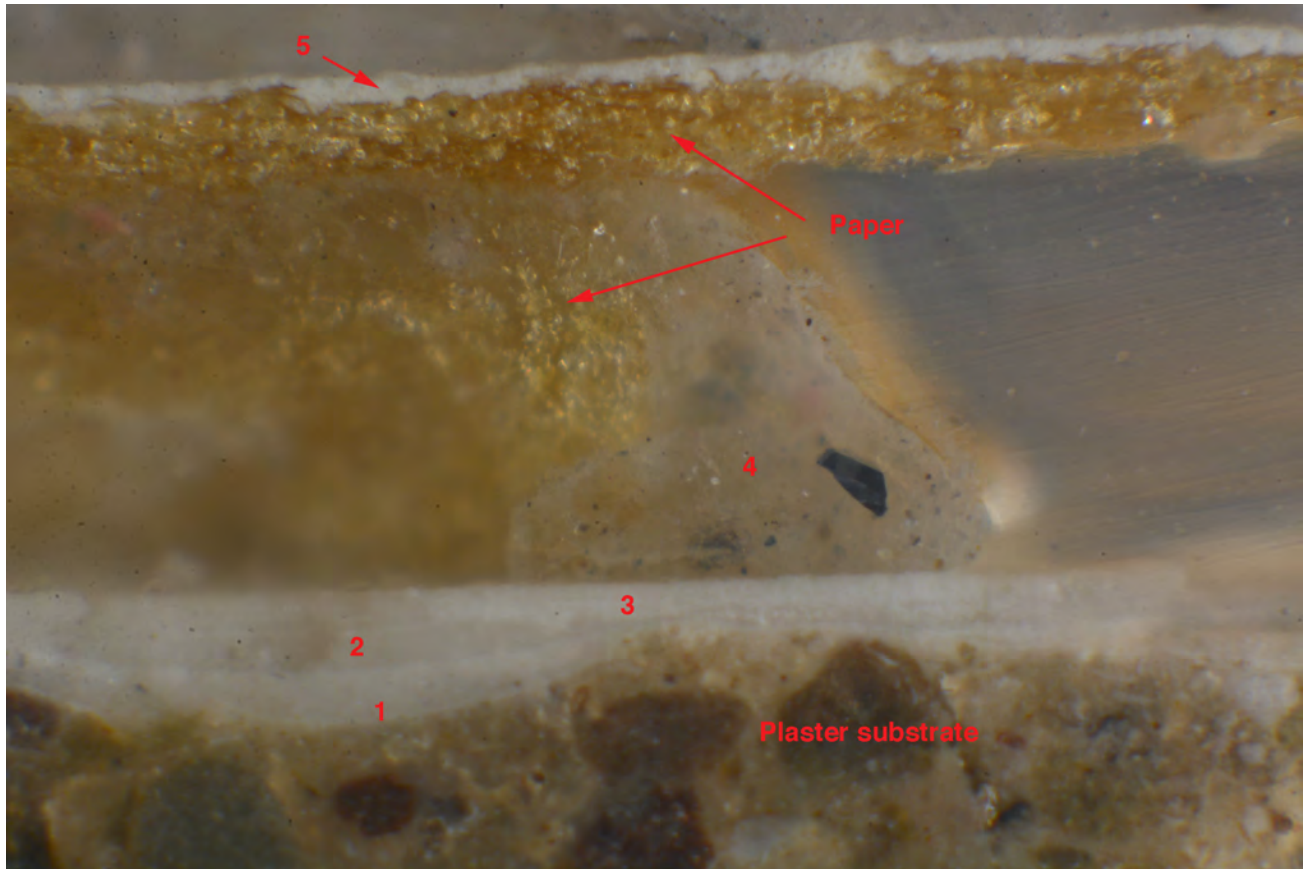
Sample 301-11: Plaster surface: Canted ceiling

Note: The sample has been mounted in polymer resin, cut and polished to 8000 micron grit polishing cloth. The plaster substrate [sand finish plaster] is clearly seen at the base of the sample: note the sand particles within the plaster matrix. There are three lime white layers of lime white wash coating [1, 2, 3]. There is a glue layer [4] that was applied in order to adhere the paper, which is noted. There is a thin white layer on the surface [5]. The paper application dates to the twentieth century.
