Thomas Cole National Historic Site Historic Structure Report

Volume II: Appendices
October 2019

THOMAS COLE NATIONAL HISTORIC SITE
THOMAS COLE HOUSE
HISTORIC STRUCTURE REPORT
PMIS 216977

VOLUME II
APPENDICES

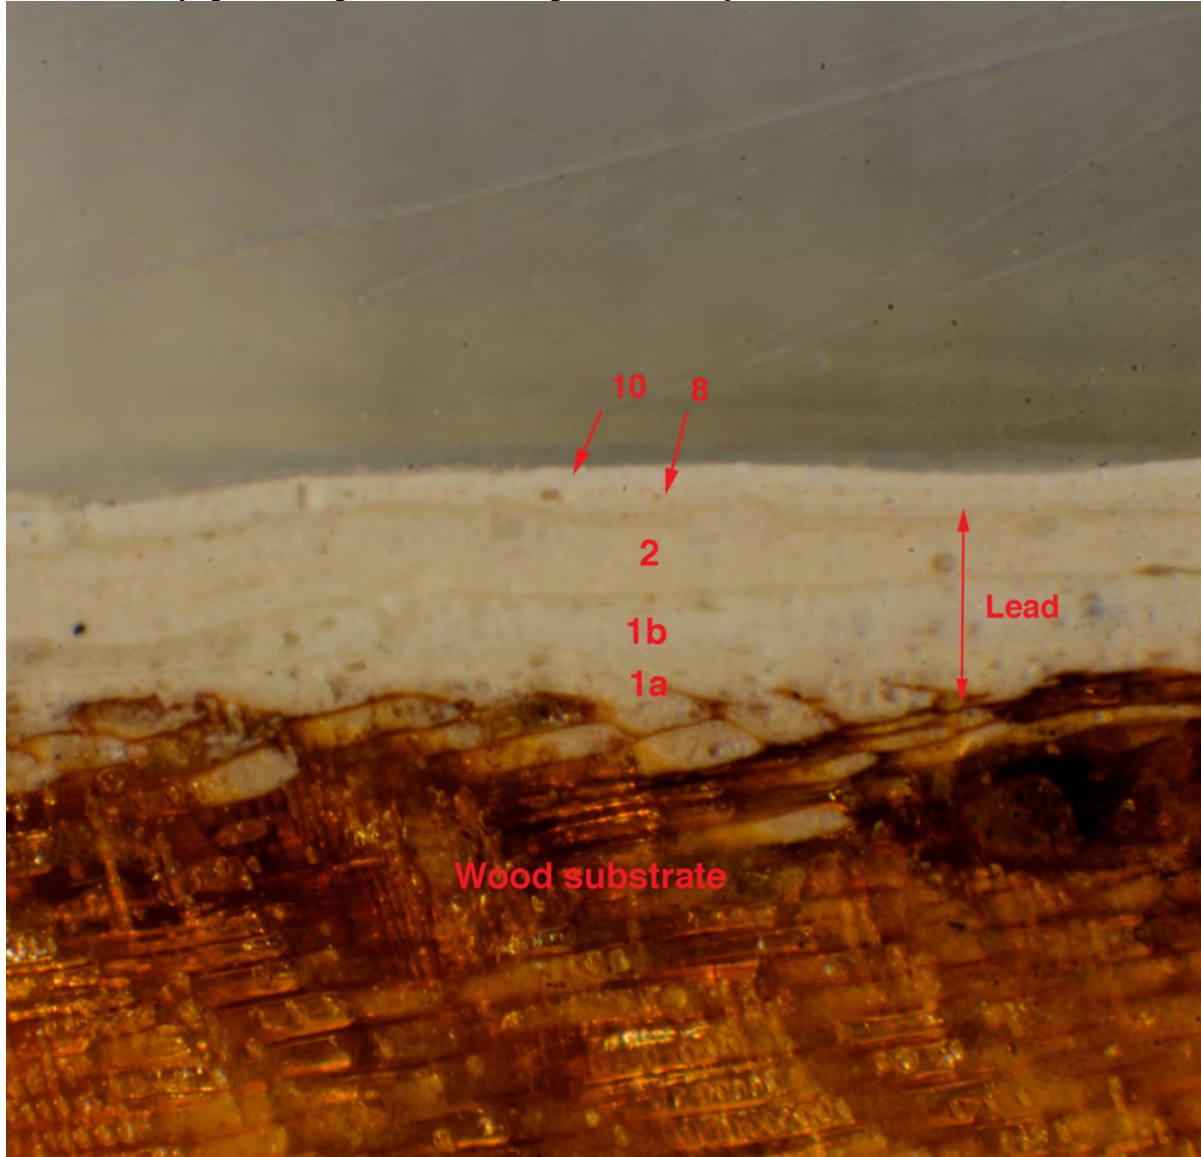
Sample 302-1: Door to Stair; Rail

Note: The sample has been mounted in polymer resin, cut and polished to 8,000 micron grit polishing cloth for additional examination. The wood substrate is clearly seen at the base of the sample as noted. The wood is dark and may have been left unpainted for a long period of time. There are two lead finishes, which probably post date the Cole era. The last two layers relate to the late finishes seen on Sample 301-1: East wall, Window W 25: Window sill.

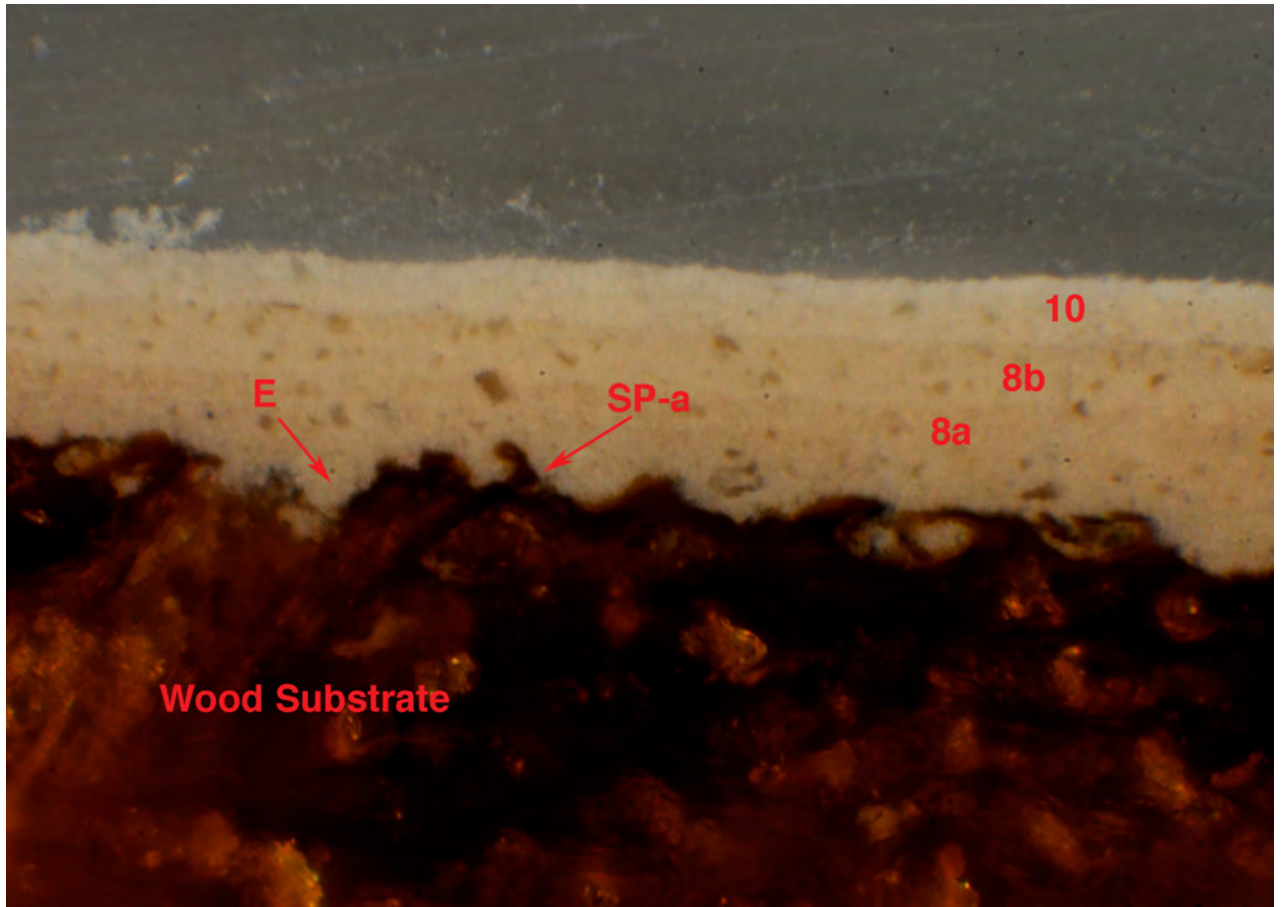
Sample 302-2: Door to Attic [storage]

Note: The sample has been mounted in polymer resin, cut and polished to 8,000 micron grit polishing cloth for additional examination. The wood substrate is clearly seen at the base of the sample as noted. The wood is dark and was left unpainted for a long period of time. The surface of the wood is rough [E] and darkened from exposure and surface particulate [SP-a]. The paint layers are later and are not lead based; these paint layers relate to the late finishes on Sample 301-1: East wall, Window W 25: Window sill.

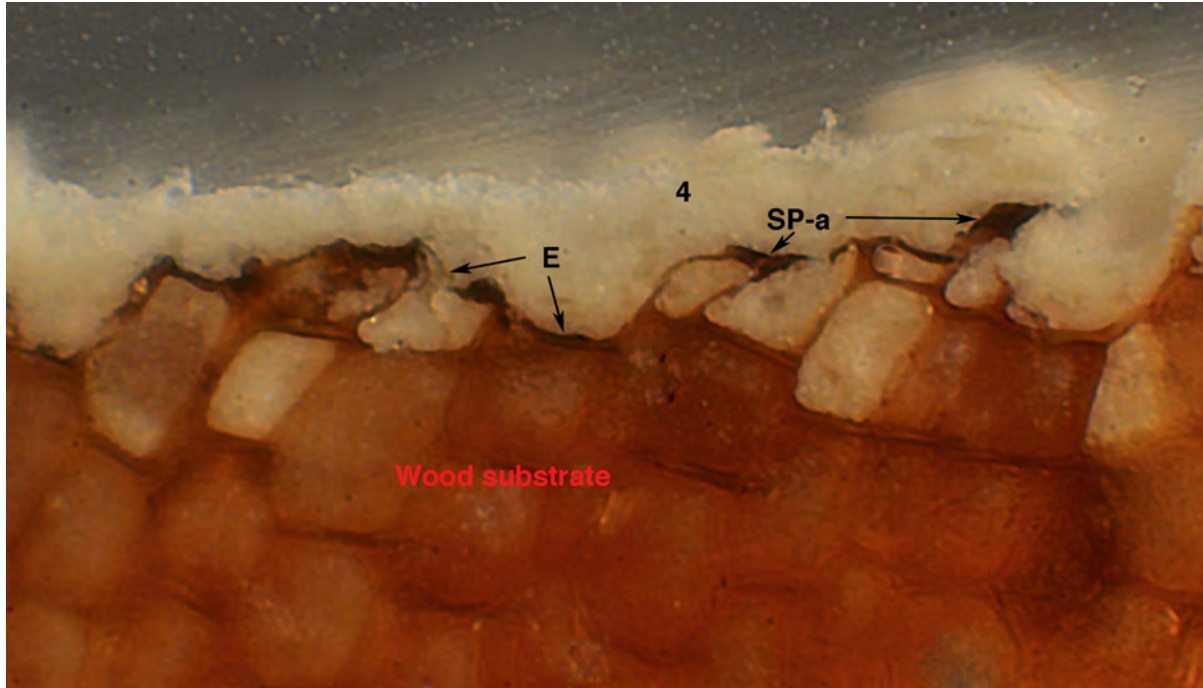
Sample 302-4: Door Frame, doorway to Room 301, Lintel

Note: The sample has been mounted in polymer resin, cut and polished to 8,000 micron grit polishing cloth for additional examination. The wood substrate is clearly seen at the base of the sample as noted. The wood is dark and was left unpainted for a long period of time. The surface of the wood is rough from exposure [E] and shows the application of paint from Finish 4, noted that is seen on the benchmark: **Sample 301-2: East wall, Window W 25: Window sash.** During the Cole period, this element would have been unpainted.

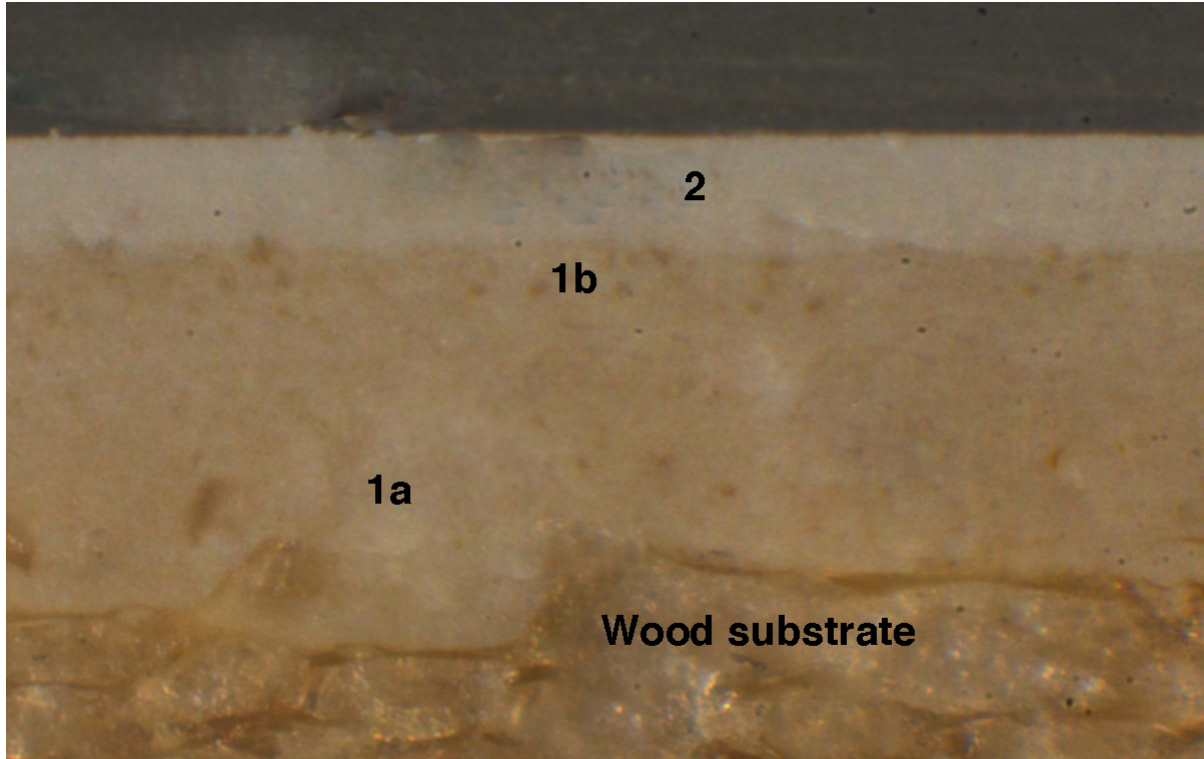
Sample 302-5: Baseboard, East wall

Note: The sample has been mounted in polymer resin, cut and polished to 8,000 micron grit polishing cloth for additional examination. The wood substrate is clearly seen at the base of the sample as noted. The surface of the wood is white in color, suggesting a recent date. There are two non-lead finishes: the first is comprised of two layers [1a, 1b] that appears to be contemporary with Finish 8 on Sample 301-2: East wall, Window W 25: Window sash. The last layer [2] appears to be contemporary with Finish 10 on the benchmark layer, Sample 301-2: East wall, Window W 25: Window sash.

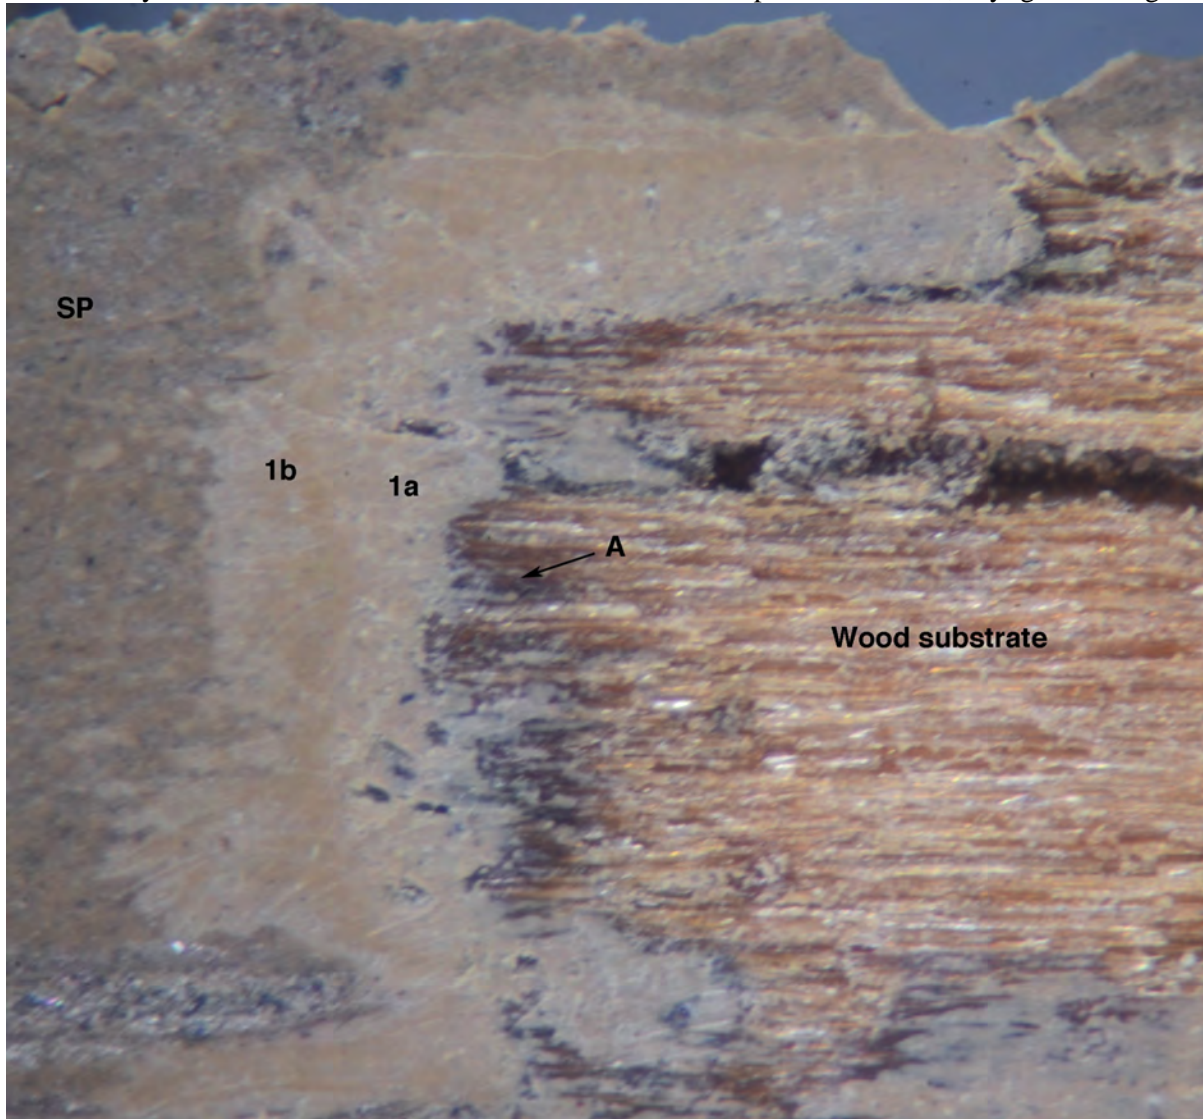
Sample 302-6: Floor board, 6" from the south wall

Note: The view of the sample is looking down onto the finish surface. The sample has been cut to present this view. The wood substrate is clearly seen and identified. The surface of the wood is darkened by exposure and surface particulate [A]. The paint layers [1a, 1b] comprise the same moderate-light yellowish grey floor paint that is seen in Room 301. The surface of the paint is very discolored and covered with surface particulate [SP].
