Thomas Cole National Historic Site Historic Structure Report

Volume I: Parts 1 & 2
October 2019

THOMAS COLE NATIONAL HISTORIC SITE
THOMAS COLE HOUSE
HISTORIC STRUCTURE REPORT
PMIS 216977

JOHN G. WAITE ASSOCIATES, ARCHITECTS

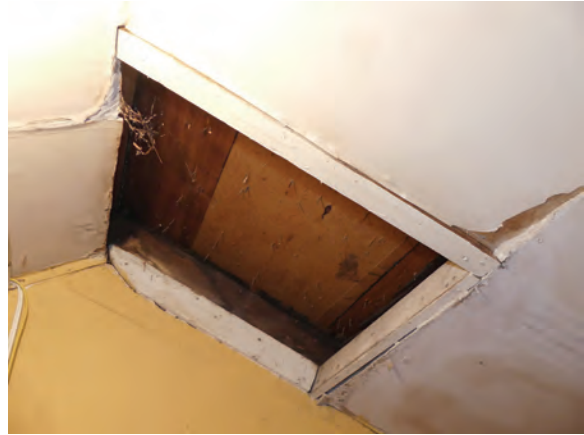
Figure 22. The framing for the roof hatch remains in the attic entry (302). JGWA, 2019.

The framing for an original roof hatch, centered at the top of the south roof slope, can be seen in attic room 304. This important feature was covered over when the current wood shingle roof was installed circa 2001.

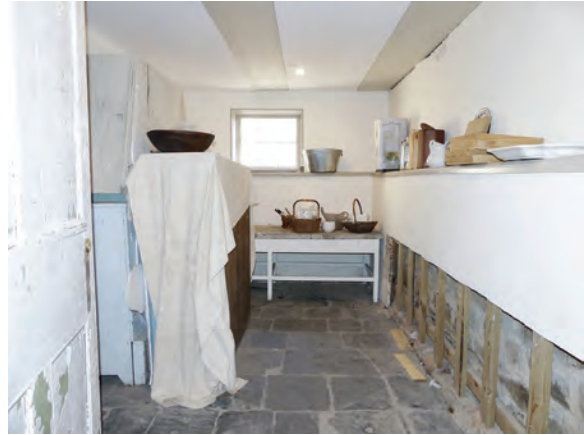
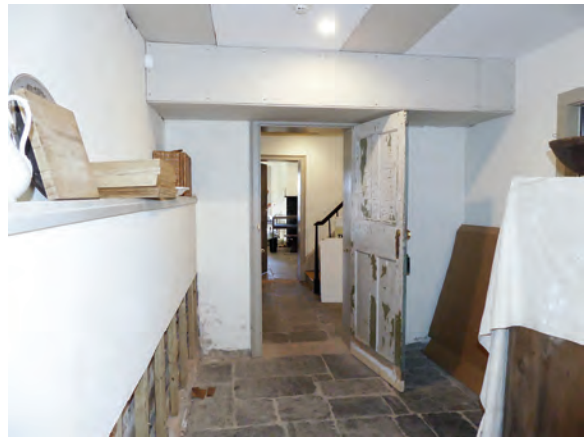
Figure 28. Room B02, looking east (upper image) and west (center image). JGWA, 2018.

FLOOR: The floor is made up of large bluestone slabs. At the east end of the room, beneath the marble-topped table, the floor is patched with cement.

The plaster and lath were removed from the south wall circa 2000-2001 to remediate mold, and replaced with wood studs set on brick bases. A small section of the original plaster on split wood lath remains at the east end of the lower wall.

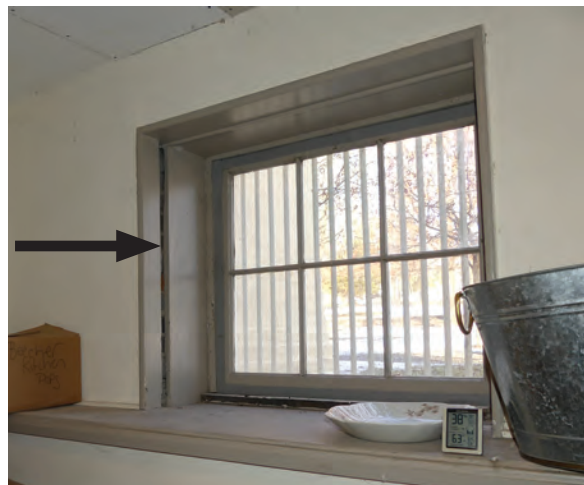
(Lower image) Detail of the window in B02. The opening in the north jamb held a sliding sash/louvered panel that could cover the window. Originally, the slot continued to the east window now in B03. The sliding panel was removed when the east chimney was rebuilt and a brick infill flue inserted for the circa 1922 boiler. JGWA, 2019.

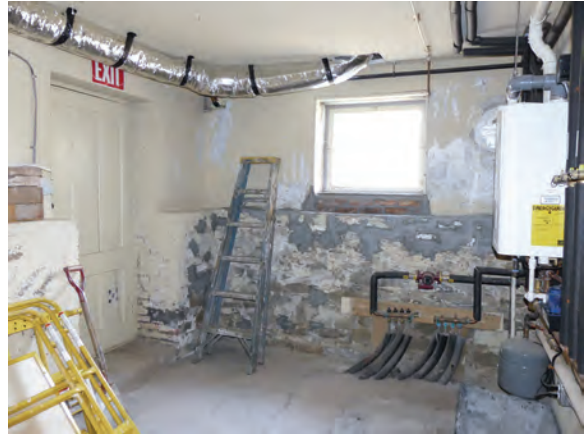
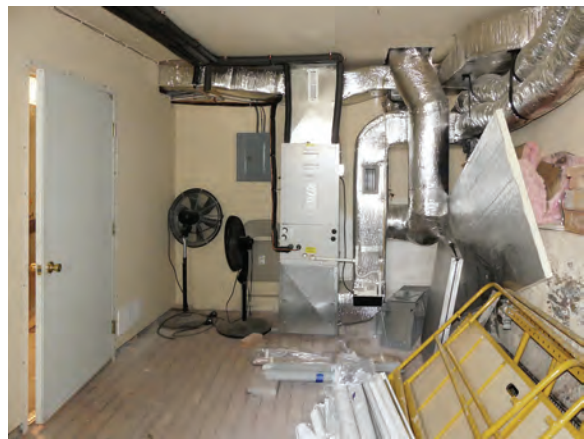
Figure 29. Room B03, looking east (upper image) and west (lower image). JGWA, 2018.

FLOOR: At the east end of the room, the floor is concrete, with remnants of the concrete platform for the old steam boiler in the southeast corner. Brick pavers (3-1/2" x 8") laid east/west in a running bond make up the rest of the floor.

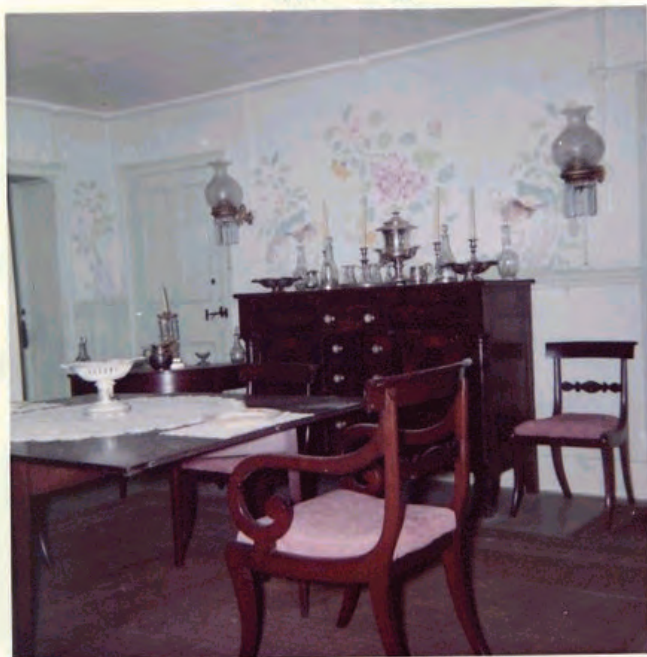
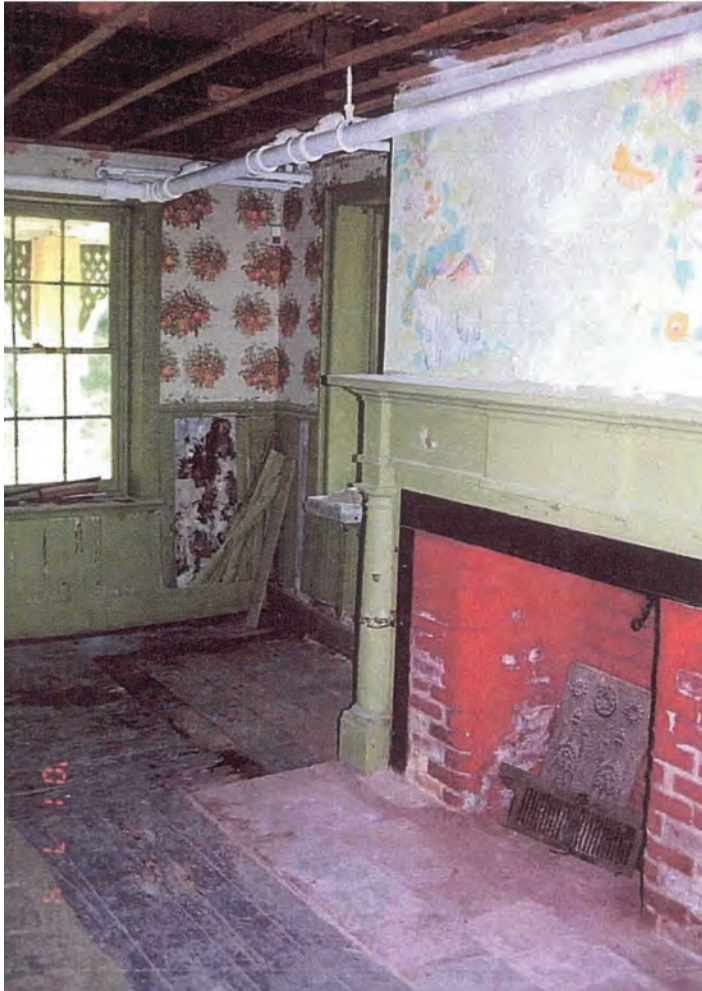
Figure 32. Two views of room B04. The undated upper image looks southwest prior to the circa 2000-2001 renovations. Note what appears to be wide board flooring and the wood wainscot on the wall. The fireplace hearth does not appear to be the surface currently in place. The lower image of the dining room, circa 1964, looks northeast. The original door to the small pantry is shown complete with a latch. The two solar lamp brackets are of a type that became popular in the 1840s. THCO Archives.

Large (8" x 10-1/2 to 11") brick tiles make up the 5'-3" wide hearth, which projects 1'-10 1/2" from the surround. An outer row of bluestone pavers surrounds the tiles. This does not appear to be the hearth seen in an undated color photograph of the room when the wood floor was in place (see Figure 32).

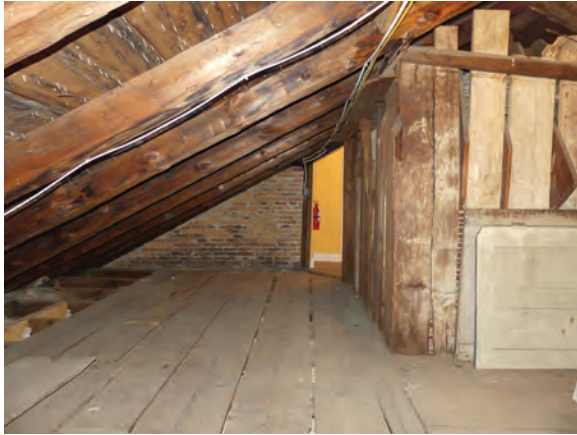
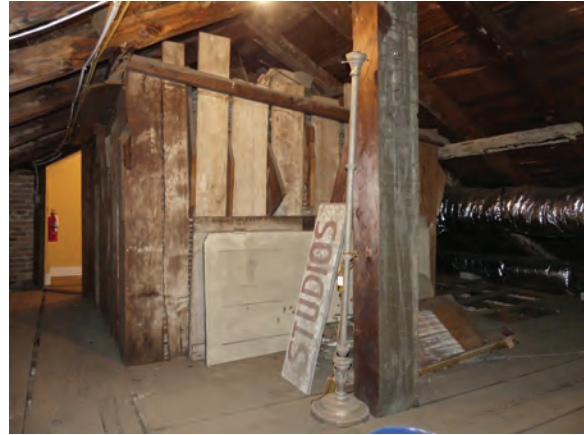
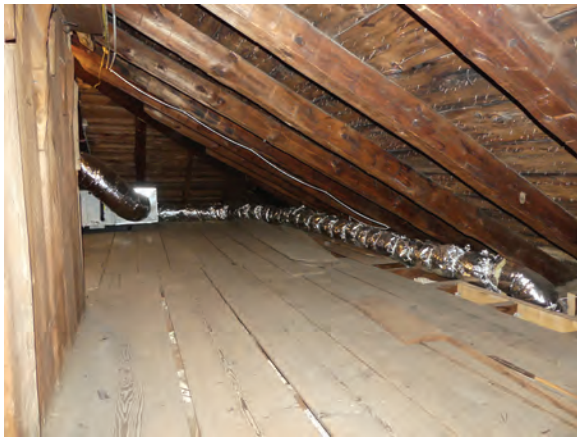
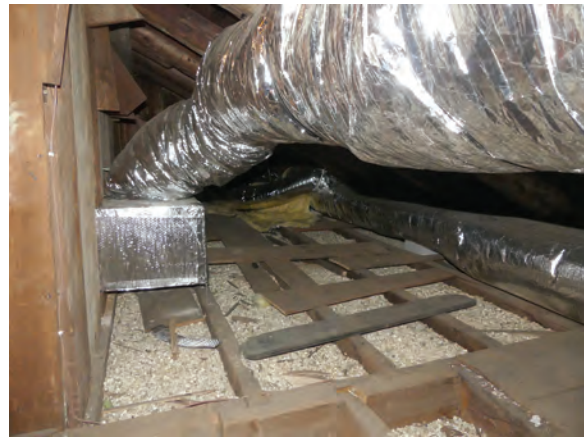
Figure 83. North side of the unfinished attic (303), looking east (upper image) and west (lower image). JGWA, 2018.

Figure 84. The partition enclosing the attic level stairwell (upper image); and the south side of the attic, looking east (lower image). JGWA, 2018.

It is recommended that the attic space no longer be used for storage of any kind.

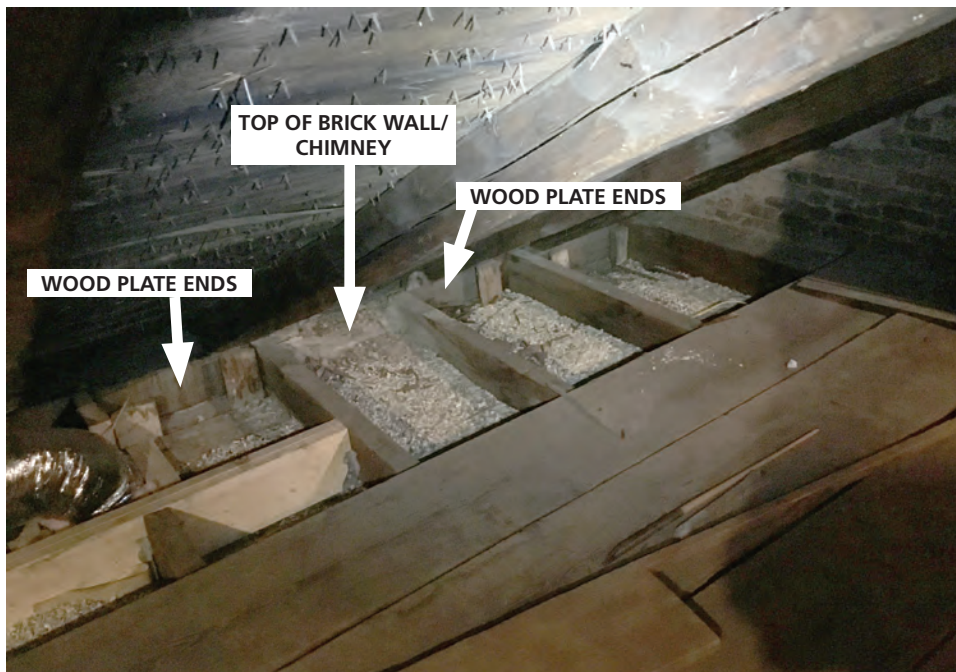
A small brick chimney that serviced the hall stove was originally positioned above the roof overhang, immediately south of the second-floor window. The base of this feature is visible in the attic (see Figure 85). It was likely removed when the 1922 heating system was installed.

Figure 85. The attic retains evidence of the small north chimney that serviced the Hall (101) stove. JGWA, 2019.

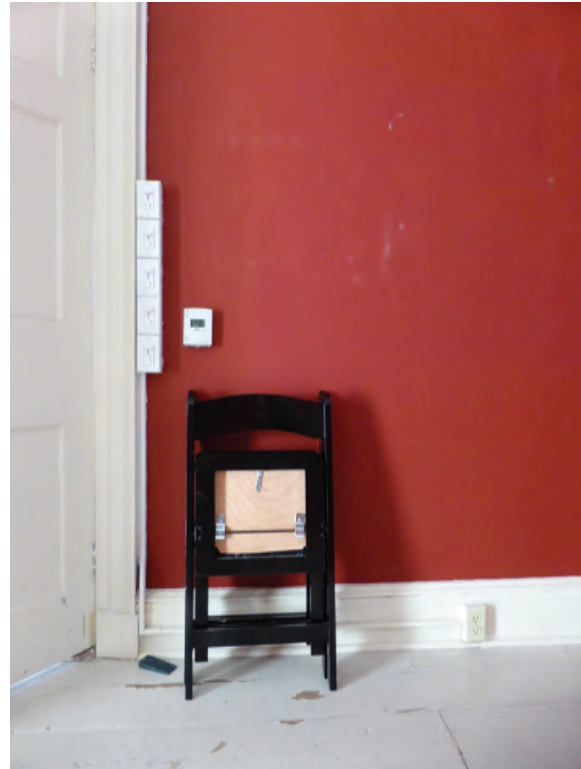
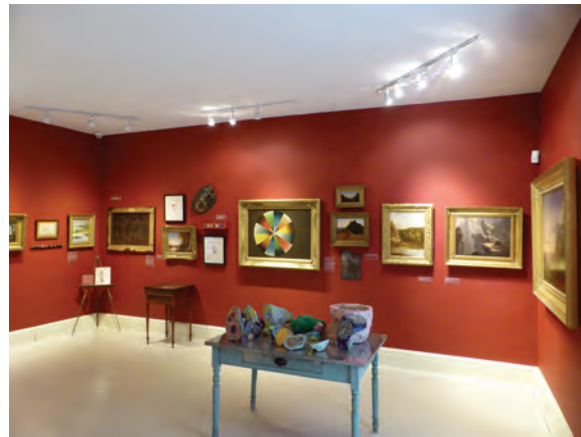
- Five separate sections of modern track lighting have been mounted to the ceiling. There is a smoke detector above the doorway and a video camera mounted on the ceiling at the northeast corner of the room. These devices are visually obtrusive, and they detract from the historic character of the house (see Figure 92).

- A motion detector is mounted in the southeast corner of the room, approximately two feet beneath the ceiling.
- Surface-mounted conduit is routed along the north door architrave, from baseboard to ceiling, with five surface-mounted light switches and dimmers, ganged vertically (see Figure 92). The conduit extends horizontally along the baseboard, to a surface-mounted receptacle approximately four feet north of the door. A surface-mounted *HOBOT* data logger is attached to the wall near the switches.

Figure 92. The modern track lighting mounted to the ceiling of the Girls' Room (202) is visually obtrusive and detracts from the historic character of the house. The surface-mounted conduit and vertically ganged dimming controls for this lighting are equally conspicuous. JGWA, 2019.
